Four-Point Bending Testing of 24-in. (600-mm) Diameter NS-type Ductile Iron Pipe

CSI Report 2023/05
Center for Smart Infrastructure (CSI)
Department of Civil and Environmental Engineering
University of California, Berkeley July 2023

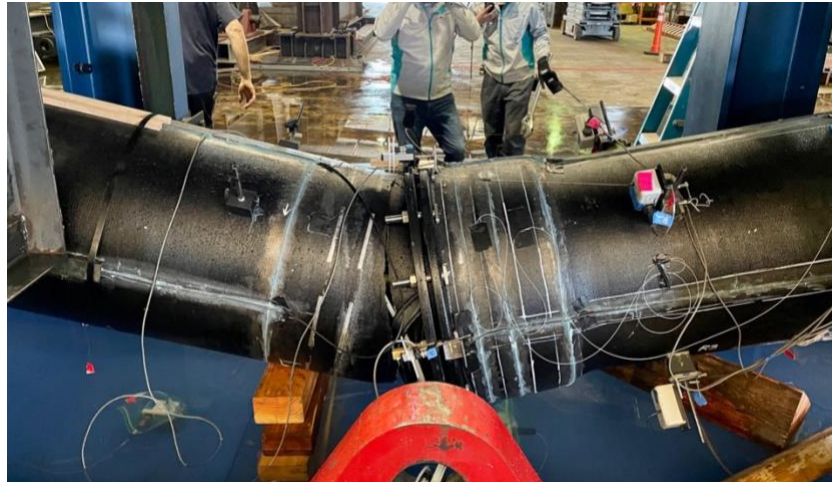
Figure 4-3 Large deformation and failure

Figure 4-3 shows the figure of the specimen with large deformation and failure. Notably, a large crack was observed on the spigot while the specimen reached about 20-degree deflection, followed by significant water leakage. On the other hand, no apparent failure was observed on the bell section of the specimen. In addition, Figure 4-4 illustrates a portion of the gland that experienced failure on the top side, where the bolts were bent. This failure occurred due to the interaction between the gland and the spigot during the downward pushing of the pipe. As the gland exerted pressure against the spigot, a large shearing force was generated, leading to the cutting of the gland material. Consequently, this introduced significant deformation to the surrounding bolts, resulting in their bending.

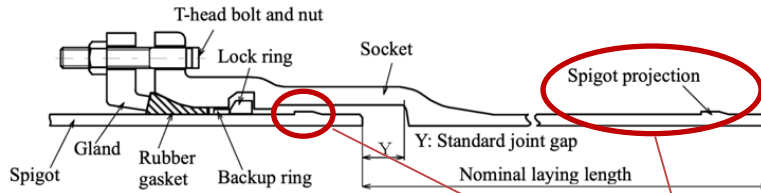
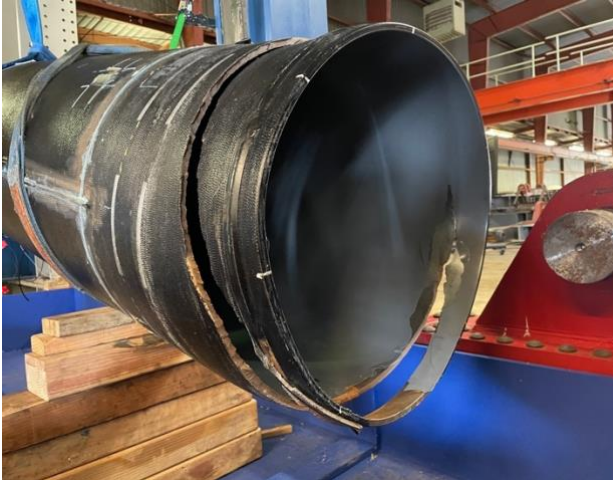
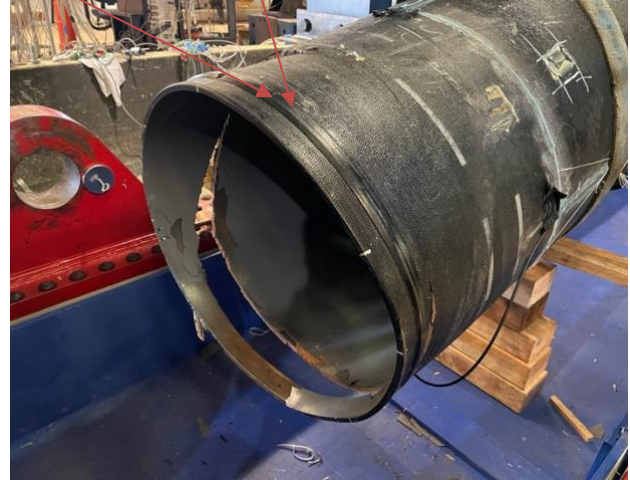
Figure 4-5 Failure of the spigot

The cracks observed on the spigot of the specimen originated from the edge of the spigot projection, located approximately 2-¼ inches from the spigot end, as shown in Figure 4-5. During the pushing-down process, the top side of the spigot exhibited a tendency to move inward towards the bell, while the bottom side tended to move away from the bell. Consequently, the bottom side of the spigot projection made full contact with the locking ring, resulting in a brittle tensile failure at the bottom side of the edge of the spigot projection. This specific location experienced a high stress concentration due to the contact forces and interactions between the spigot and the locking ring.

The initial crack at the edge of the bottom of the spigot projection then proceeded to propagate through the sides towards the top side. Shear forces primarily drove this propagation. The combination of the stress concentration at the edge of the spigot projection and the shear forces resulted in the formation and progression of the observed cracks, ultimately leading to the failure of the spigot and the subsequent water leakage.
