# **Tension Testing of 8-in. (200-mm) Diameter AWWA C900 DR14 iPVC Pipe**

CSI Report 2026/02  
Center for Smart Infrastructure (CSI)  
Department of Civil and Environmental Engineering  
University of California, Berkeley August 2026

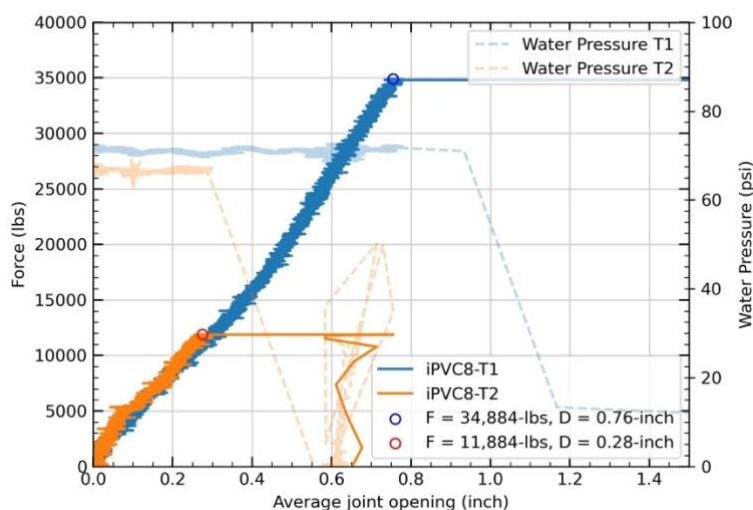
**Figure 4-1 Axial force, average joint opening, and water pressure results of Specimen 1 and 2**

opening results are shown in Figure 4-1. The maximum axial force with corresponding average joint opening of each specimen are 1) 34,884 lbs force with 0.76 inch displacements, and 2) 11,884 lbs force with 0.28 inch displacements. Water pressure drops were observed at the time reaching the maximum axial force for both specimens. The force and displacement relationships prior to failure are very similar between the two specimen, suggesting the initial setups of the experiments were similar. Specimen 2 failed at an earlier stage, compared to Specimen 1. This might be because of the different designs of the gaskets. The TurnerLok gasket has larger but fewer teeth which might potentially introduced a local concentrated stress, resulting in earlier localized failure. Also, as discussed later on, the specimens behaved differently as the loading increased, which may have contributed to the difference in the failure load. This issue will be investigated in the FE analysis of the experiments planned in the future. The test results are summarized in Table 4-1.

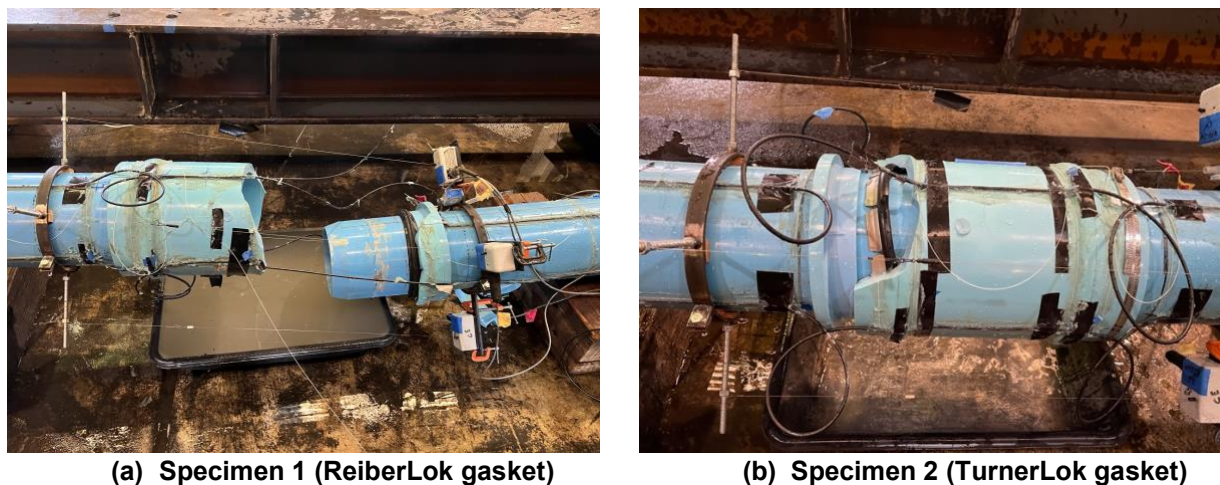
**Figure 4-2 Failure of Specimen 1 and 2**

On both of the specimens, the failure occurred in the joint segment close to the point where the teeth bit on the pipe. This indicates that the interaction between the teeth and the jointed segment caused the failure. The failures of both specimens are shown in Figure 4-2. Although shear/tensile stresses at the gasket locations likely governed both failures, the failure patterns were different. In Specimen 1 (ReiberLok gasket), the failure occurred around the circumference of the fitting. On the other hand, in Specimen 2 (TurnerLok gasket), the failure was observed only on the top side of the joint. The difference might be due to the design of the gasket. The ReiberLok gasket has numerous smaller teeth, which potentially distribute the applied load more evenly. With more teeth, the forces per tooth are smaller, reducing stress concentration around individual teeth. TurnerLok gasket has fewer but larger teeth, which concentrate greater stress at their boundaries.

This might be why Specimen 2 failed at an earlier stage. A detailed evaluation of the pipe failure mechanism will be carried out with the finite element model planned in the future.

The fitting broke at the north pipe connection, potentially because of the larger spatial variation in strains on the north side connection compared to the south side connection.

The fitting broke at the south pipe connection, potentially because of the larger spatial variation in strains on the south side connection compared to the north side connection.

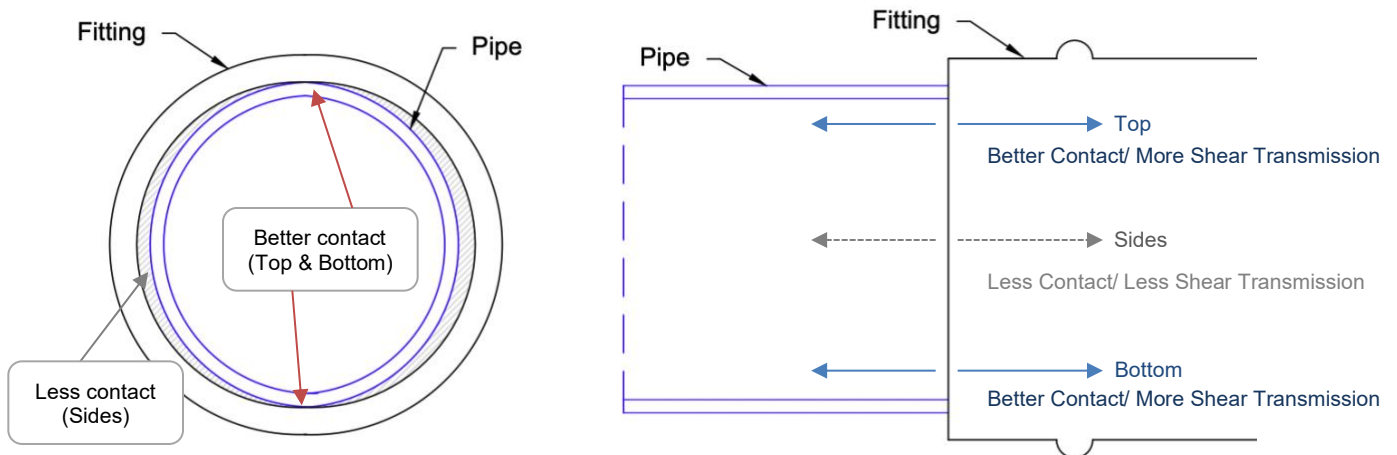
Figure 4-4 Sketch of pipe-fitting deformation mechanism

The strain data on the south pipe of Specimen 1 show a slight variation between the top and bottom. This could be due to the pipe being slightly bent towards the top. The strain developments on the east and west sides are similar at the beginning of the loading. However, when the load reached approximately 16,000 lbs, the strains started to develop at a slower pace. This indicates that there was less stress on the two sides compared to the top and bottom. It is possible that the pipe started to elongate during this loading stage. Consequently, the locking gasket had less contact to the pipe at the east and west sides in comparison to the top and bottom. This resulted in less axial force being transferred through the two sides compared to the top and bottom. This phenomenon is illustrated in Figure 4-4.

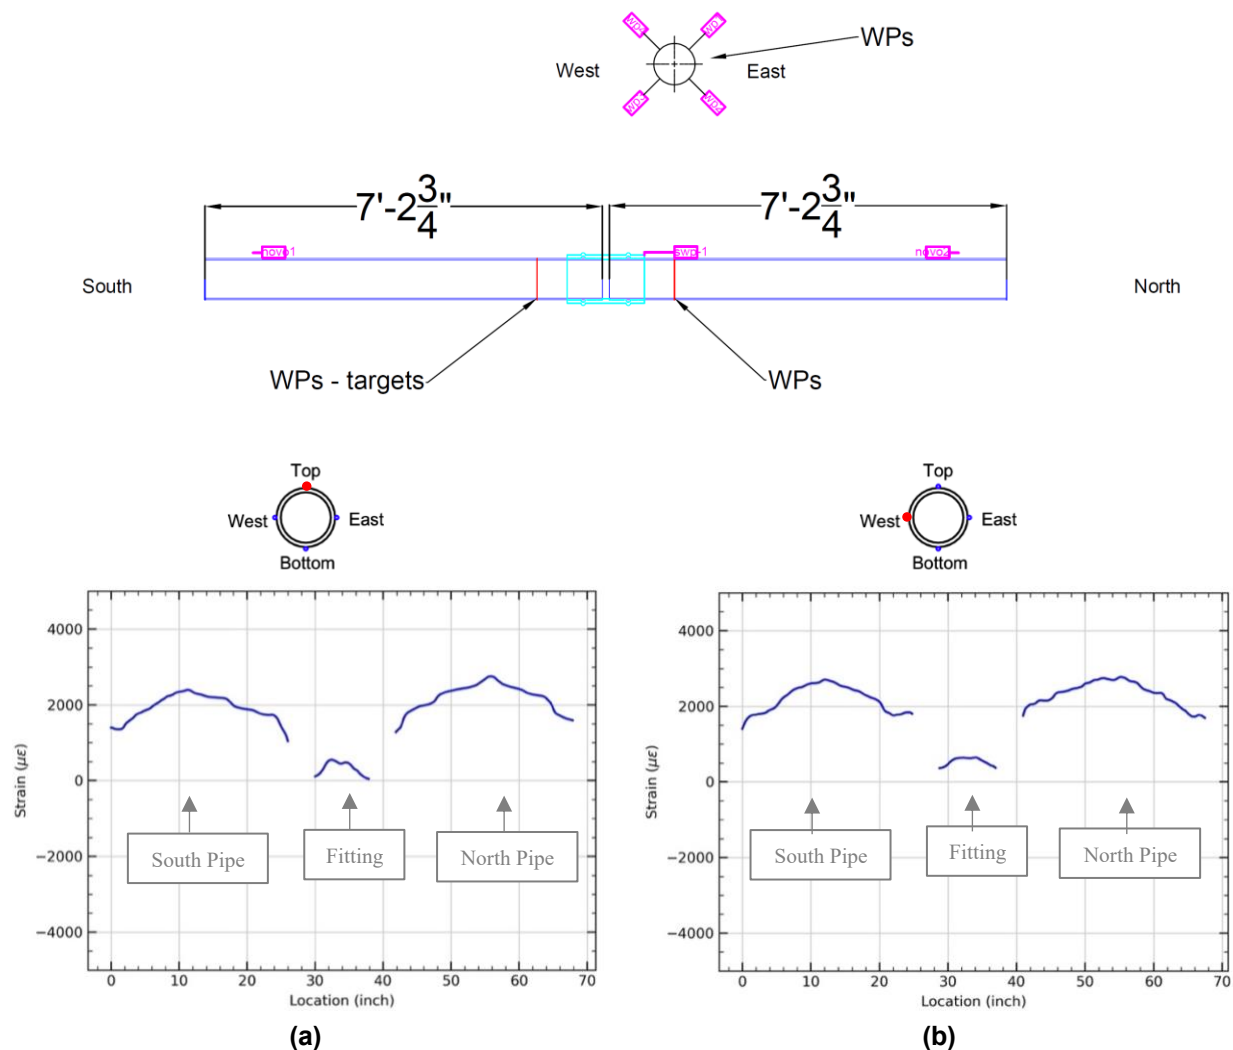
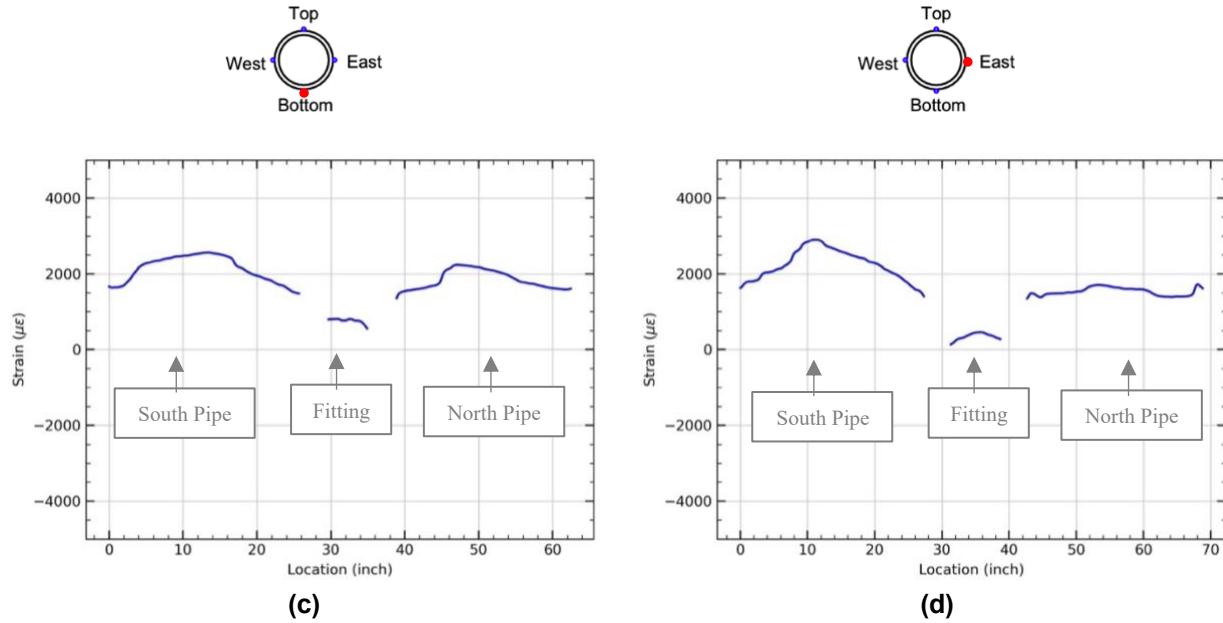
**Figure 4-5 Axial strain development of west pipe of Specimen 1 under 32,000-LBS axial loading condition. (a) Top, (b) West side, (c) Bottom, (d) East side**

Figure 4-5 shows the axial strain distribution of Specimen 1 under 32,000 lbs loading condition, close to failure. The figures are plotted from the south to the north, and the two gaps on the plots are the locations of the boundaries between the fitting and the pipes where no DFOS was attached. Tensile strains are observed at all locations when forces are applied in the axial direction. The strain profiles on the south and north pipes are similar, while the magnitudes of strain on the fitting are smaller than those measured on the pipes. This is due to the difference in thickness between the fitting and the pipes. The thicker wall of the fitting makes it much stiffer than the pipes, resulting in smaller strains developed on the fitting compared to the pipes.

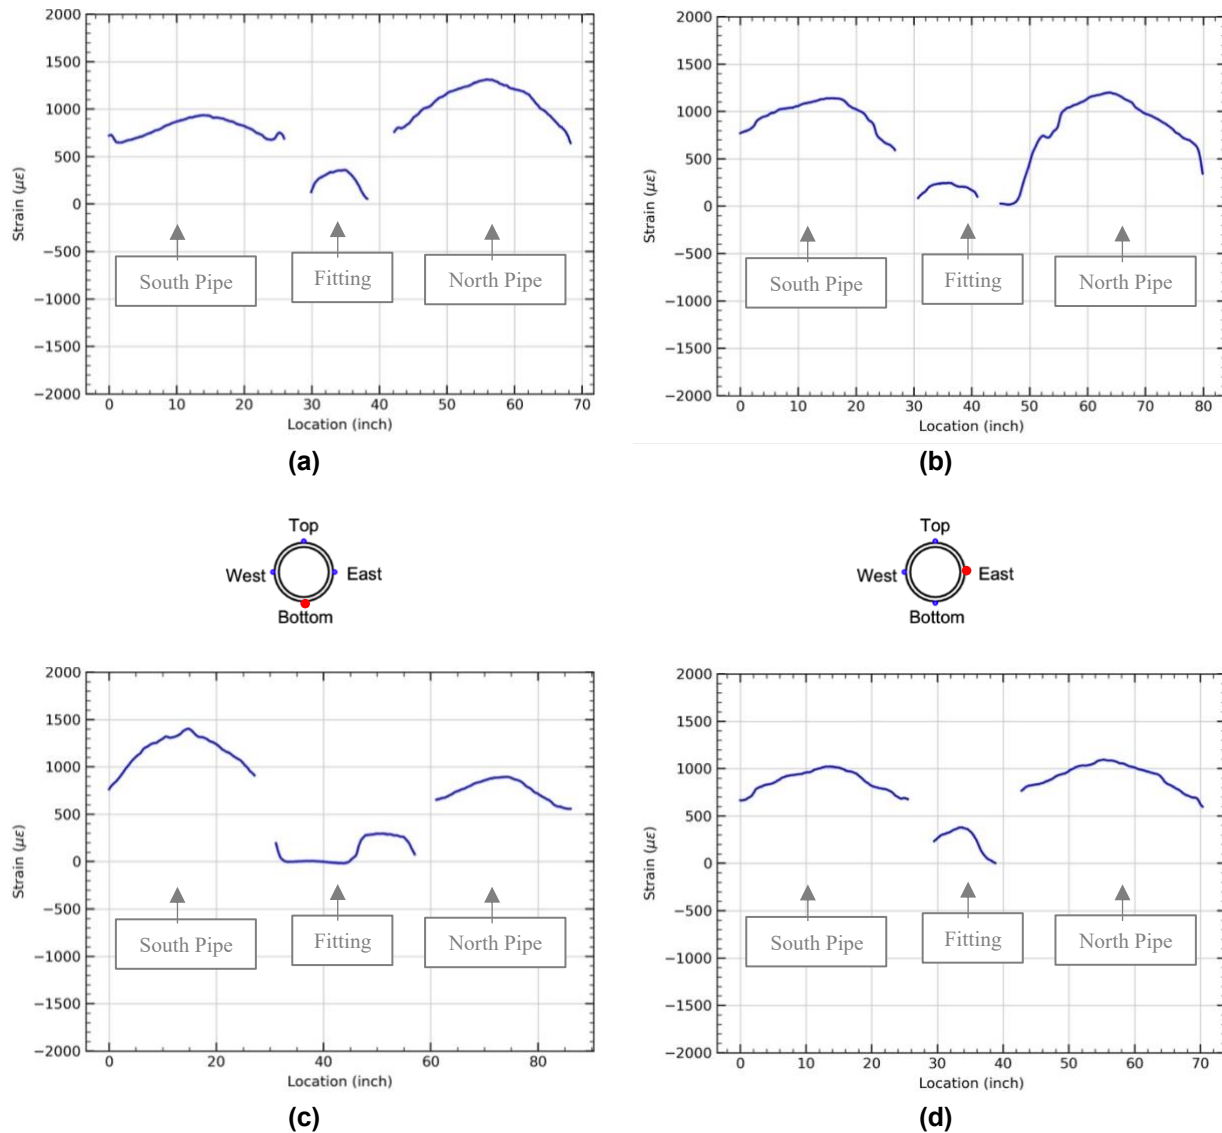
**Figure 4-6 Axial strain development of west pipe of Specimen 2 under 11,500-LBS axial loading condition. (a) Top, (b) West side, (c) Bottom, (d) East side**

Figure 4-6 illustrates strain measurements from Specimen 2 under an 11,500 lbs axial loading condition. Since the maximum load was smaller, the strain magnitudes are also smaller compared to those from Specimen 1. However, a similar pattern of strain distribution is noted with larger strains observed on the pipes as opposed to the fittings. This is because the pipes have a smaller wall thickness than the fittings.

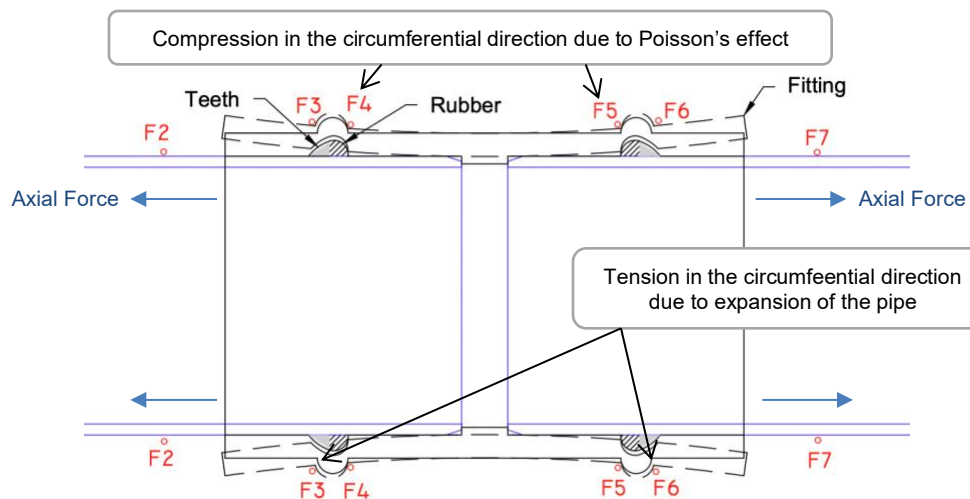
**Figure 4-8 Sketch of the fitting deformation under axial force**

Sensor F3 was positioned north of the gasket location, while Sensor F4 was located south of it. As the pipe was pulled out, the wedged side of the teeth on the gasket pressed against the fitting, causing the outer side of the fitting from the gasket location to expand by the gasket-fitting

interaction, as shown in Figure 4-8. This phenomenon is clearly observable in the results measured by Sensor F3, where the fitting exhibited tension all around its circumference. A similar pattern is evident in the results from Sensor F6.

Compressive strains are observed on the inner side of the fitting from the gasket location, as indicated by Sensor F4 measurements. As demonstrated in earlier sections, the longitudinal strains in this section are smaller, leading to reduced hoop strains due to Poisson's effect. Although similar behavior would be expected at the location of Sensor F5, its results are not reported in this study due to sensor damage during testing. The fitting degormation mechanism is visualized in Figure 4-8.
