Comparative Shear Testing and Finite Element Analysis of PowerSeal Saddle for Service Line Installations

Tianyu Han, Qinglai Zhang, Shakhzod M. Takhirov, Kenichi Soga
Center for Smart Infrastructure (CSI)
Department of Civil and Environmental Engineering
University of California, Berkeley

Prepared for PowerSeal Pipeline Products Corporation

CSI Report 2022/01
Center for Smart Infrastructure (CSI)
Department of Civil and Environmental Engineering
University of California, Berkeley
Dec 2022

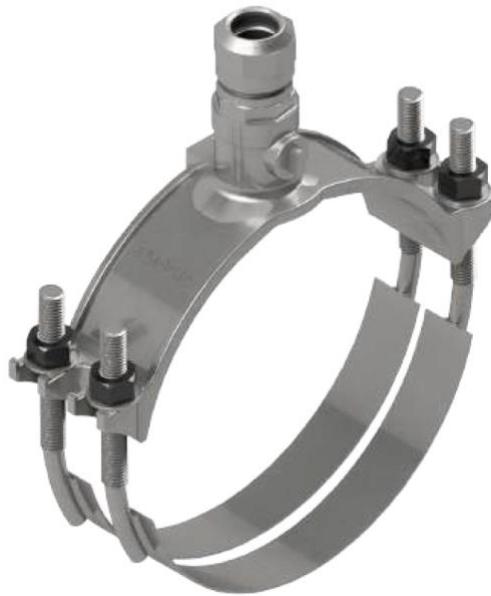
Figure 1-1. PowerSeal model 3450AS saddle

This report discusses the results of tests conducted on a conventional saddle and the service saddle manufactured and supplied by PowerSeal Pipeline Products Corporation (PowerSeal herein). PowerSeal model 3450AS shown in Figure 1-1 was selected for this study. Specifications of the saddle are provided in Appendix A [1].

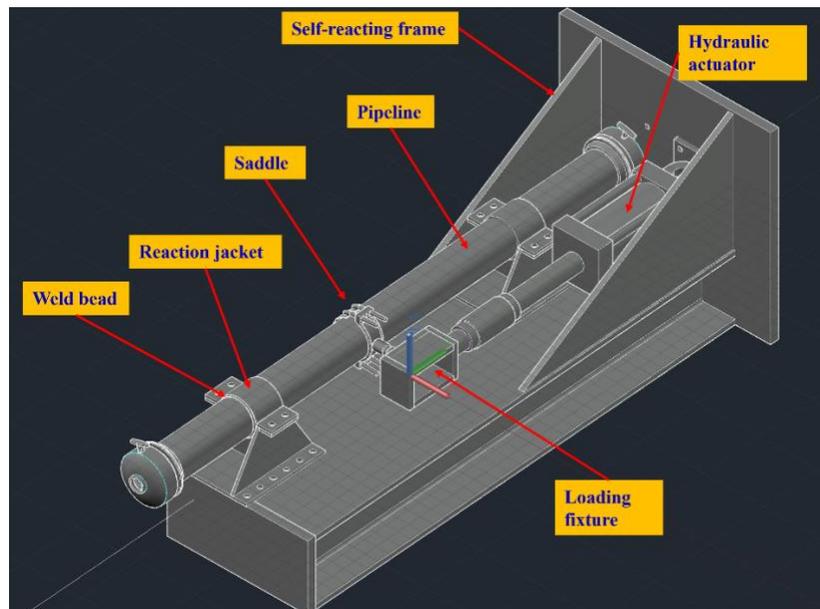
Figure 2-1. Schematic drawing of experimental setup

A special experimental setup was developed at the Center for Smart Infrastructure (CSI), UC Berkeley. It was based on the utilization of a self-reacting frame that accommodated both the loading and reacting parts as presented in Figure 2-1. Special jackets were designed and fabricated

to hold the water distribution pipeline in place. A 120-kip hydraulic actuator was used to apply the force via a loading fixture.

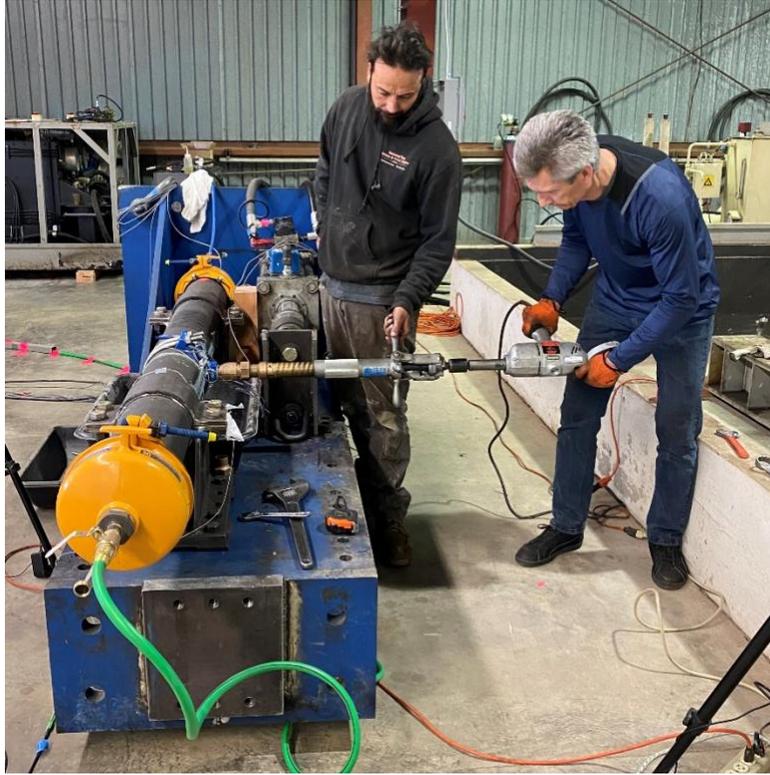
Figure 2-2. Drilling a tap hole in distribution pipeline through a saddle

A ductile iron pipe manufactured by US Pipe with a nominal diameter of 6-in was used in the tests. A service tap hole in the pipe was drilled by utilizing the tools provided by EBMUD as presented in Figure 2-2. Since the service line is much more flexible than the distribution line it was assumed that their interaction is negligible. Hence, the service line was not installed.

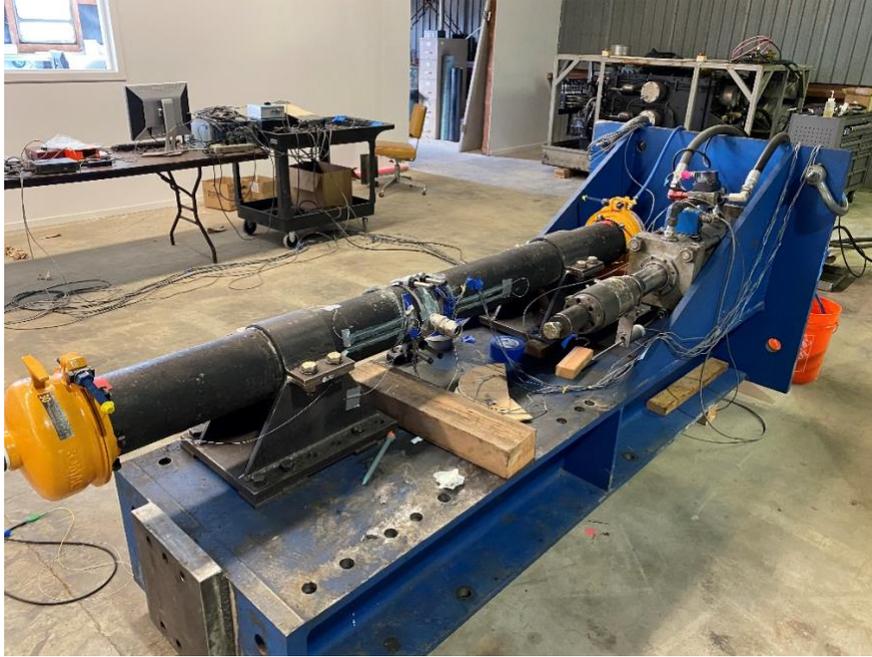
Figure 2-3. Overall view

An overall view of the fully assembled experimental setup is presented in Figure 2-3. Since the primary intention of the project was to study the saddle performance under shear loading (without applying any moment) a pivoting hoist ring was used as the loading element. This detail of the load application is presented in Figure 2-4.

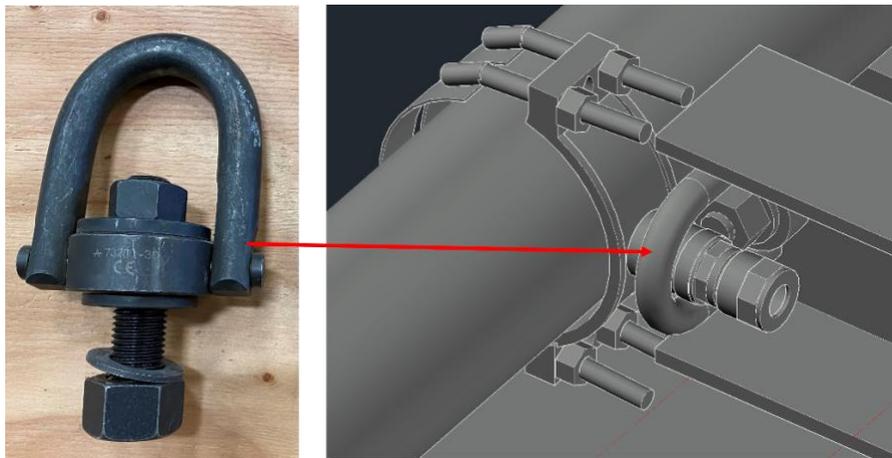
Figure 2-4. Detail of load application

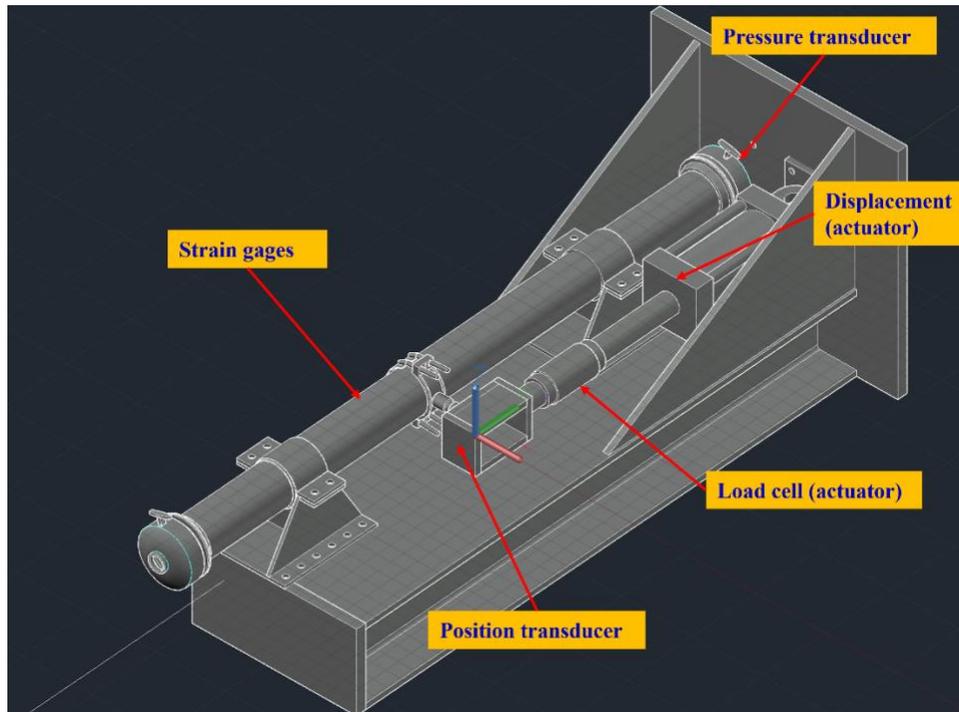
Figure 3-1. Locations of conventional instruments

A schematic drawing showing the locations of the conventional instruments is presented in Figure 3-1. The actuator has a position transducer and a built-in load cell. The pipe was pressurized to 70 psi and the pressure inside of the pipe was monitored by a pressure transducer installed on one of the endcaps. An air release valve was installed on another endcap. Six strain gages were installed on the pipeline. An additional position transducer was installed to monitor the displacement of the saddle right next to the loading point as presented in Figure 3-2.

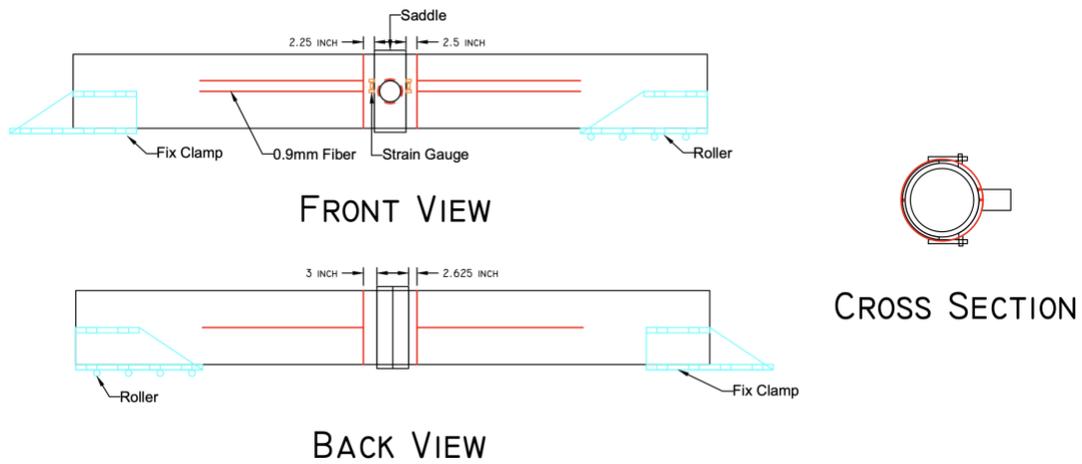
Figure 3-3. Locations of fiber-optic sensors for the Benchmark saddle

The NanZee NZS-DSS-C07 fiber-optic cable was installed on both the pipeline and the saddle by the 3M structural plastic adhesive DP8010. Schematic drawings showing the location of the fiber-optic sensors for the benchmark saddle and the PowerSeal saddle are presented in Figure 3-3 and Figure 3-4, respectively. The same piece of the distribution pipeline was used throughout the experimental program and only the saddle was change from test to test. The locations are the same on the pipeline but different on the saddles due to the different designs of two saddles.

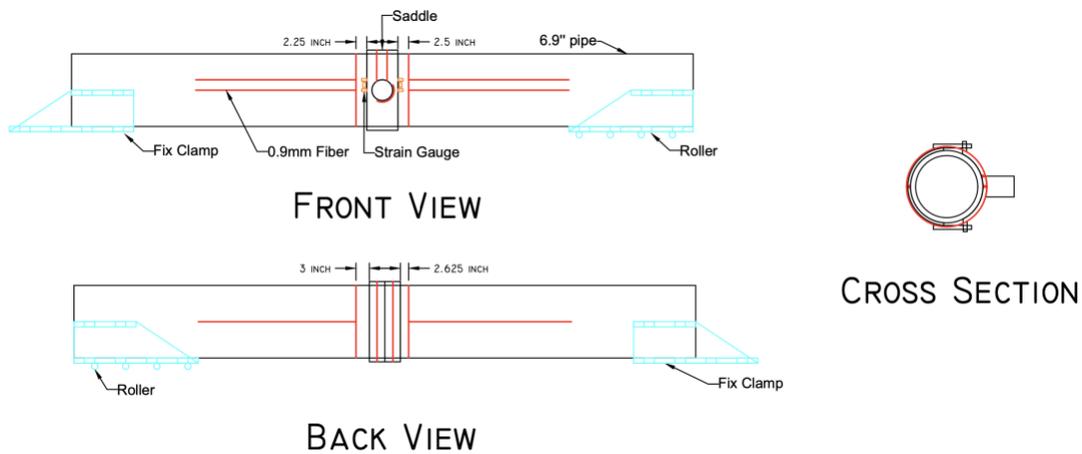
Figure 3-4. Locations of fiber-optic sensors for the PowerSeal saddle

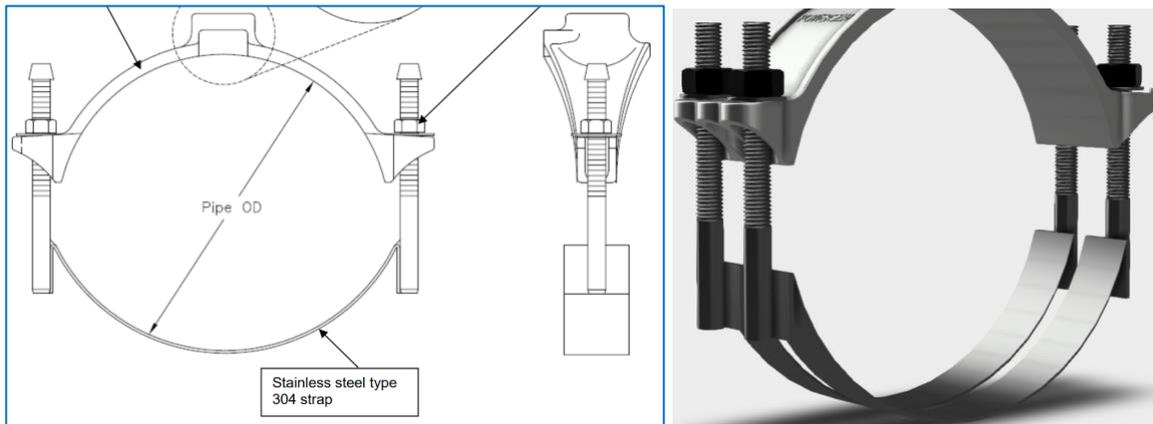
Figure 3-5. Straps with lower capacity

A total of seven tests (three on the conventional saddle and four on PowerSeal saddle) were conducted as listed in Table 3-2. The first saddle from PowerSeal had type 304 straps, shown in Figure 1-1 and listed in the saddle’s specifications in Appendix A. The second and third saddles arrived with straps of another design as presented in Figure 3-5, which have a different design on the connection part between the bolt and the strap. Based on the experiments conducted on these straps, they have a much lower capacity than the ones shown in Figure 1-1. Thus, the straps used on the first test (PS1) were re-used for the second (PS2) and the third (PS3) tests. The performance of PowerSeal saddle with the low-capacity strap was tested in the fourth test (PS2-NewStraps). The performance of PowerSeal saddles was compared to that of the benchmark with the same application of the torque to the nuts pre-tensioning the straps to the pipe. Tests were performed on

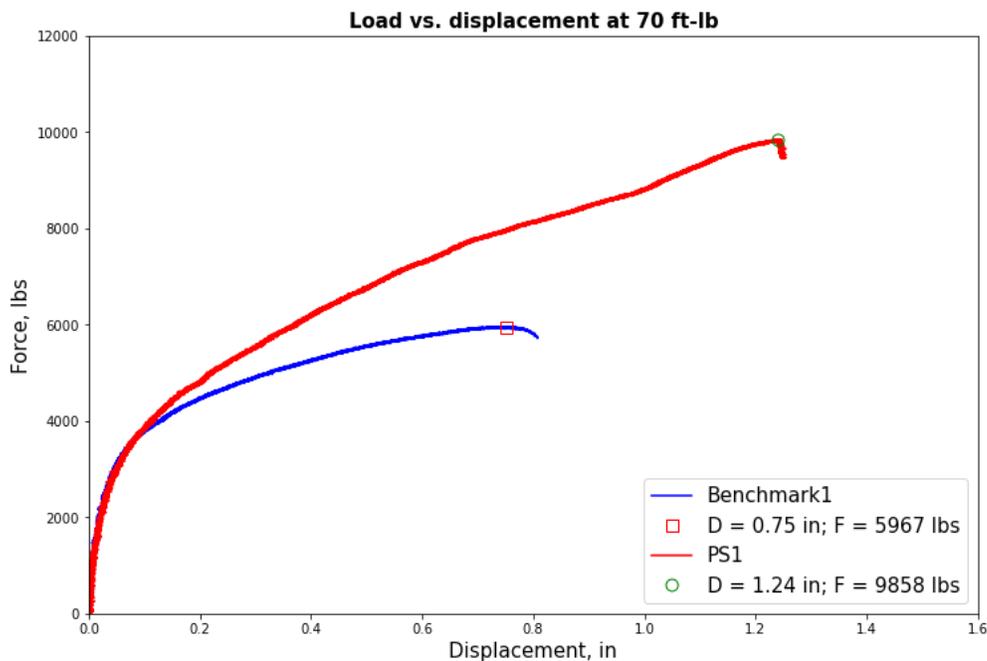
Figure 4-1. Test results for 70 ft-lb torque

For a given applied torque, a monotonic pull parallel to the longitudinal axis of the pipeline was applied. The tests were conducted up to failure of the saddle or a significant water leak. This report summarized peak values of the force and the respective displacement at maximum force obtained from the test data. The test results are provided in pairs for each torque value comparing the saddle from PowerSeal to the benchmark. The results for the torque at 70 ft-lb are shown in Figure 4-1. The results for 85 ft-lb and 100 ft-lb torque values are shown in Figure 4-2 and Figure 4-3, respectively. The results for PowerSeal saddles with different straps at 85 ft-lb torque are shown in Figure 4-4.

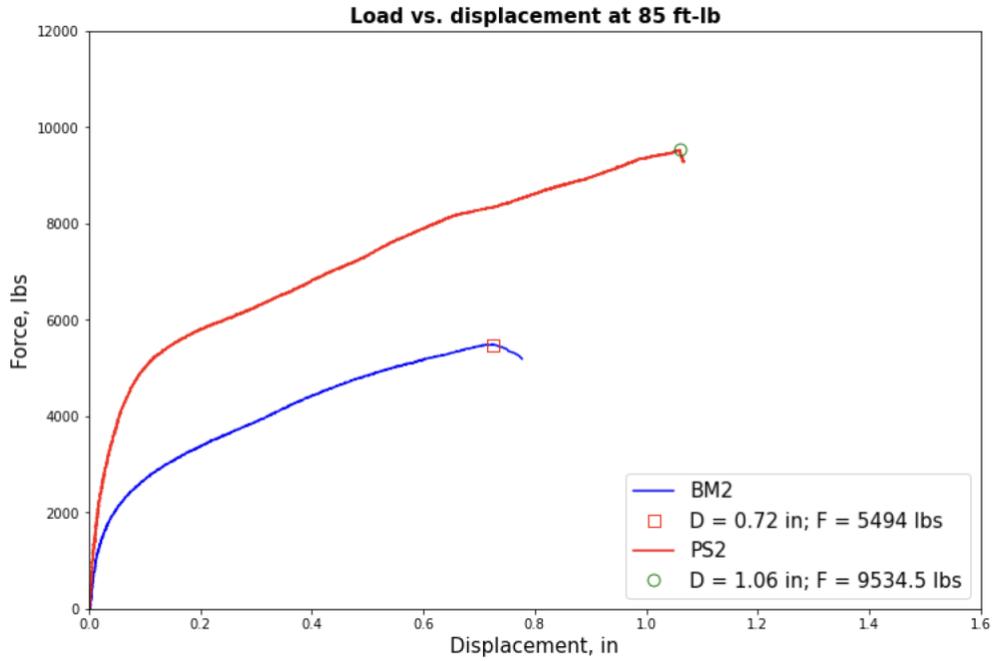
Figure 4-2. Test results for 85 ft-lb torque

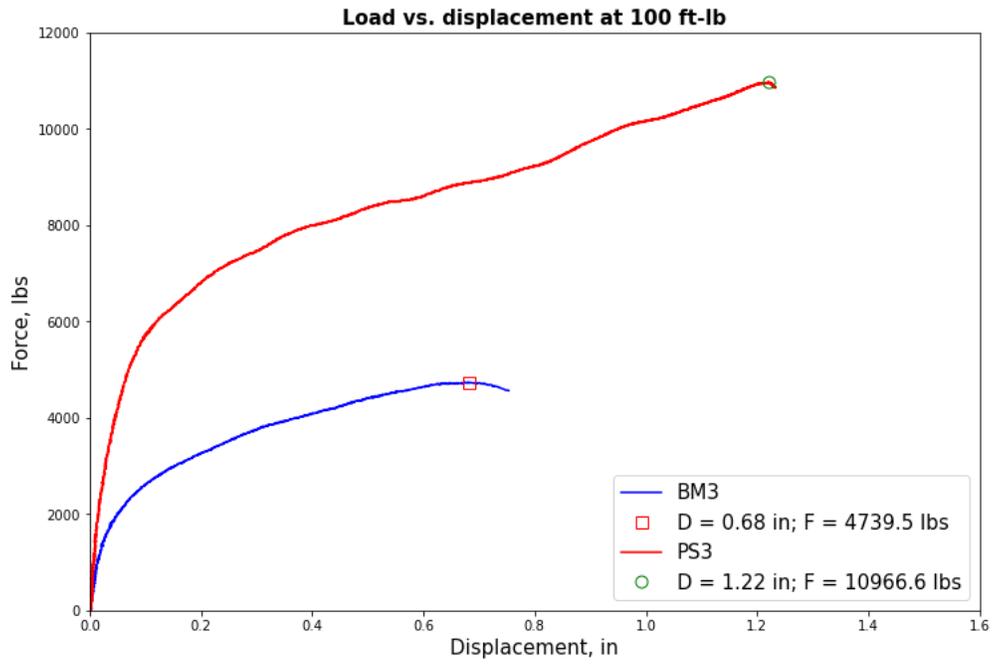
Figure 4-3. Test results for 100 ft-lb torque

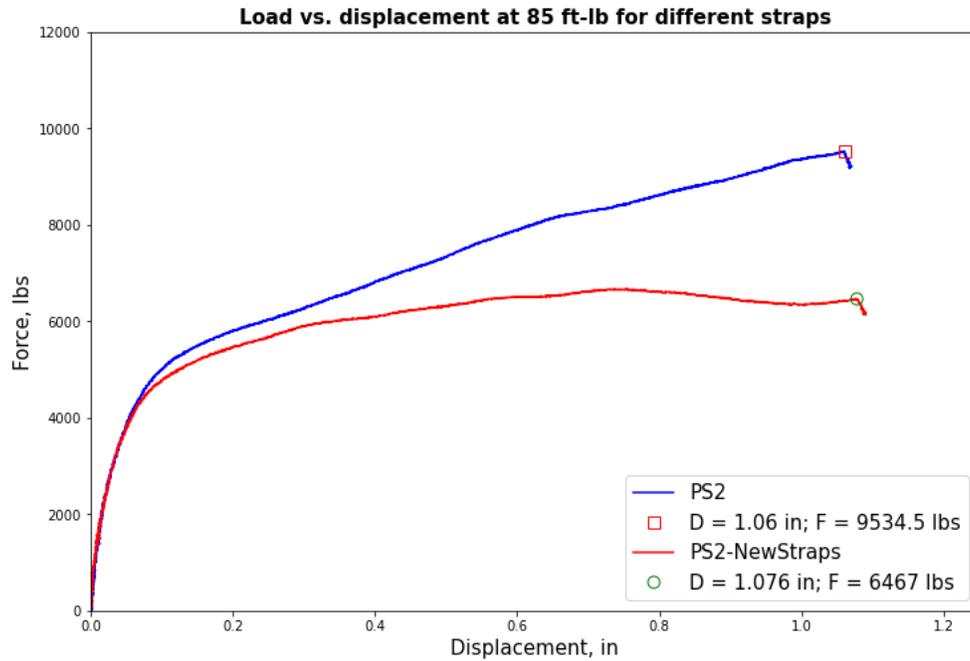
Figure 4-4. Test results for PowerSeal saddles with different straps at 85 ft-lb torque

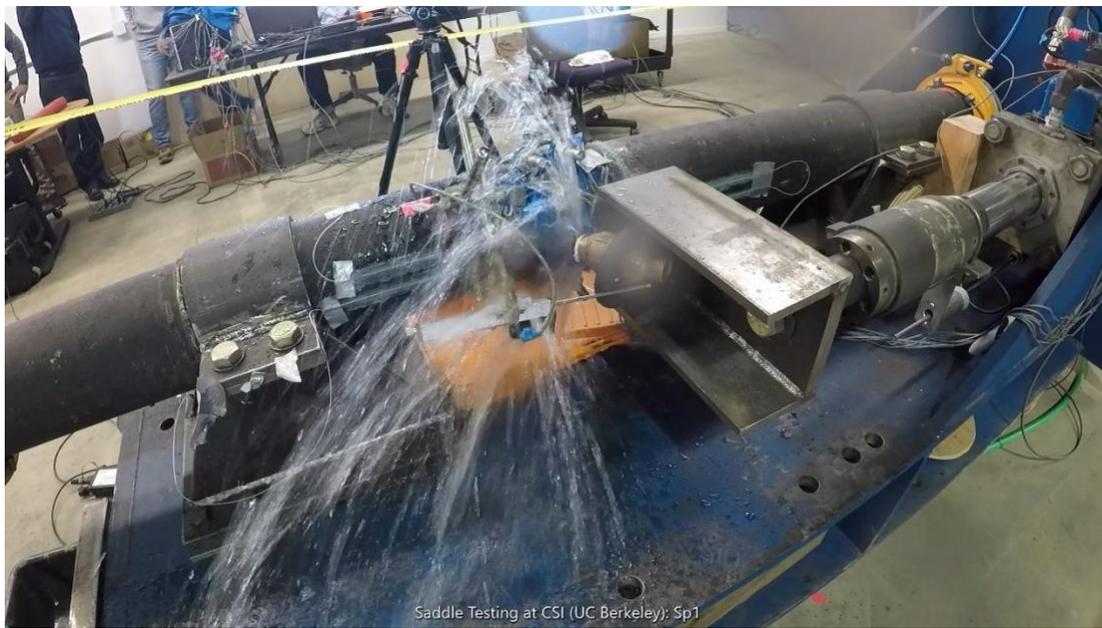
Figure 4-5. Typical failure of benchmark saddle

The failure modes of the benchmark and the PowerSeal saddles were completely different from one another. The tests on the benchmark saddles were stopped because of the failure of the saddle and an explosive water release as presented in Figure 4-5. The force dropped right after the failure for the benchmark saddle cases.

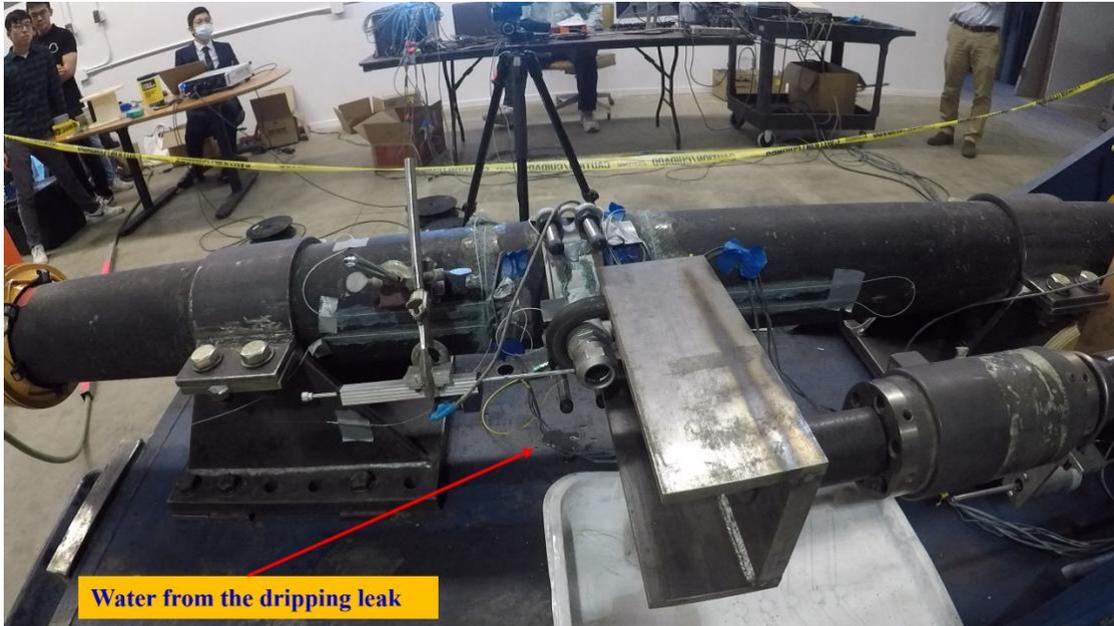
Figure 4-6. PowerSeal saddle: dripping water leak close to the maximum force

Water leaked from the PowerSeal saddles started at a level of a few drips as presented in Figure 4-6. The testing of the PowerSeal saddles was stopped when the gradually increasing water leak turned into a significant leak (at which the maximum force was recorded). It is worth noting that the benchmark saddle was completely sheared off, whereas the PowerSeal saddles just slid off the pipe.

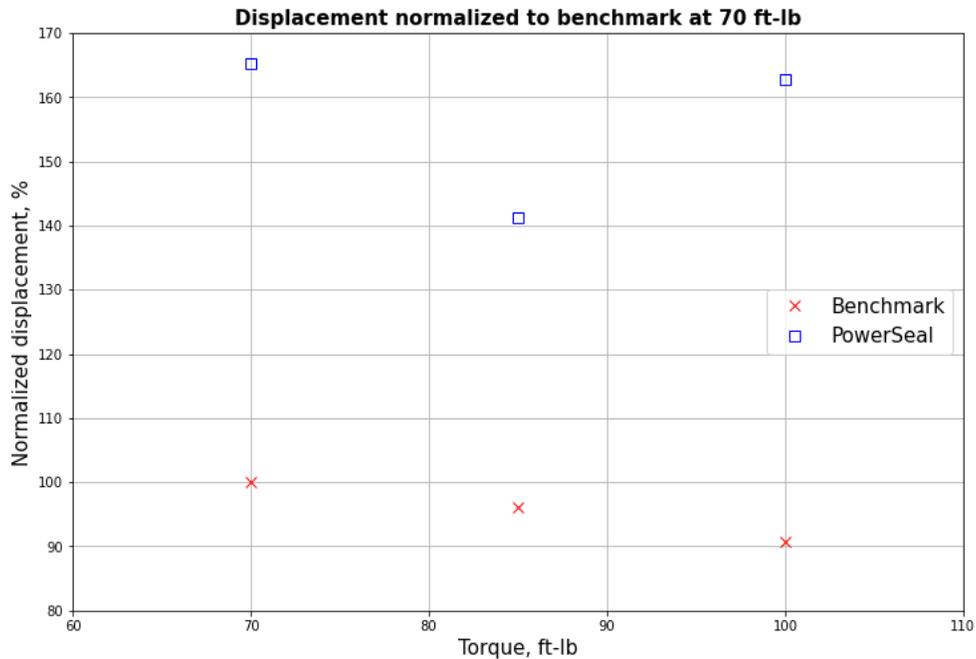
Figure 4-7. Normalized displacement

A displacement normalized to that of the benchmark at 70 ft-lb torque is presented in Figure 4-7. Results show that the PowerSeal saddle has at least a 40% higher displacement capacity than the conventional saddle. A maximum force normalized to that of the benchmark at 70 ft-lb torque is shown in Figure 4-8. The PowerSeal saddle has at least a 60% greater force capacity than the conventional saddle. The PowerSeal saddle did not fail in a dramatic way. An explosive water leak happened in the case of the benchmark saddle.

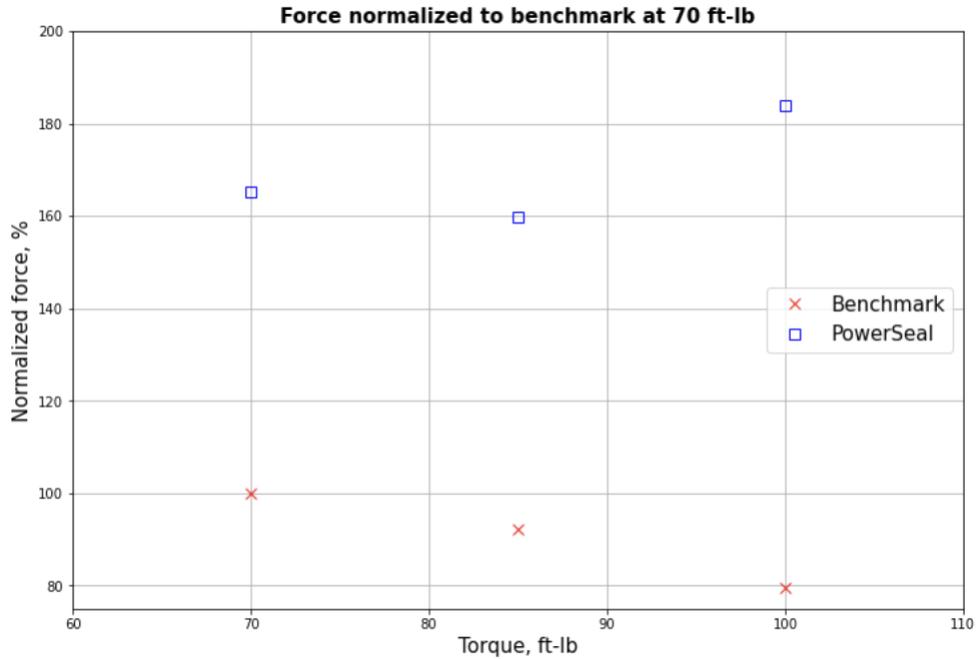
Figure 4-8. Normalized force

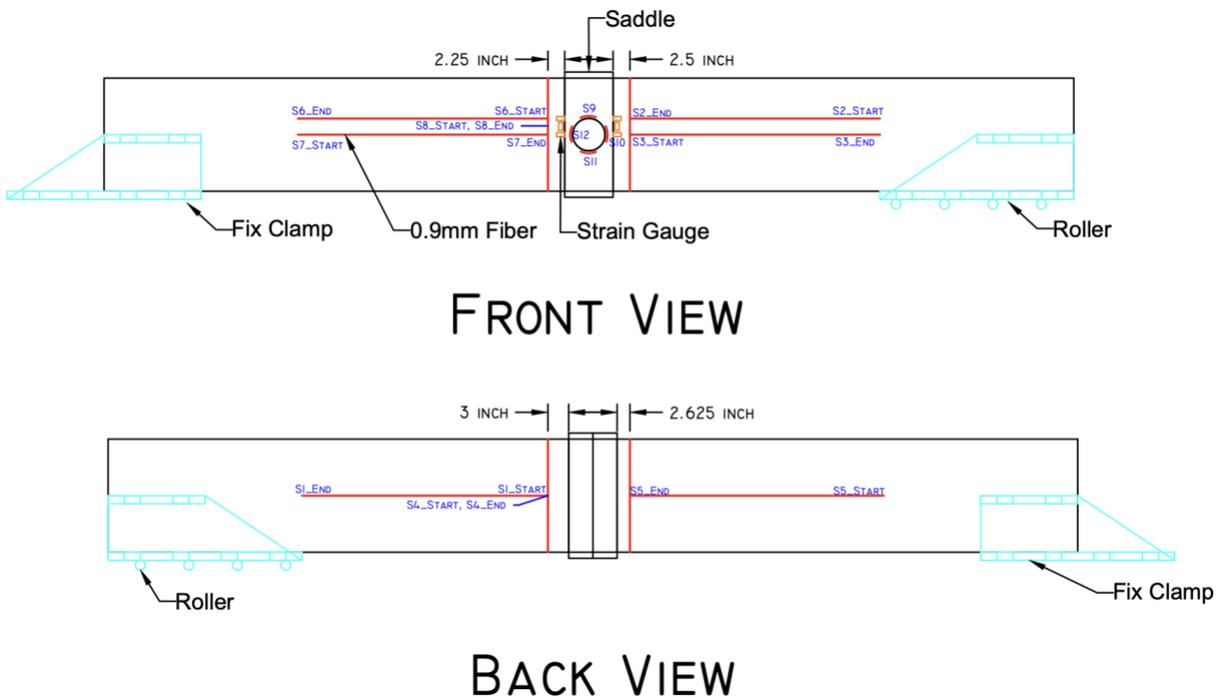
Figure 5-1. Index for the fiber-optic cables for Benchmark1 and Benchmark3

For the convenience of data processing, the fiber-optic cables were indexed by segments. The index for Benchmark1 and Benchmark3 is presented in Figure 5-1. The index for PS1 is presented in Figure 5-2. The index for PS2, PS3, and PS4 is presented in Figure 5-3. In this section, all the indices will refer to the ones shown in Figure 5-3.

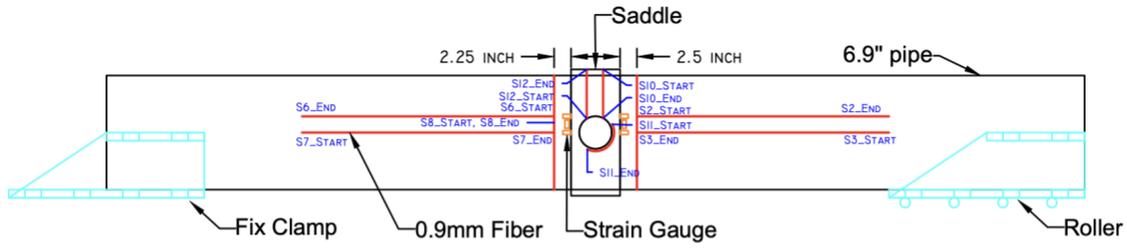
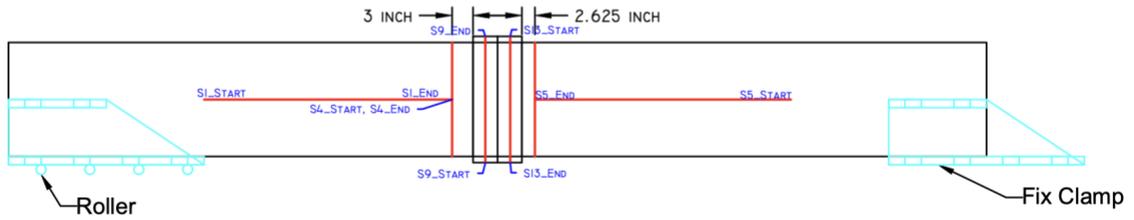
Figure 5-2. Index for the fiber-optic cables for PS1

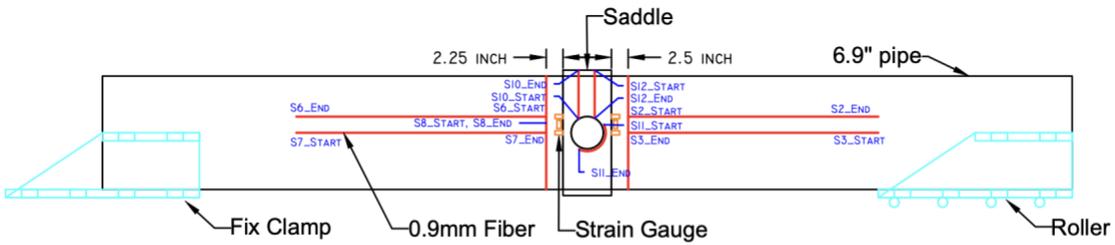
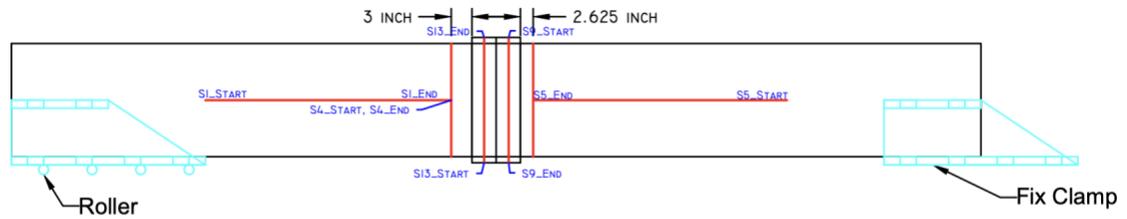
Figure 5-3. Index for the fiber-optic cables for PS2, PS3, and PS4

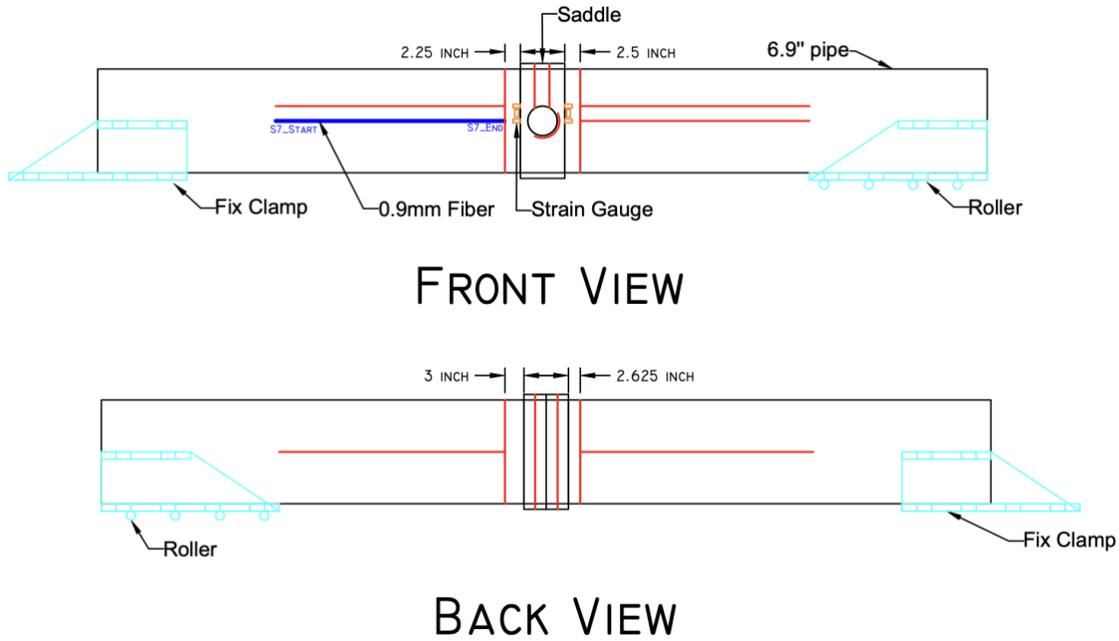
Figure 5-4. Location of Sensor 7 (the blue segment along the longitudinal direction of the pipeline)

The fiber-optic data collected from Sensor 7, Sensor 8, and Sensor 13 are compared and analyzed in this report. Sensor 7 was installed along the longitudinal direction of the pipeline (Figure 5-4). Sensor 8 was installed along the circumferential direction of the pipeline (Figure 5-5). Sensor 13 was installed on the strap (Figure 5-6). The test results of all fiber-optic sensors are provided in Appendix D.

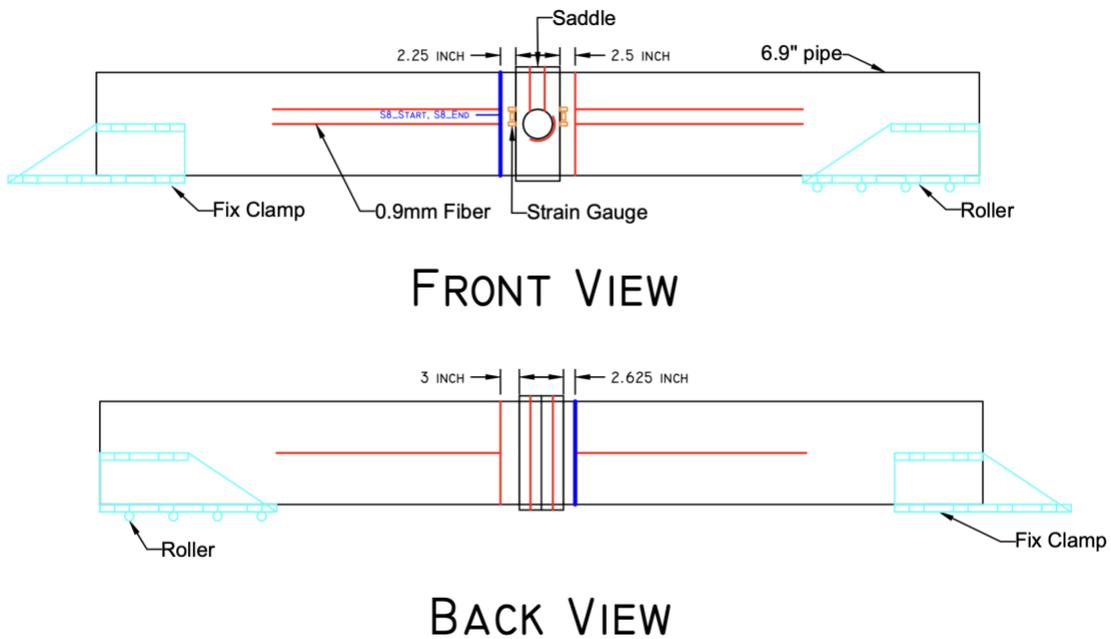
Figure 5-5. Location of Sensor 8 (the blue segment along the circumferential direction of the pipeline)

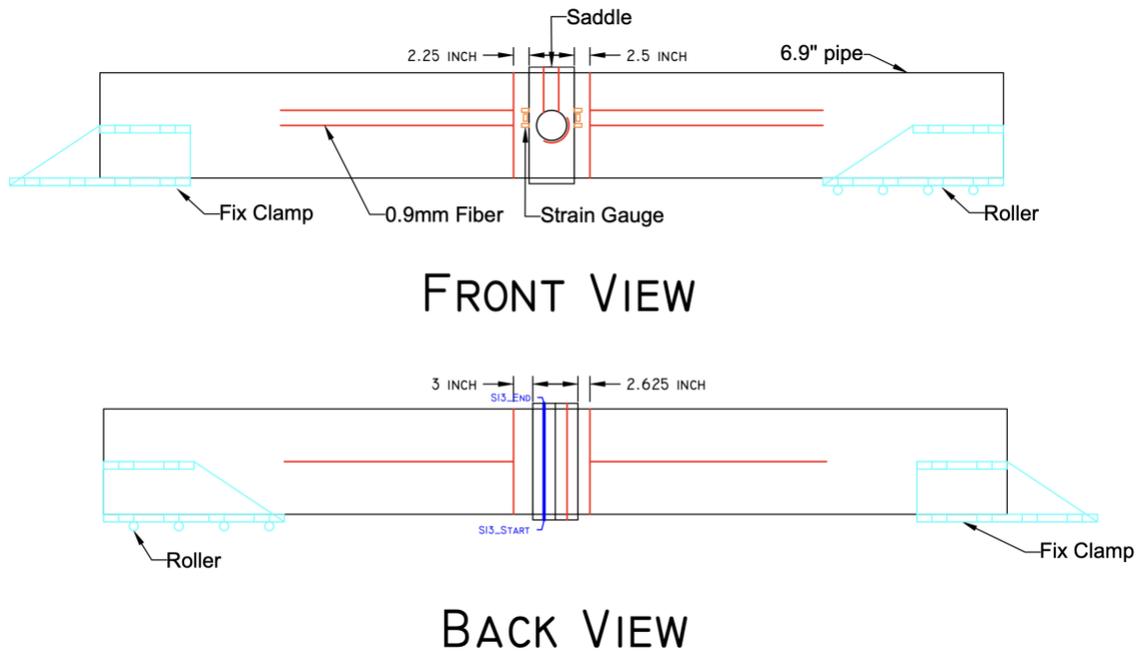
Figure 5-6. Location of Sensor 13 (the blue segment on the strap)

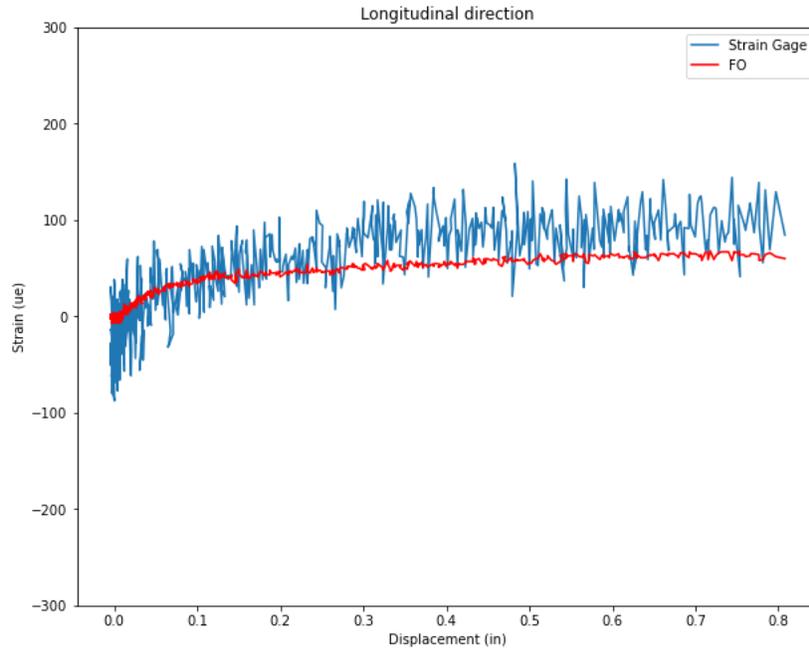
In the longitudinal direction, the end point of Sensor 7 is compared with the strain gage (Pacific - 9 (0:2:0)r rgt center). The result is presented in Figure 5-7.

Figure 5-7. Comparison between the strain gage and fiber-optic data in the longitudinal direction on the pipeline

It can be found that in both longitudinal and circumferential directions, the fiber-optic data has similar trends as the strain gage data but with smaller magnitudes, which might be mainly due to the different locations of the fiber-optic sensors and strain gages. In order to avoid the large bending angle of the fiber-optic cable, the end point of Sensor 7 and the start point of Sensor 8 were installed more than 2 inches away from the saddle. While the strain gages do not have this limitation, they were intentionally installed much closer to the saddle, which were about 0.5 inches away from the saddle (Figure 5-9). Thus, it is expected that the strain gages would measure larger strains than the fiber-optic sensors.

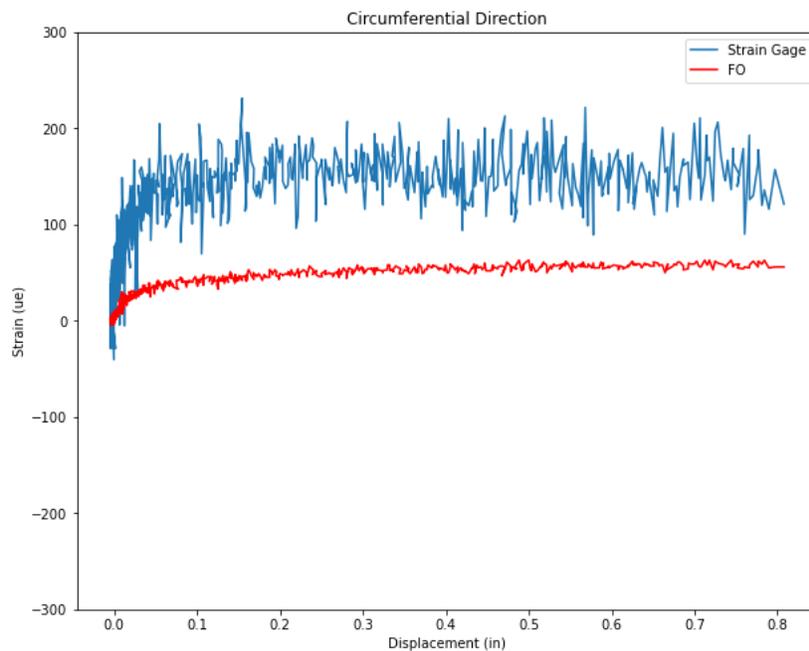
In the circumferential direction, the start point of Sensor 8 is compared with the strain gage (Pacific - 11 (0:2:2) rgt circum). The result is presented in Figure 5-8.

Figure 5-8. Comparison between the strain gage and fiber-optic data in the circumferential direction on the pipeline

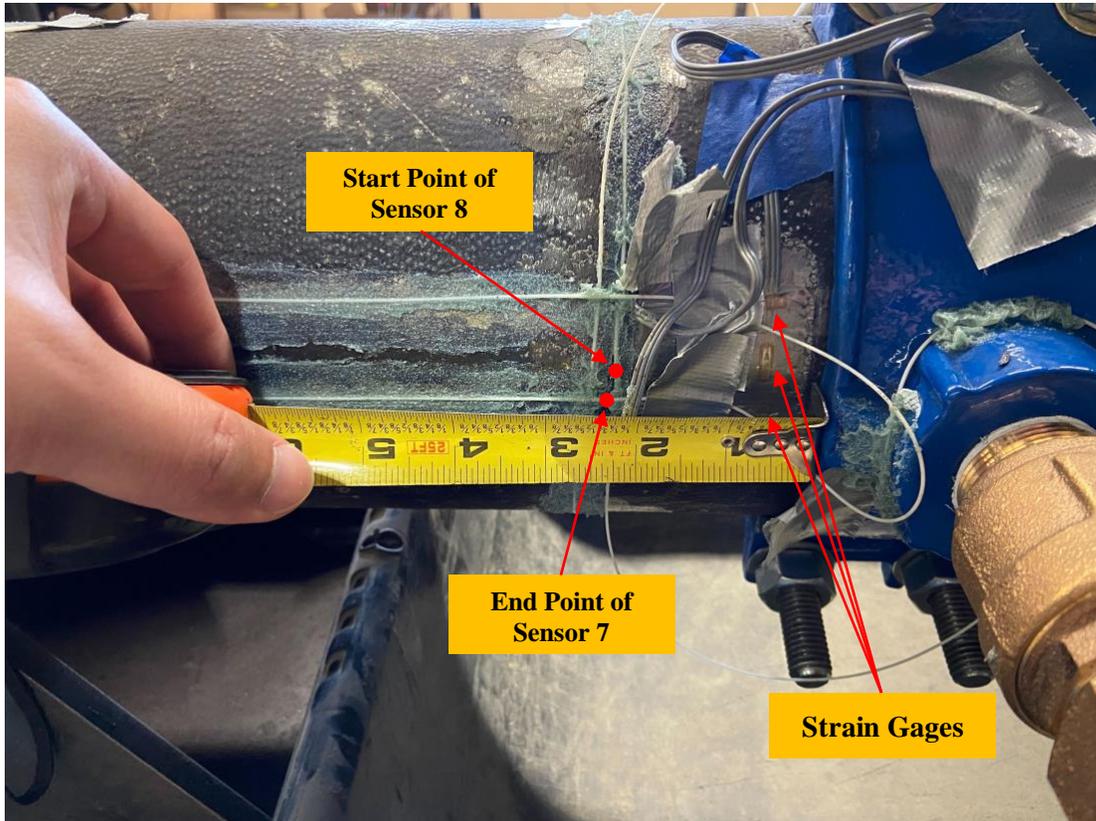
Figure 5-9. Locations of strain gages and the data points of fiber-optic sensors for BM1

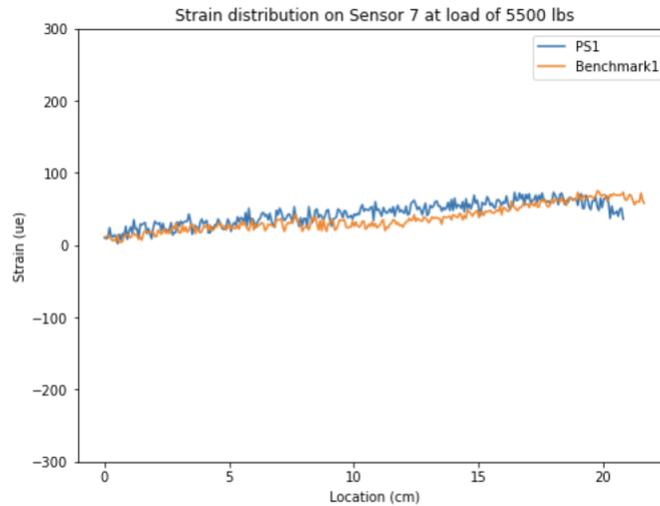
Figure 5-10. Strain distribution on Sensor 7 at load of 5500 lbs.

The results of the strain distribution on Sensor 7 at loading of 5500 lbs. for Benchmark 1 and PS1 are shown in Figure 5-10. The results of the maximum strains changing with the loading and displacement on Sensor 7 for the two tests are shown in Figure 5-11. It can be found that, in the longitudinal direction, before Benchmark1 failed, the strain distributions and the maximum

strain developments on the pipeline were very similar for Benchmark1 and PS1. In addition, the strain on the pipeline would become larger when it got closer to the saddle.

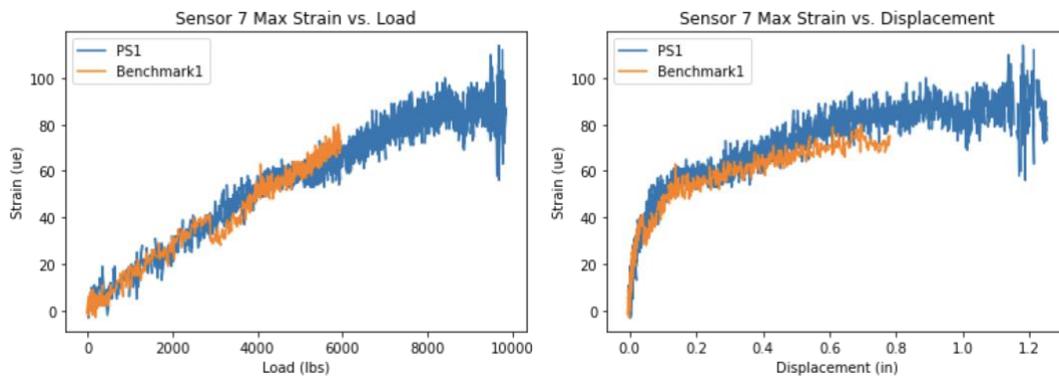
Figure 5-11. Maximum strain on Sensor 7

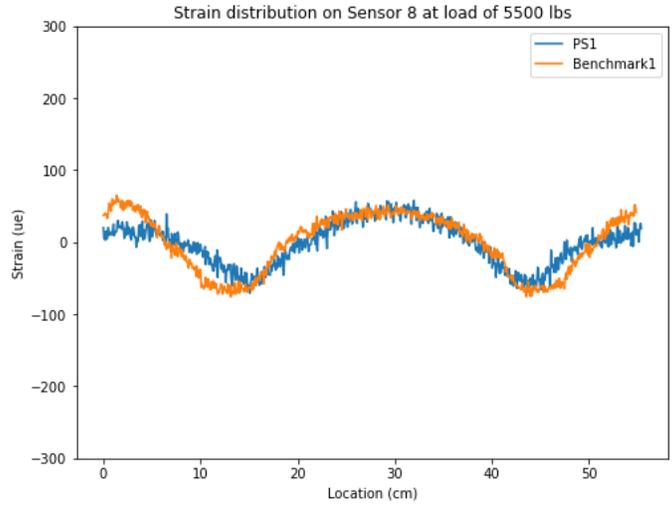
Figure 5-12. Strain distribution on Sensor 8 at load of 5500 lbs.

The results of the strain distribution on Sensor 8 at loading of 5500 lbs. for Benchmark1 and PS1 are shown in Figure 5-12. The results of the maximum and minimum strains changing with the loading and displacement on Sensor 8 for the two tests are shown in Figure 5-13. In the circumferential direction, the strain distributions and the maximum and minimum strain developments on the pipeline also had very similar trends for the two tests, but the strains for Benchmark1 were slightly larger than the ones for PS1 in terms of the magnitude before Benchmark1 failed. In addition, it is worth noting that as the start point and end point of Sensor 8 were both at the middle of the pipeline in the front (Figure 5-5), it can be found that, the pipeline would experience tension on the front and back of the pipeline, and compression on the top and bottom of the pipeline in its circumferential direction (Figure 5-14). It indicated that the pipeline was slightly squeezed by the saddle along its latitudinal axis while the saddle was pulled monotonically.

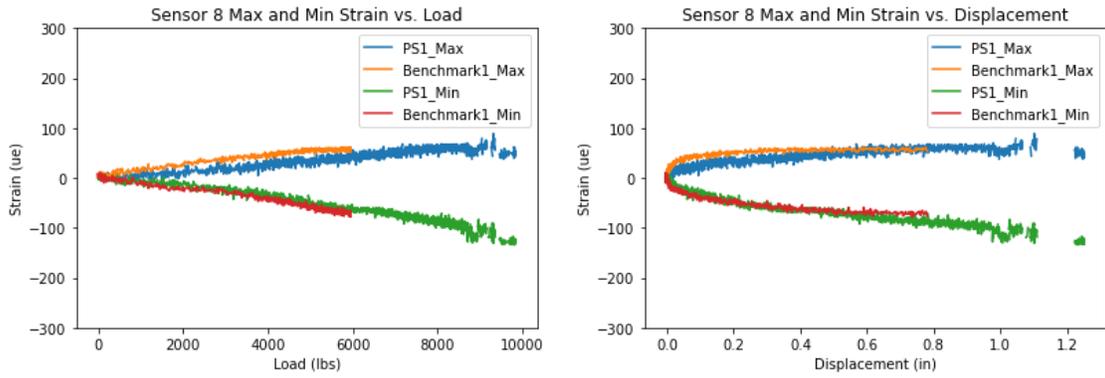
Figure 5-13. Maximum and minimum strain on Sensor 8

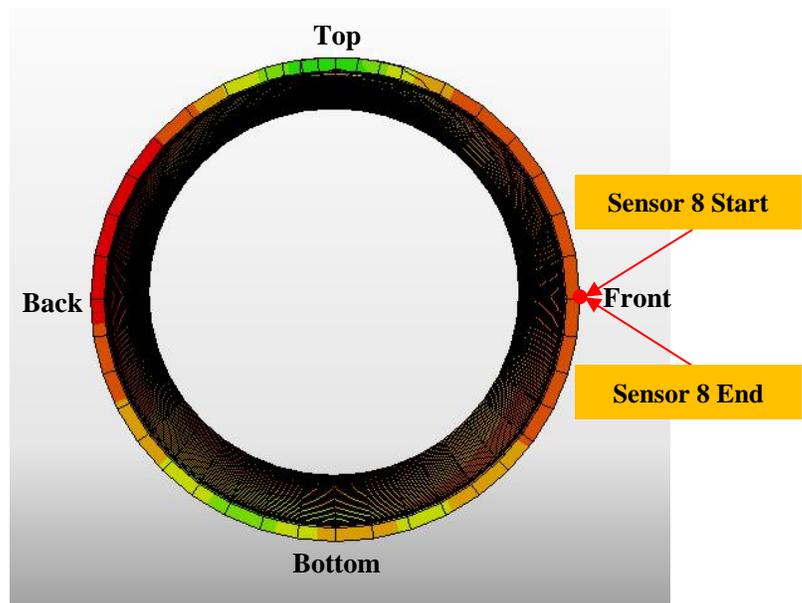
Figure 5-14. Cross-section of the pipeline

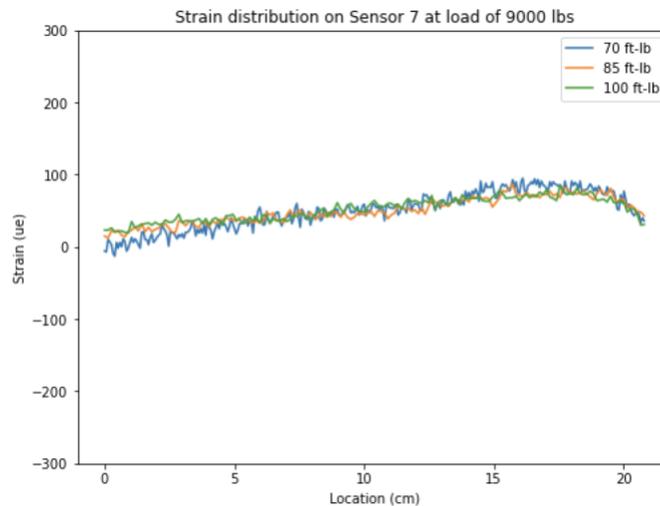
Figure 5-15. Strain distribution on Sensor 7 at load of 9000 lbs.

It is worth noting that in the longitudinal direction, the strain distributions on the pipeline for three tests were very similar. However, under the same loading and displacement conditions, the saddle with smaller torques would lead to larger maximum strains on the pipeline. In the circumferential direction, the strain distributions and the maximum and minimum strain developments on the pipeline had very similar trends, but the saddle with smaller torques would cause larger strains on the pipeline in terms of the magnitude. It might be because the saddle with smaller torques would have a larger rotating angle θ under the monotonic pulling, which would create a larger moment on the pipeline and result in larger strains on the side opposite to the pulling direction (Figure 5-20).

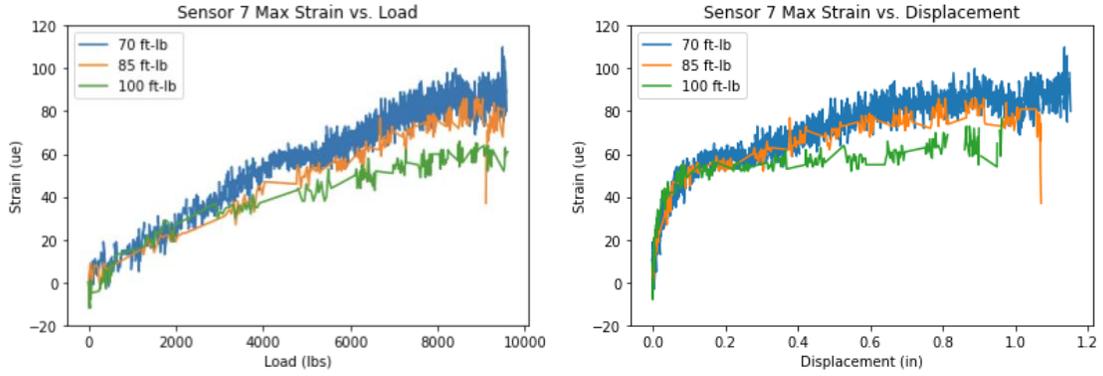
Figure 5-16. Maximum strain on Sensor 7

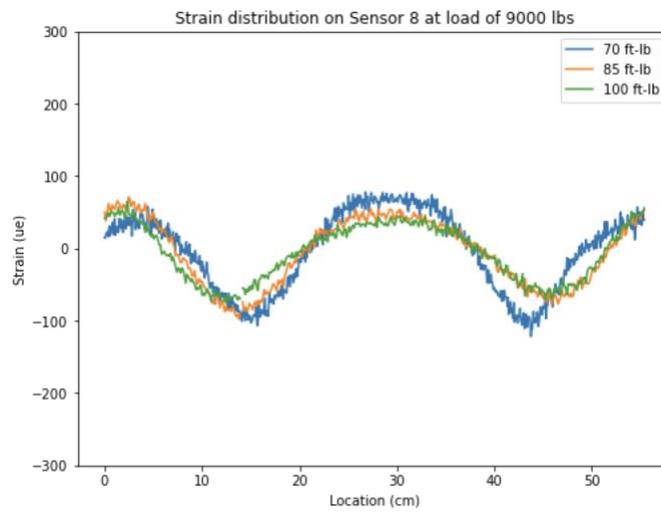
Figure 5-17. Strain distribution on Sensor 8 at load of 9000 lbs.

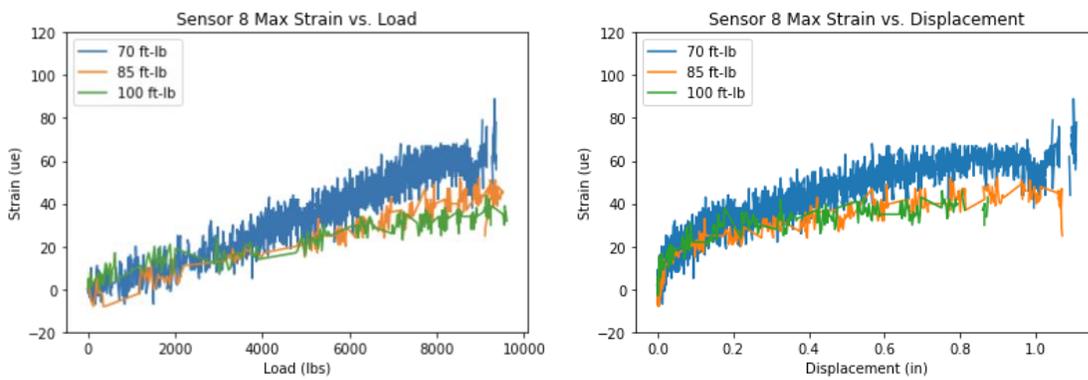
Figure 5-18. Maximum strain on Sensor 8
