Comparative Shear Testing and Finite Element Analysis of PowerSeal Saddle for Service Line Installations

Tianyu Han, Qinglai Zhang, Shakhzod M. Takhirov, Kenichi Soga
Center for Smart Infrastructure (CSI)
Department of Civil and Environmental Engineering
University of California, Berkeley

Prepared for PowerSeal Pipeline Products Corporation

CSI Report 2022/01
Center for Smart Infrastructure (CSI)
Department of Civil and Environmental Engineering
University of California, Berkeley
Dec 2022

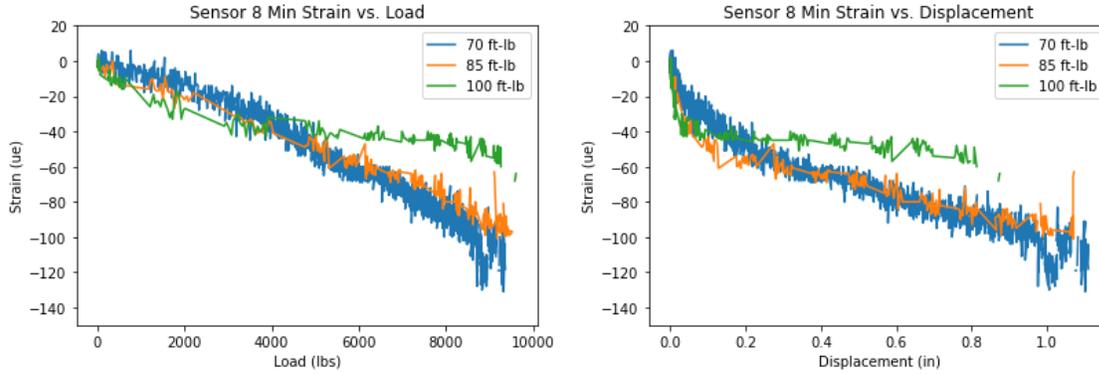
Figure 5-19. Minimum strain on Sensor 8

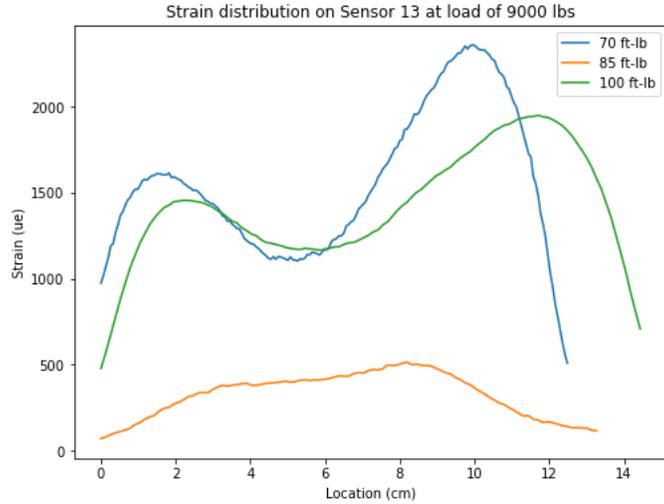
Figure 5-21. Strain distribution on Sensor 13 at load of 9000 lbs.

The results of the strain distribution on Sensor 13 at loading of 9000 lbs. for PS1 (70 ft-lb), PS2 (85 ft-lb), and PS3 (100 ft-lb) are shown in Figure 5-21. The results of the maximum strains changing with the loading and displacement on Sensor 13 for three tests are shown in Figure 5-22. On the saddle, it can be noticed that compared to the ones for PS1 and PS3, the strain distribution for PS2 had a similar trend but a much smaller magnitude. It might be because the fiber-optic cables were not fully stucked on the straps in this test. As a result, PS2 also had a smaller maximum strain than PS1 and PS3 when the load and displacement increased. Besides, for PS1 and PS3, it can be found that the magnitudes of two peaks were different, where the strap experienced a larger tension on its top side. It indicated that the saddle might have an offset upwards under the monotonic shear loading. Also, for a given displacement, PS3 would have a larger maximum strain than PS1, which is because PS3 experienced greater axial load than PS1.

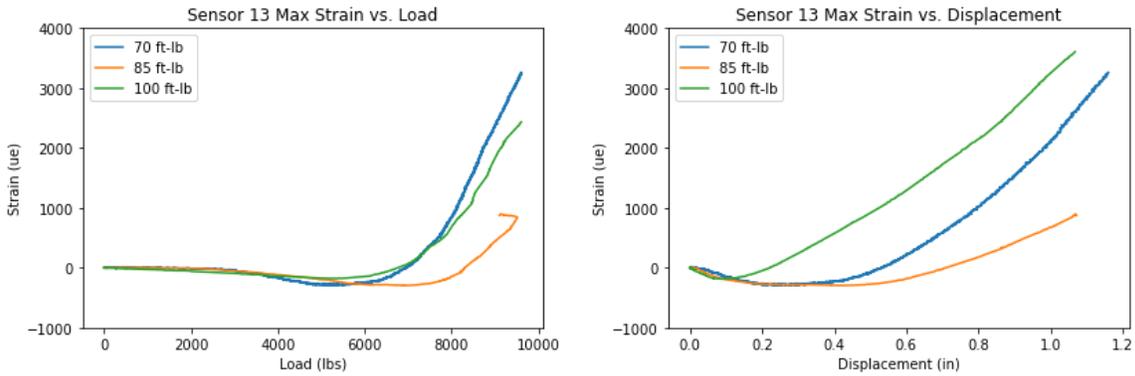
Figure 5-22. Maximum strain on Sensor 13

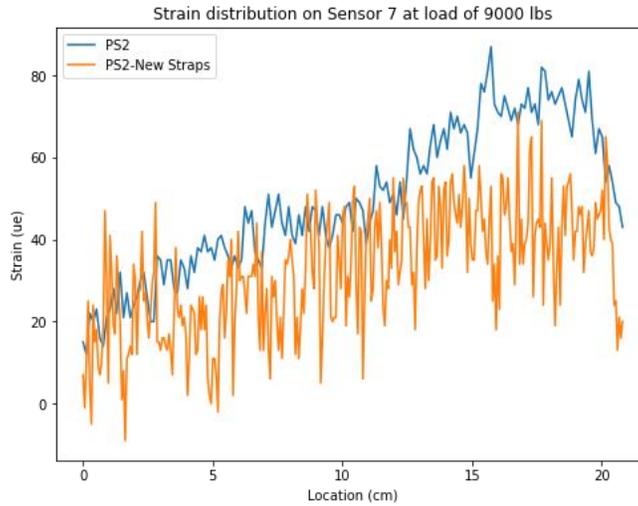
Figure 5-23. Strain distribution on Sensor 7 at load of 9000 lbs.

The results of the strain distribution on Sensor 7 at loading of 9000 lbs. for PS2 (with original straps) and PS2-New Straps (with low-capacity straps) are shown in Figure 5-23. The results of the maximum strains changing with the loading and displacement on Sensor 7 for the two tests are shown in Figure 5-24. In the longitudinal direction, PS2 (with original straps) would cause a larger strain on the pipeline under the monotonic shear loading.

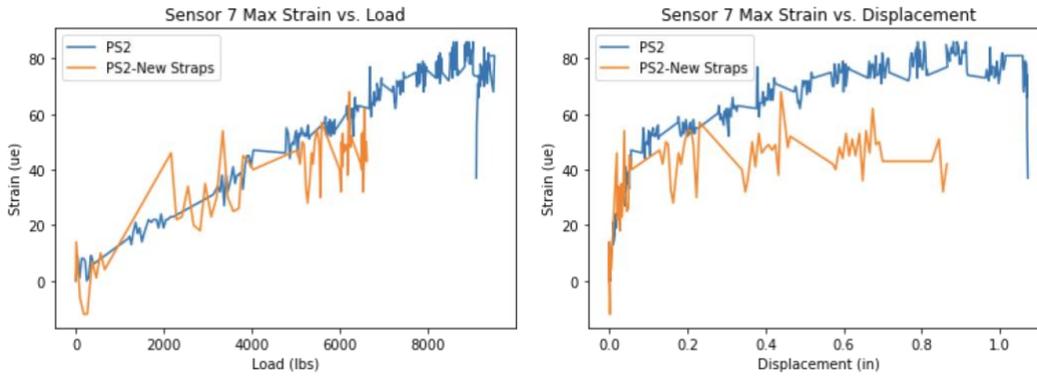
Figure 5-24. Maximum strain on Sensor 7

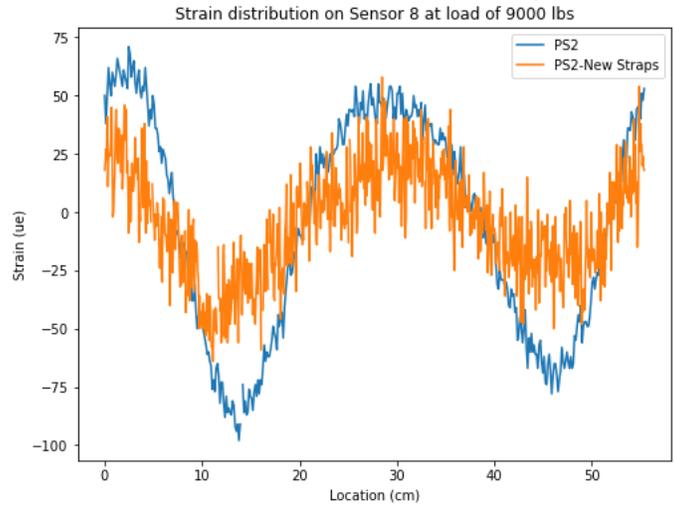
Figure 5-25. Strain distribution on Sensor 8 at load of 9000 lbs.

The results of the strain distribution on Sensor 8 at loading of 9000 lbs. for PS2 (with original straps) and PS2-New Straps (with low-capacity straps) are shown in Figure 5-25. The results of the maximum strains changing with the loading and displacement on Sensor 8 for the two tests are shown in Figure 5-26. In the circumferential direction, PS2 (with original straps) would cause a larger strain on the pipeline in terms of the magnitude under the monotonic shear loading.

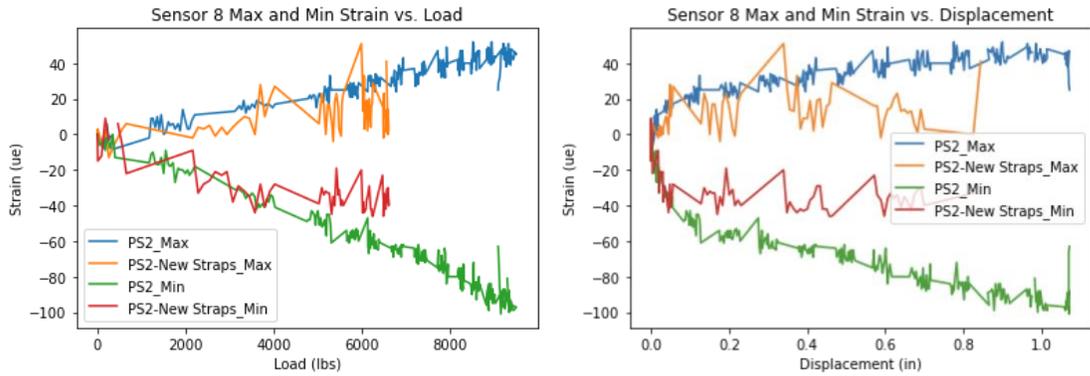
Figure 5-26. Maximum strain on Sensor 8

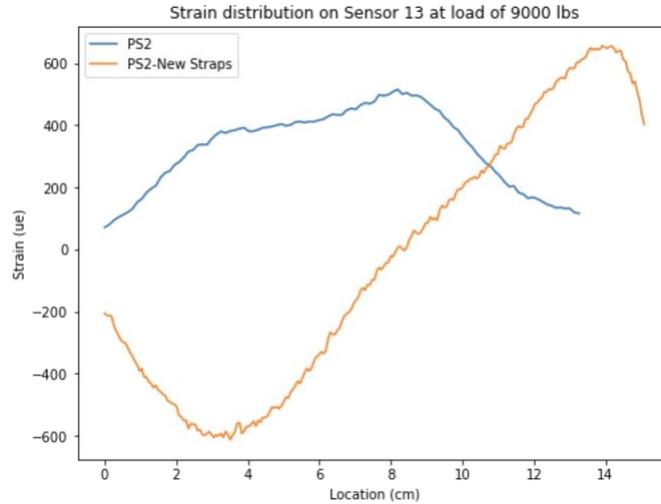
Figure 5-27. Strain distribution on Sensor 13 at load of 9000 lbs.

The results of the strain distribution on Sensor 13 at loading of 9000 lbs. for PS2 (with original straps) and PS2-New Straps (with low-capacity straps) are shown in Figure 5-27. The results of the maximum strains changing with the loading and displacement on Sensor 13 for the two tests are shown in Figure 5-28. On the straps, it was worth noting that PS2-New Straps would have a very different strain distribution trend than PS2, which would experience compression on the bottom side and tension on the top side. PS2-New Straps would also experience larger maximum strains than PS2 under the same loading and displacement conditions.

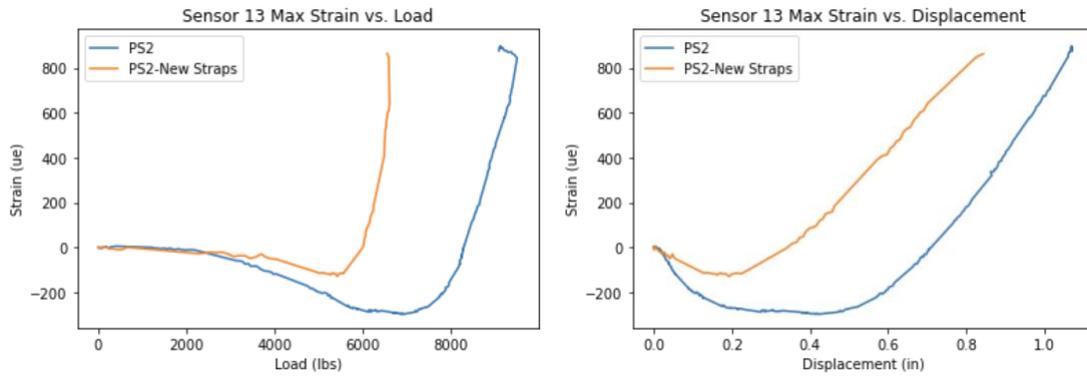
Figure 5-28. Maximum strain on Sensor 13

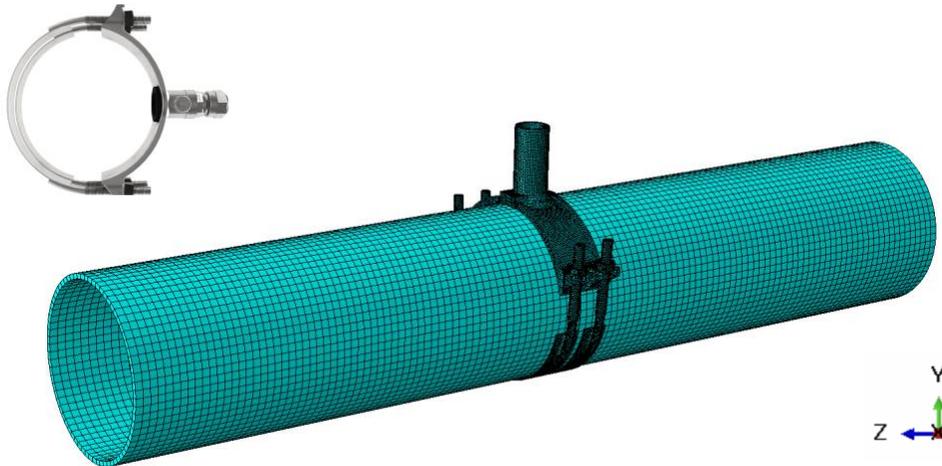
Figure 6-1 3-D FE model mesh for saddle test

The boundary and loading conditions are briefly summarized as follows. One pipe end was fixed in X, Y, Z directions, while another end of the pipe was allowed to move horizontally in z direction as the lab test. The FEM enables contacting and sliding interactions between the pipe and the saddle. The normal behavior of the interaction is set as hard contact in ABAQUS, and the friction coefficient of the tangential behavior is set as 0.5 according to the standard friction coefficient between materials of ductile iron and stainless steel [3].

The modeling process begins with applying an 85-ft-lb torque on each bolt. 70 psi water pressure was applied on the inner surface of the pipe. Then the shear loading was applied on the saddle with 3 inches displacement. This FEM was used to verify PS2 (PowerSeal saddle with 85-ft-lb torque on the bolts).

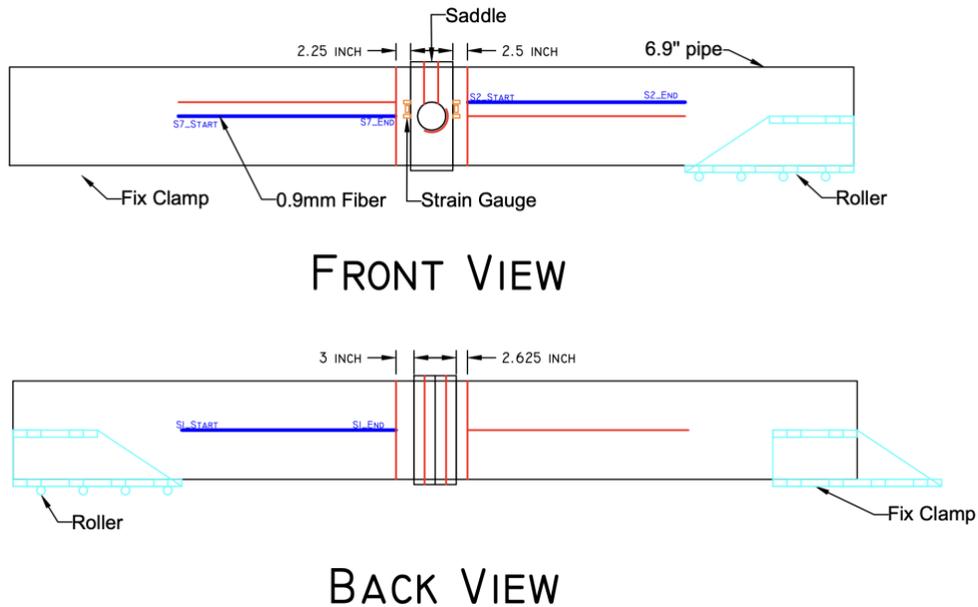
Figure 6-4 Location of longitudinal sensors on the pipe: S1, S2, S7 (the blue segment along the longitudinal direction of the pipeline)

Figure 6-4 and Figure 6-5 indicate the locations of longitudinal and circumferential sensors on the pipe.

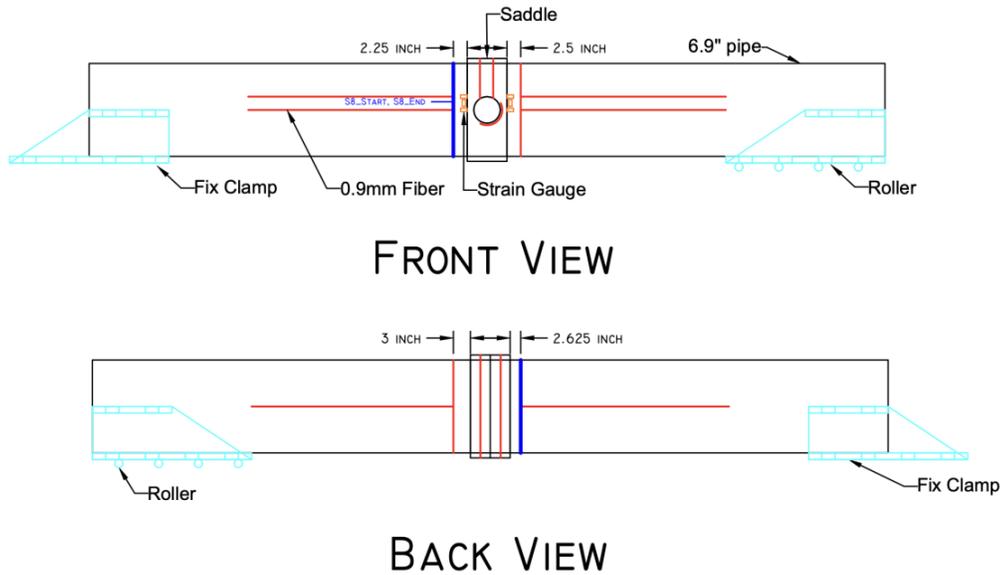
Figure 6-5 Location of circumferential sensor on the pipe: S8 (the blue segment along the circumferential direction of the pipeline)

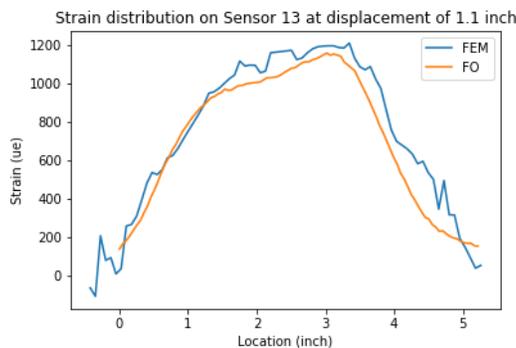
(a)

It can be observed from Figure 6-8(a) that the strap was under tension as simulated by the FEM. The strain from two ends of the strap to the center is increasing and the maximum strain peak around $1200 \mu\epsilon$ near the center. It is reasonable because the middle area of strap as shown in Figure 6-8(b) was fully contacted to the pipe compared to the ends of strap.

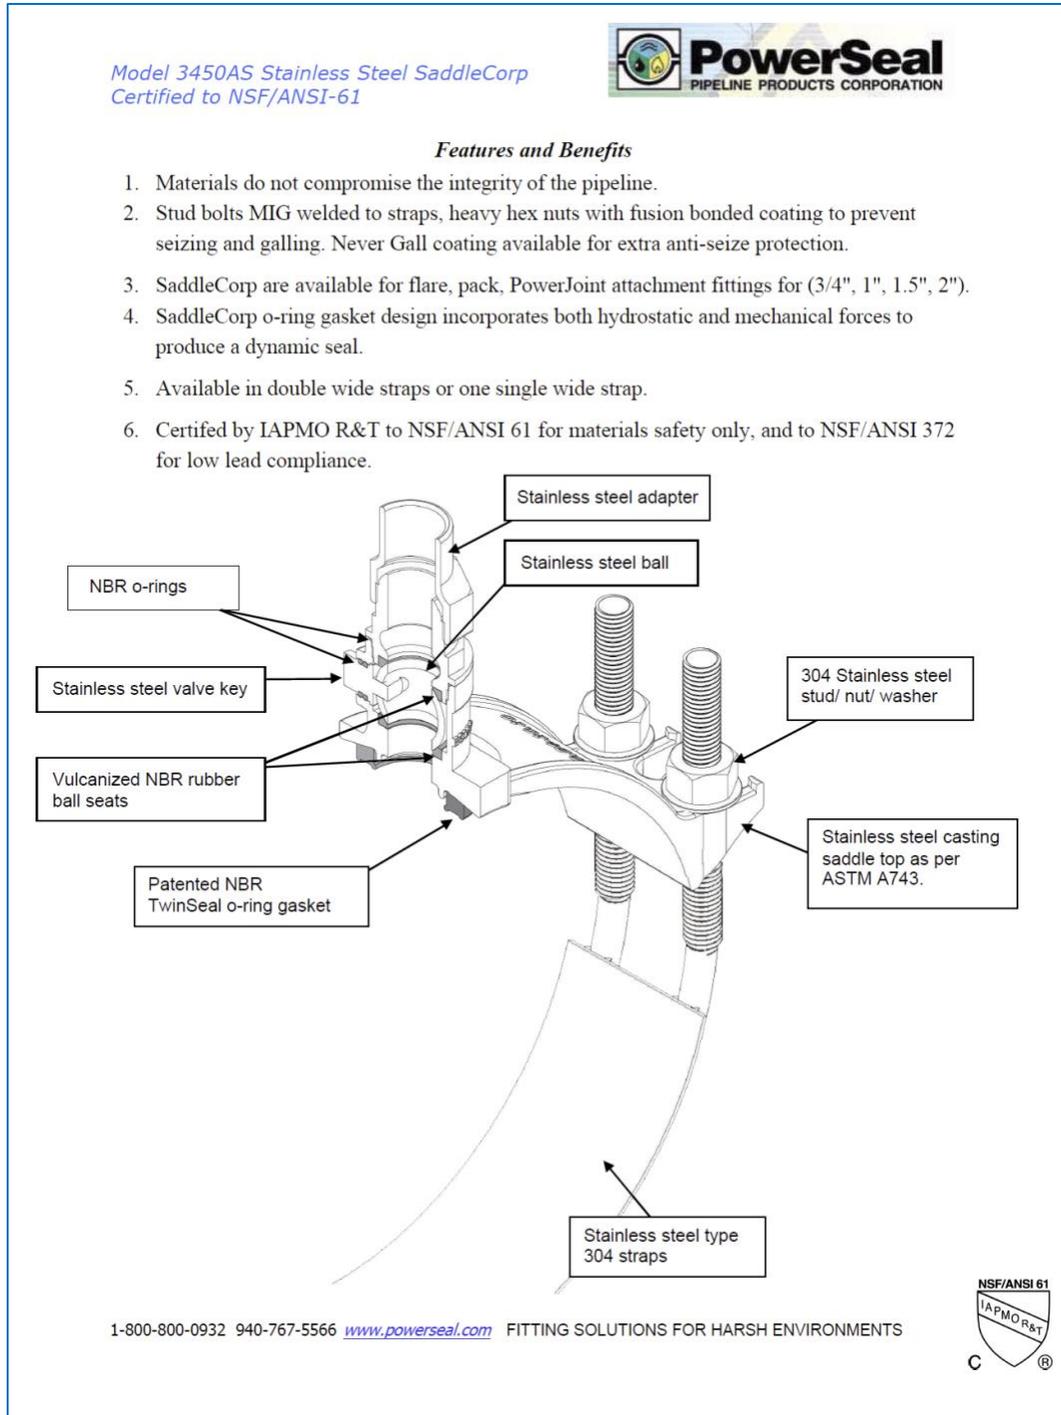
Figure A-1. Specifications of A 3450AS: page 1 (provided by PowerSeal).

1. SaddleCorp should incorporate both saddle and corp stop in one single cast piece, and shall be stainless steel as per ASTM A743.
2. The saddle body shall have an o-ring gasket permanently attached to the casting at the factory. The TwinSeal o-ring gasket along with all seals shall be made from NBR, they shall be free from porous areas, foreign material, and visible defects, all made from 100% new rubber. NBR can resist temperatures between -25 to +248°F.

3. The MIG welded strap shall be constructed of stainless steel type 304 and shall include weld attached 5/8” stainless steel 304 stud bolts. All welds shall be passivated to return their inherent corrosive resistance.

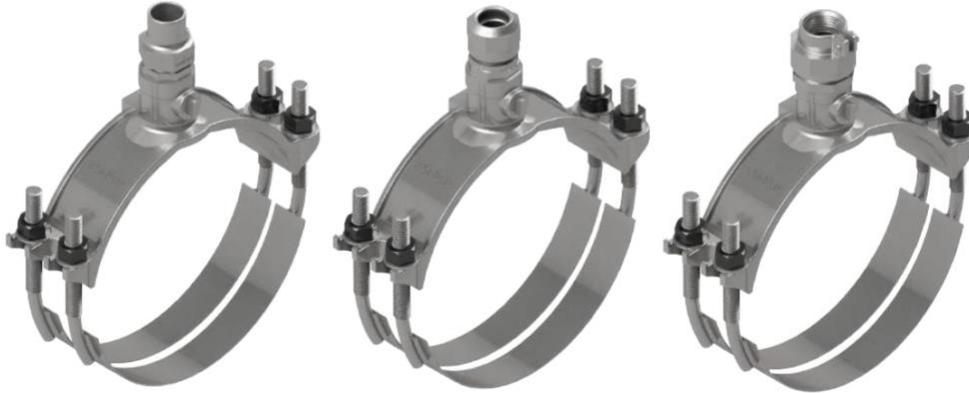
Model 3450AS Stainless Steel SaddleCorp
 Certified to NSF/ANSI-61

Flare

PowerJoint - CTS

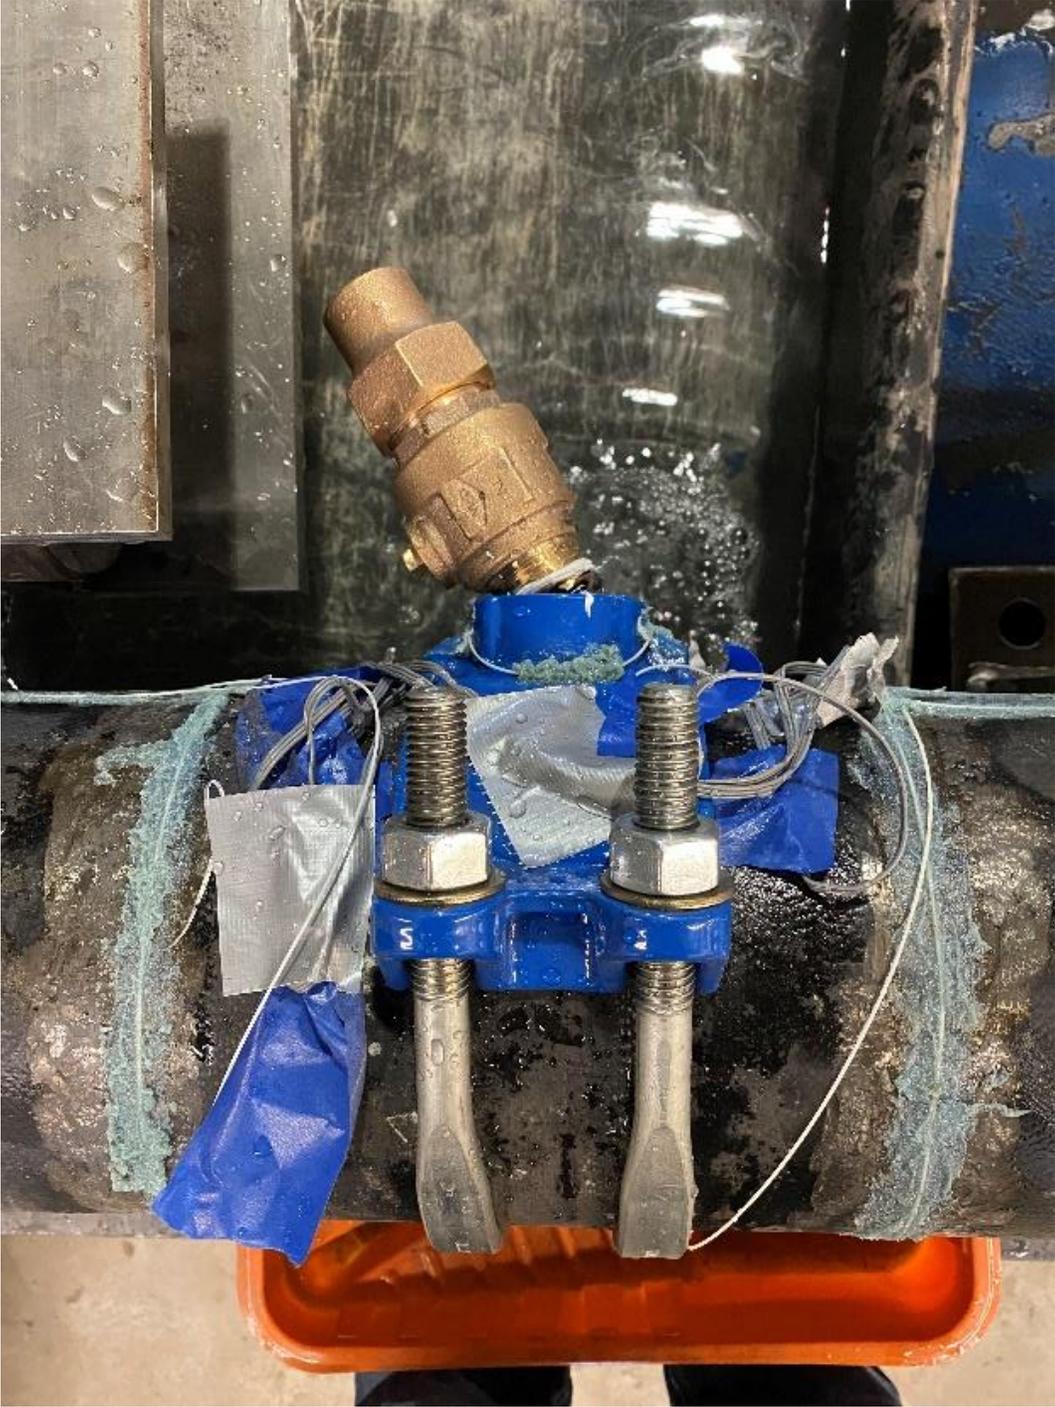
Figure B-1. Failure mode of benchmark saddle

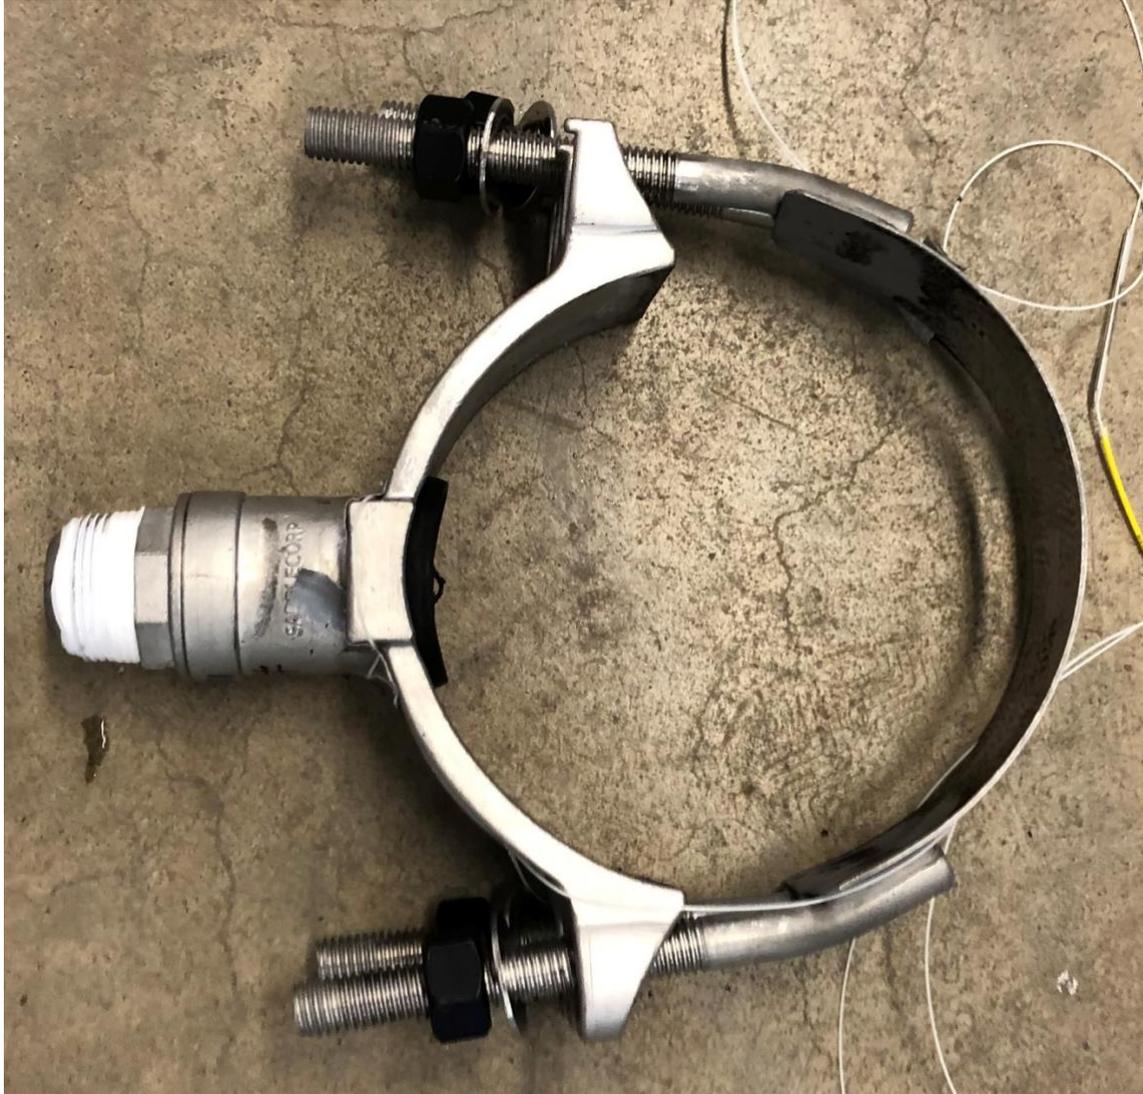
Figure B-3. PowerSeal saddle with correct straps: after a test (typical)

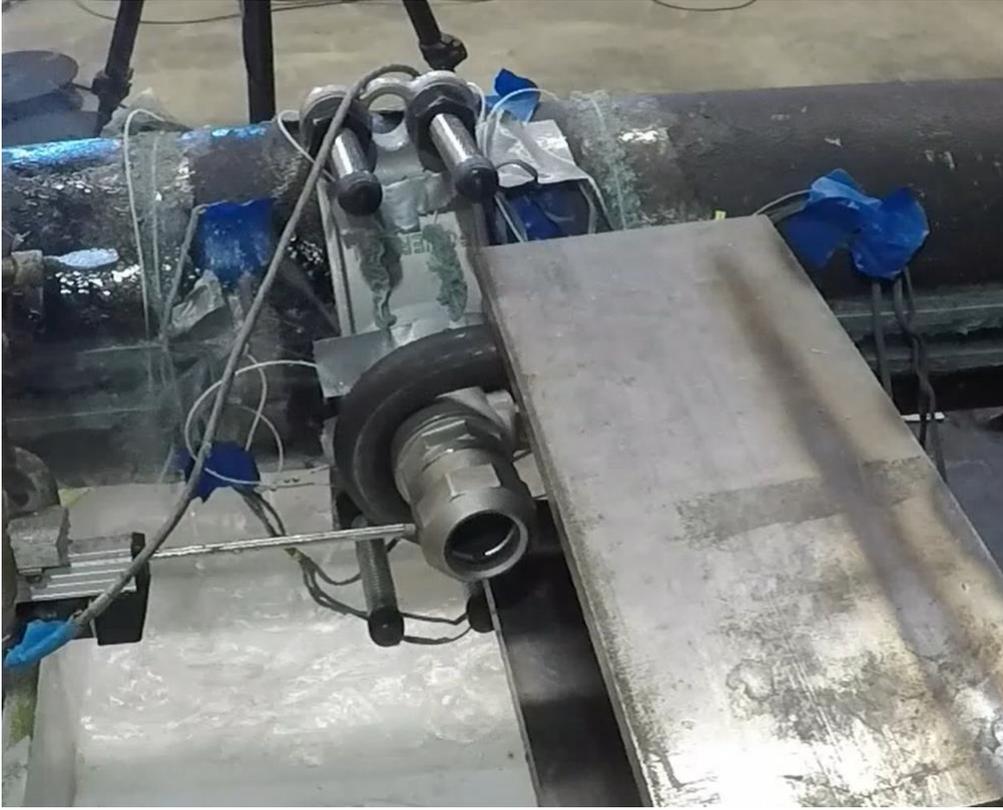
Figure B-4. Side view of PowerSeal saddle: at completion of a test (typical)

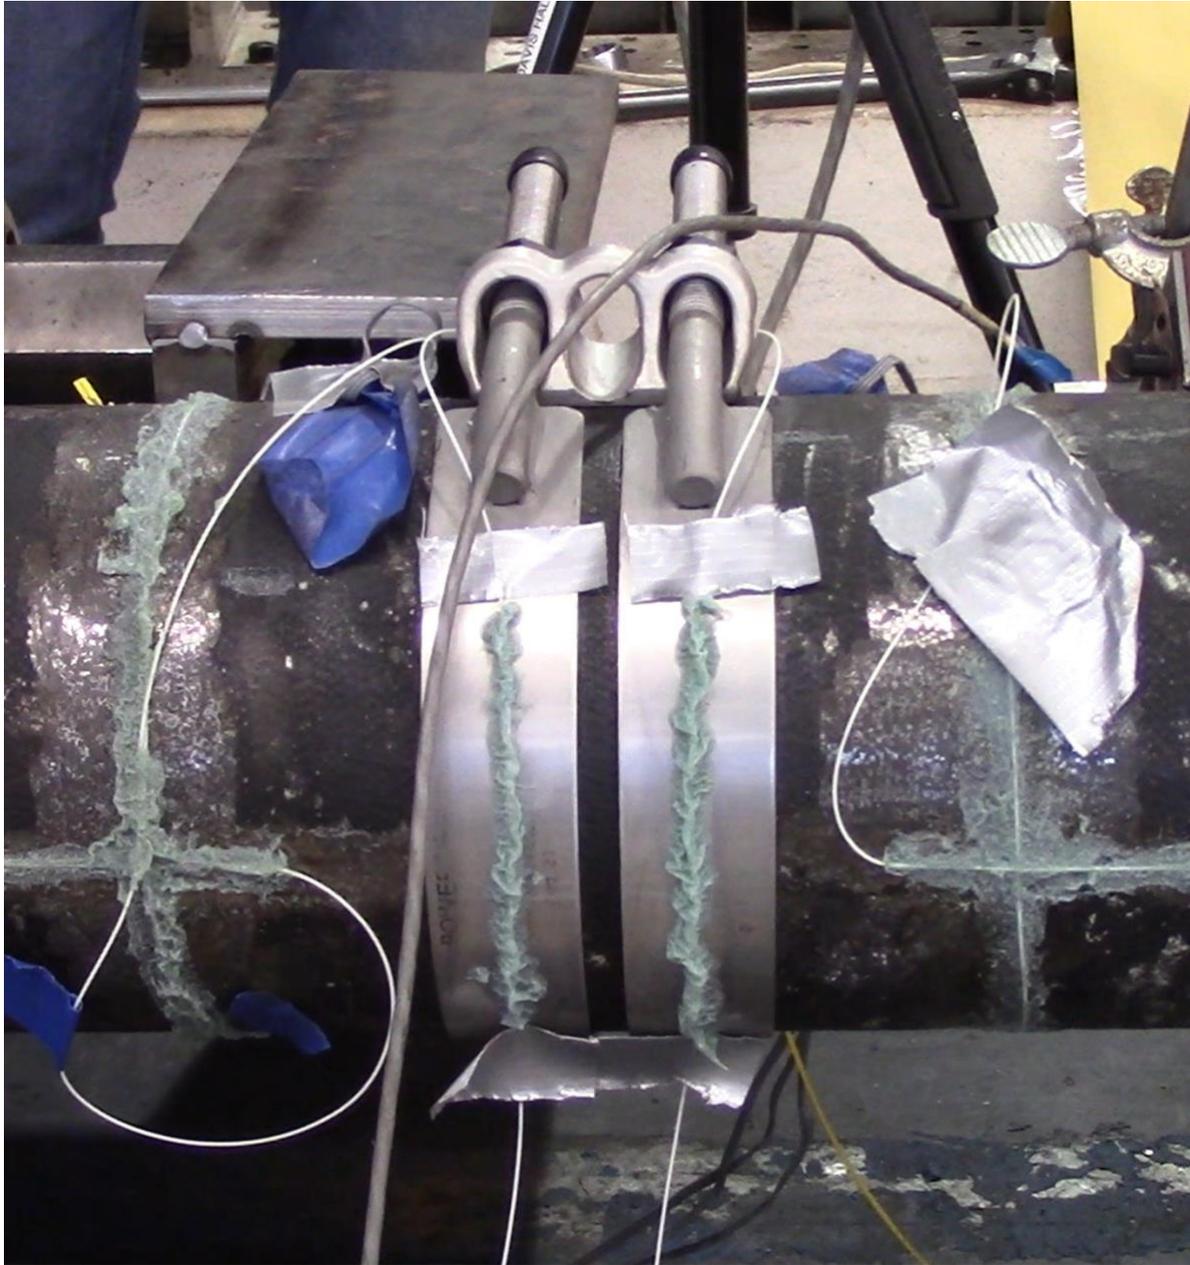
Figure B-5. PowerSeal saddle with correct straps: during a test (typical)

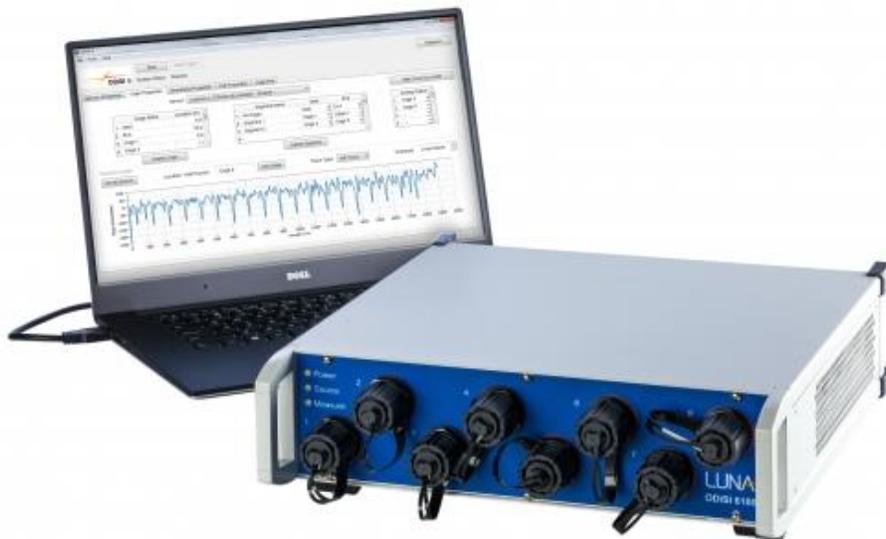
Figure C-1. LUNA ODiSI 6000 Series optical distributed sensor interrogator

Using the physical properties of light, fiber-optic sensing can detect changes in temperature, strain, and other parameters when light travels along a fiber, which uses fiber-optic cables as sensors and can measure over long distances at 100 to 1000s of points on a single cable or multiplexed cables depending on the technology used. Compared to the other sensing technologies, fiber-optic sensing has distinct advantages such as small size, light weight, and strong resistance to corrosion and water.

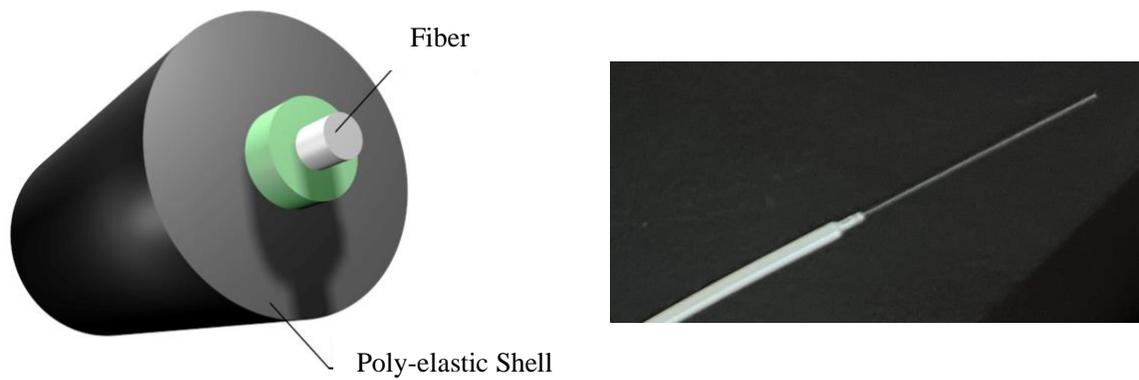
Figure C-2. NanZee NZS-DSS-C07 cable

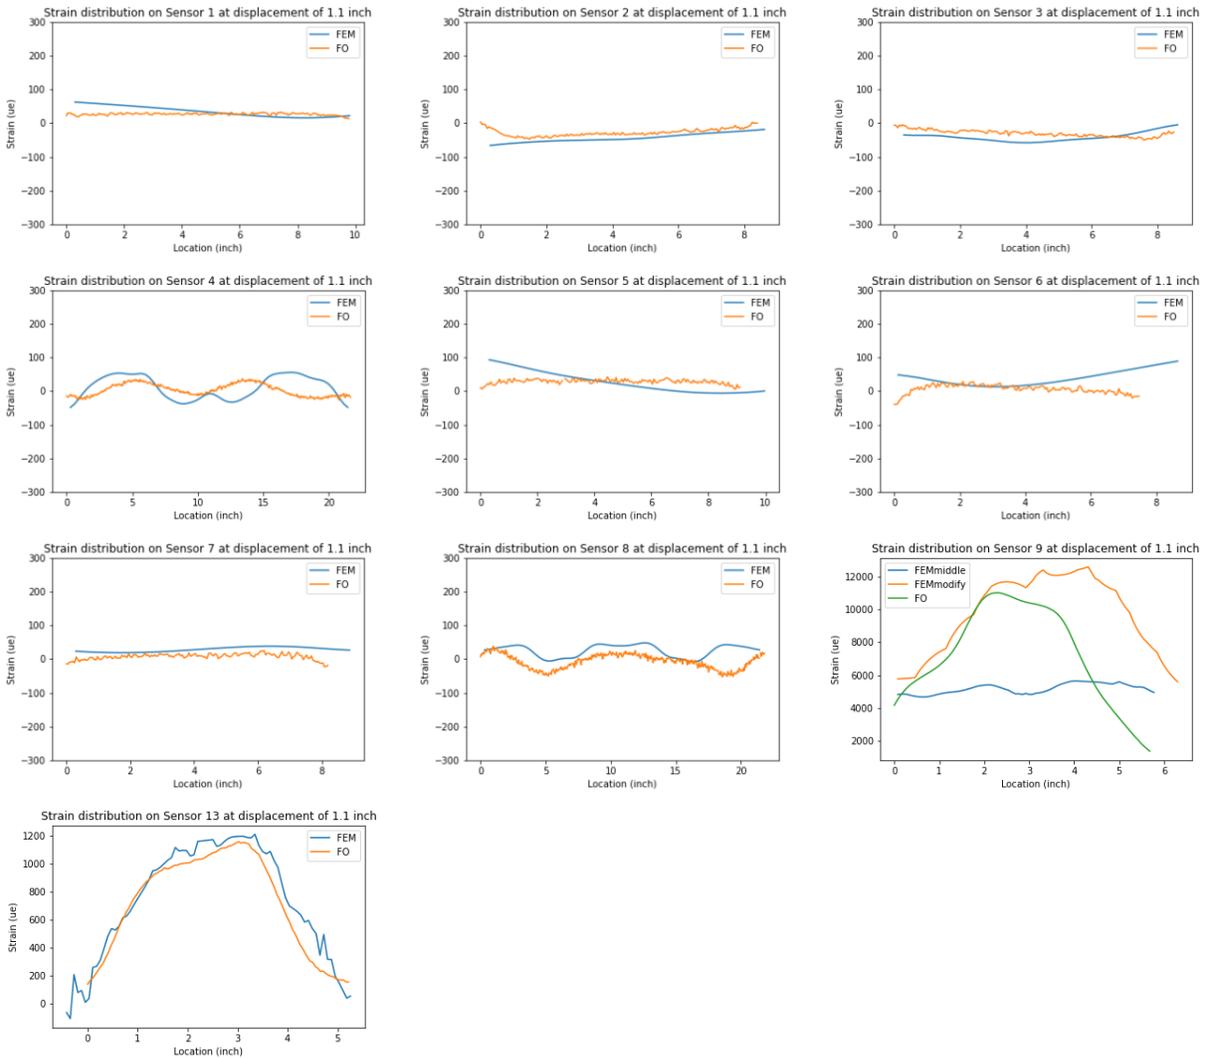
Appendix E: Finite Element Results

The comparison of the FEM results and FO data are presented below, where Sensor 10, Sensor 11, and Sensor 12 are not presented due to the uncertainty of the specific locations.
