Four-point Bending Testing of 8-in. (200-mm) Diameter TR-XTREME™ Ductile Iron pipe

CSI Report 2023/04
Center for Smart Infrastructure (CSI)
Department of Civil and Environmental Engineering
University of California, Berkeley June 2023

This report describes the experimental and numerical results of four-point bending tests performed on an 8-inch TR-XTREME™ earthquake-resistant ductile iron pipe manufactured by U.S. Pipe. The tests aim to characterize the relationship between rotation and moment of the restrained joint and the magnitude of joint rotation that initiates significant joint damage or water leakage. Two four-point bending tests were performed for two different orientations of the locking segments at the bell joint connection. In addition, the experimental results obtained from distributed fiber optic strain sensors were used to validate the three-dimensional (3D) finite element (FE) models, which can be used as the reference model for optimizing the pipeline design, installation, and risk assessment.

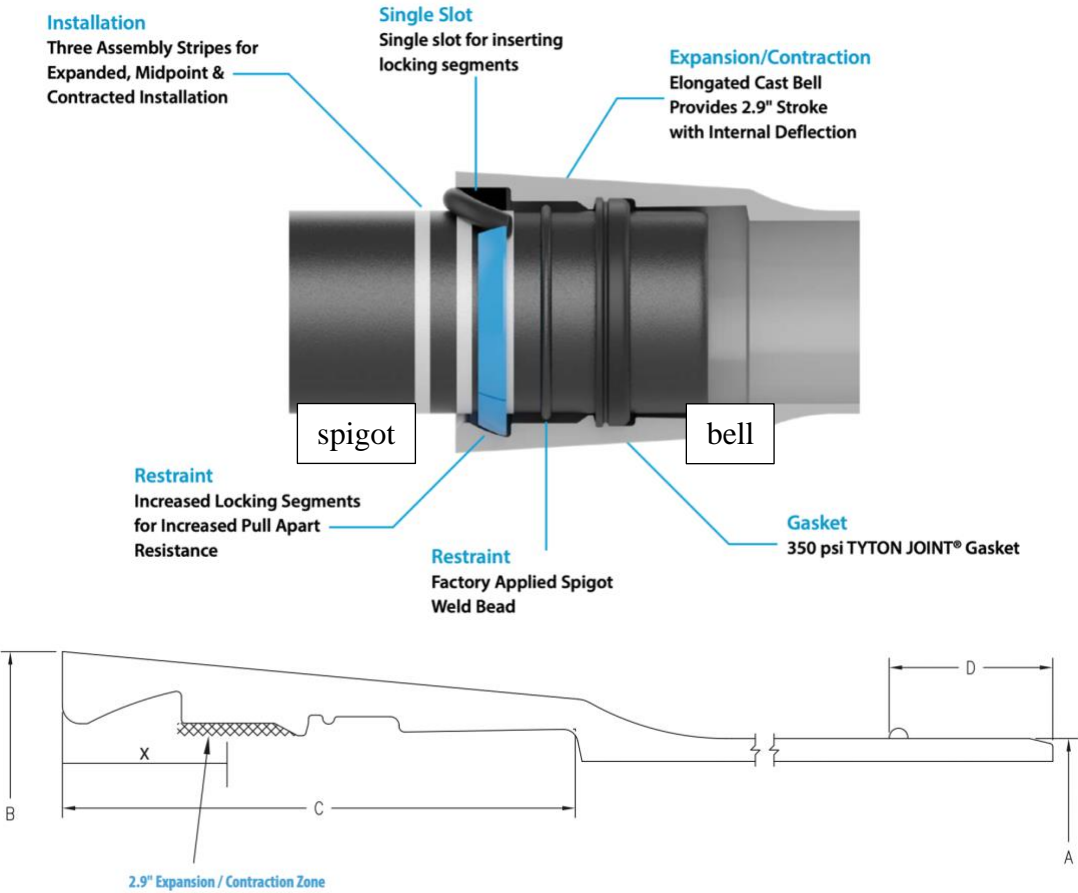
Figure 1-1 Mechanism of TR-XTREME™ joint (U.S. Pipe, 2020)

This report presents the experimental and finite element modeling results of the four-point bending tests performed on 8-inch TR-XTREME™ earthquake-resistant ductile iron pipe specimens manufactured by U.S. Pipe. The pipe is designed to maintain full water service after seismic events to achieve the seismic resiliency of the pipeline systems. The pipe has a single-restrained bell joint connection, providing 2.9-inch horizontal movement and 5-degree deflection contraction capacity. The schematic of the bell joint is shown in Figure 1-1. The spigot is designed to be inserted into the bell, passing through a water-prevent rubber gasket, and is equipped with a weld bead to bear against the locking segments, used as a locking mechanism while pulling. The single slot is used for holding the locking segments. Three white stripes on the spigot are used to indicate the installation position. The manufacturer recommends three installation positions: collapsed, midpoint, and extended location, as shown in Figure 1-2. In this study, the experiment started from the fully extended position (i.e., Option C), meaning that the weld bead on the spigot contacted the locking segments at the initial stage.

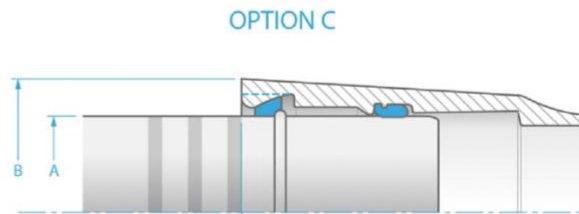
Figure 1-2 Recommended installation positions (U.S. Pipe, 2020)

Option C-Extended (Restrained) - Correct assembly is determined when the front edge of the assembly stripe closest to the spigot tip lines up with the face of the pipe bell as viewed from above, leaving three assembly stripes shown. This is the proper assembly when immediate joint restraint is required.

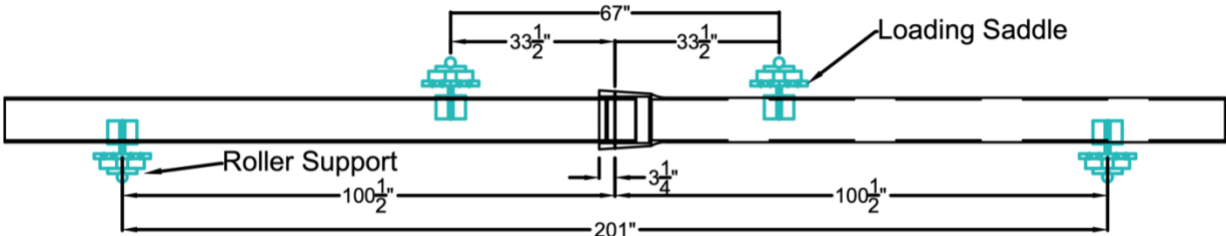
Figure 2-1 Experimental setup design

The experimental setup was developed at the Center for Smart Infrastructure (CSI) of UC Berkeley. The design of the experimental setup is shown in Figure 2-1. An actuator was located above the center line, defined as 3.25 inches away from the bell face. A steel spreader beam was located beneath the actuator used to transfer the force to the loading saddles, placed about 33.5 inches from the center line on the spigot and the bell pipe. Both pipes were supported on the rollers located 100.5 inches from the center. The overview of the fully assembled setup of the four-point bending test is shown in Figure 2-2.

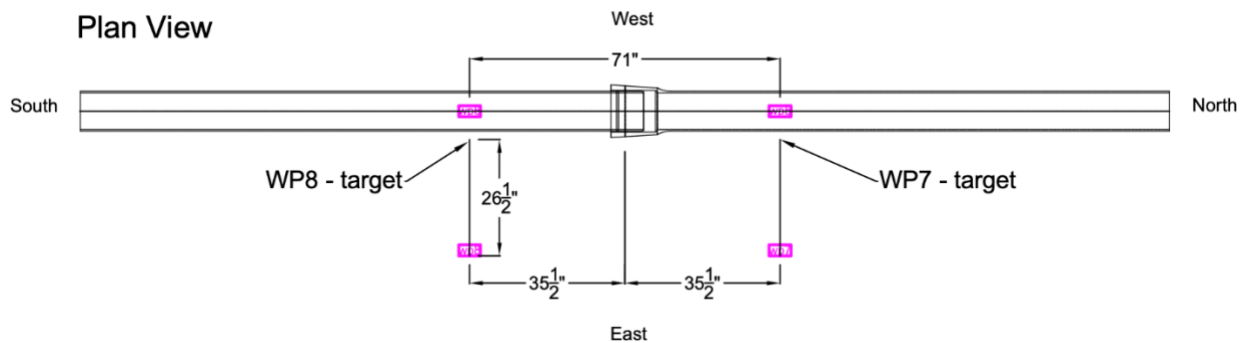
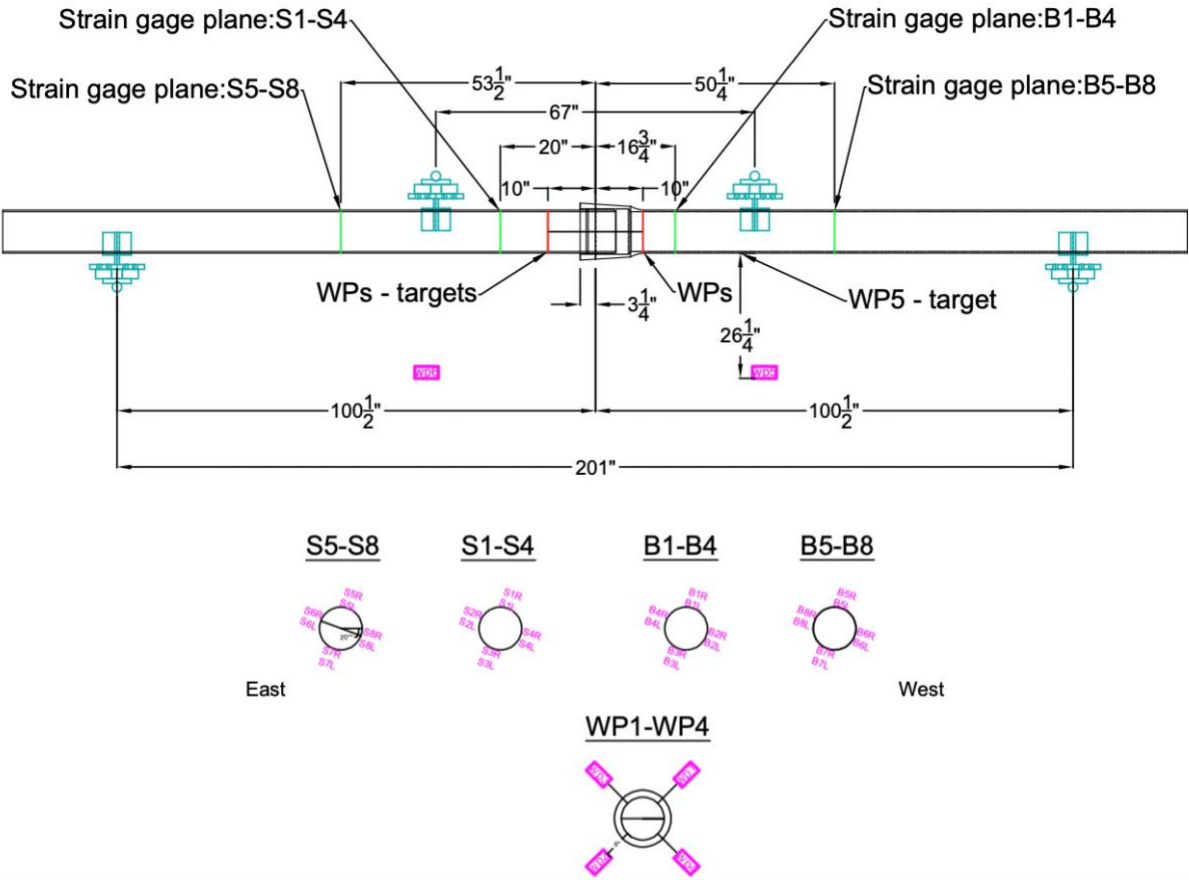
Figure 3-1 Instrumentation plan of conventional instruments

Four wire pots were placed on the bell pipe at 45 degrees apart from the quarter points around the circumference and were fixed to the spigot to measure the joint opening. Another four wire pots were used to measure the pipe displacement during the experiment. They were mounted to the bell pipe and spigot on the east and bottom sides individually. The wire pots installed on the bottom sides were used to monitor the vertical displacement, and the ones on the east side aimed to measure the horizontal movement. A total of eight wire pots were installed.

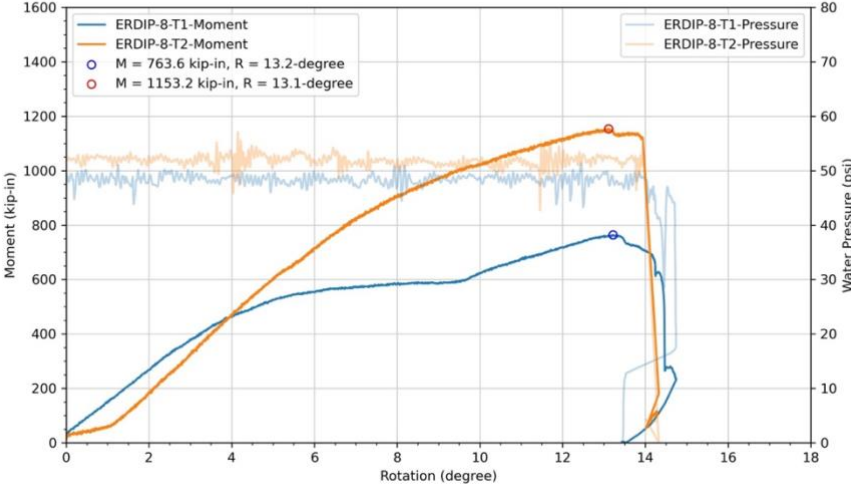
Figure 4-1 Moment, rotation, and water pressure of the tests

the force was transferred to the pipes via the two loading saddles. The moments and rotations of each specimen were calculated using the formulas mentioned above, and the results are shown in Figure 4-1. Due to the location conflict between the experimental setup and the vertical wire pots, the self-weight moving down stage results were not recorded. Figure 4-1 shows only the measured moment and rotation relationships during the actuator pushing down stage. The result of self-weight moving down stage will be discussed in Chapter 5 using the finite element model simulation. The maximum rotations with corresponding moments of each specimen are 1) 13.2 degrees rotation with 763.6 kip-in moments, and 2) 13.1 degrees rotation with 1153.2 kip-in moments. Although the maximum moments vary, the ultimate rotations are similar for both specimens. Water leakage was found around the 14-degree joint rotation for both specimens.

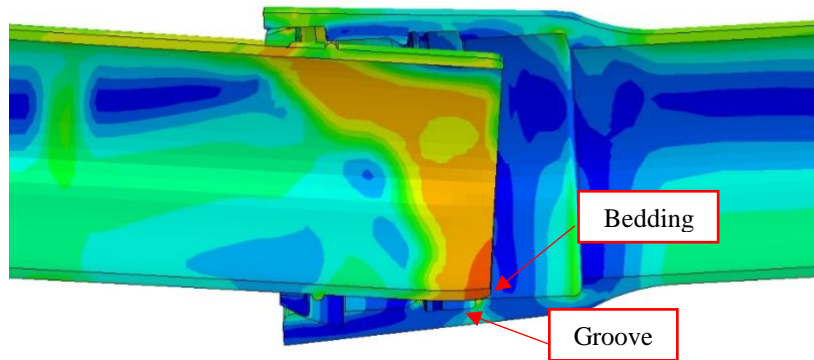
Figure 4-2 Sketch of the internal joint

However, the curves at the early test stage of less than 4 degrees of rotation show that Specimen 1 required a larger moment for a given rotation. It is hypothesized that the initial experimental setup imperfection may be the reason for the observed difference. Ideally, the spigot inside the bell section would sit on the bedding, as shown in Figure 4-2. But it is possible that the spigot of Specimen 2 was sitting on the edge of the bedding and fell into the groove at the early stage of the Specimen 2 test. Therefore, before the spigot fully bears against the bell, it was suspected that Specimen 2 required a smaller moment than Specimen 1 to achieve the desired rotation.

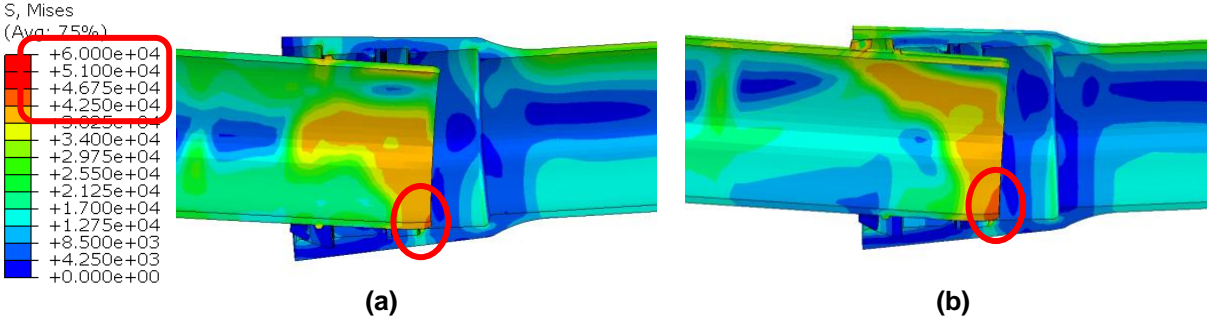
Figure 4-3 Mises stress distribution of the specimens at 11 degrees of rotation. (a) Specimen 1, (b) Specimen 2

Figure 4-3 shows the Mises stress obtained from the finite element (FE) models for both specimens at 11 degrees of rotation during the actuator pushing down stage. The detail of the FE models will be discussed in the next chapter. The FE analysis results show that the Mises stress values at the bottom of the spigot (indicated by the orange and red range) exceed the yield stress of 42,000 psi in both specimens. This observation suggests that the bottom of the spigots experience plastic strains under bending, resulting in permanent deformation and an increased risk of failure. The failure patterns were the same in both specimens. The upper section of the joint remained in an elastic state for both specimens. This finding implies that the orientations of the locking segments have minimal influence on the joint rotation capacity.

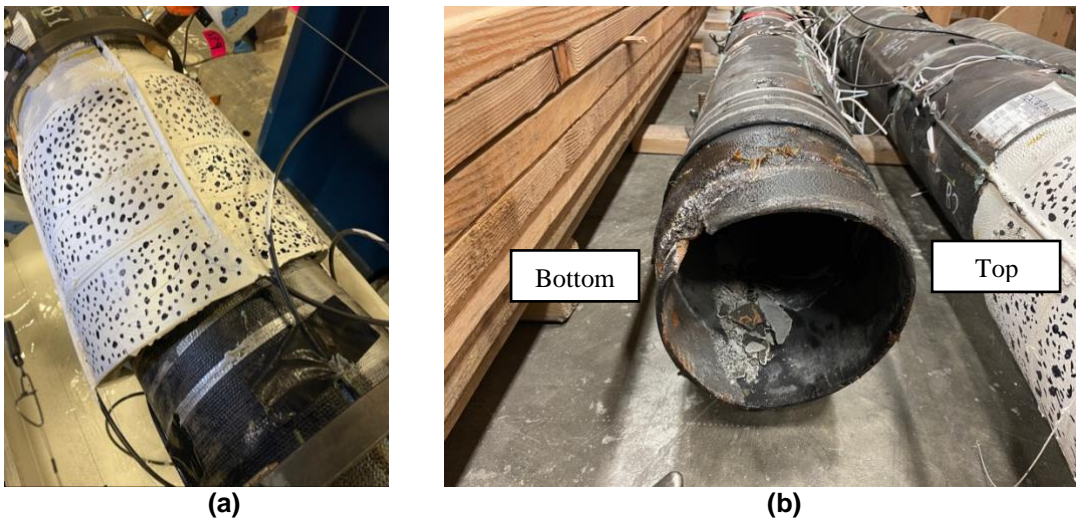
Figure 4-4 Failure of Specimen 1. (a) Bell, (b) Spigot

Figure 4-4 shows the failure pattern of Specimen 1. The primary failure occurred in the spigot, as shown in Figure 4-4 (b). The spigot was distorted at the section where it was inserted into the pipe. Moreover, since the bottom side of the spigot was bearing against the bell invert, a failure was found on the bottom side of the spigot, which resulted in water leakage.

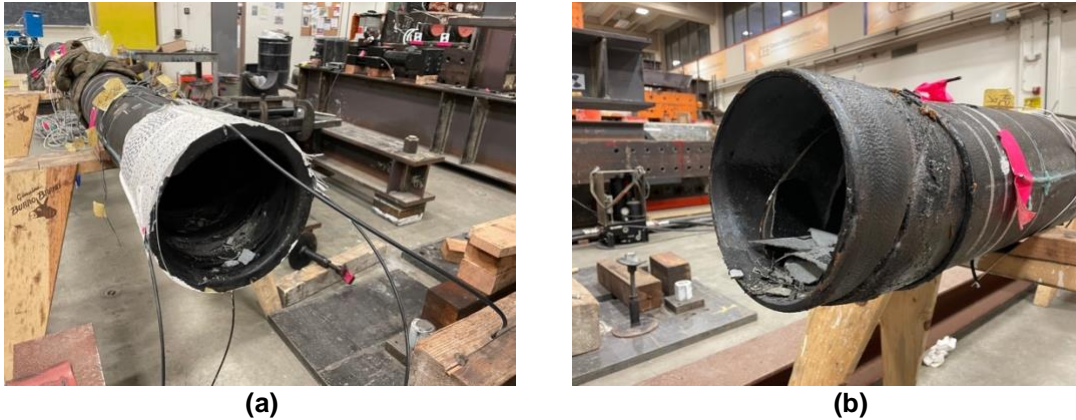
Figure 4-5 Failure of Specimen 2. (a) Bell, (b) Spigot

The failure pattern of Specimen 2 is shown in Figure 4-5. No crack was found on the bell. The primary failure occurred in the spigot. At the bottom of the spigot, a breakage similar to that of Specimen 1 can be found. Moreover, a 45-degree crack propagated from the west through the bottom to the east was observed. The crack was caused by shear force. When the bottom side of the spigot was bearing against the invert of the bell and the top of the spigot was contacting the bell crown, a shear force was introduced, as shown in Figure 4-6.

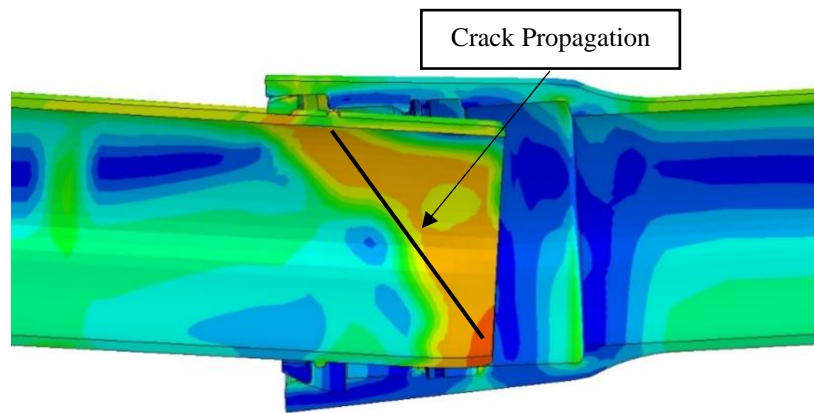
Figure 4-6 Sketch of the failure mechanism

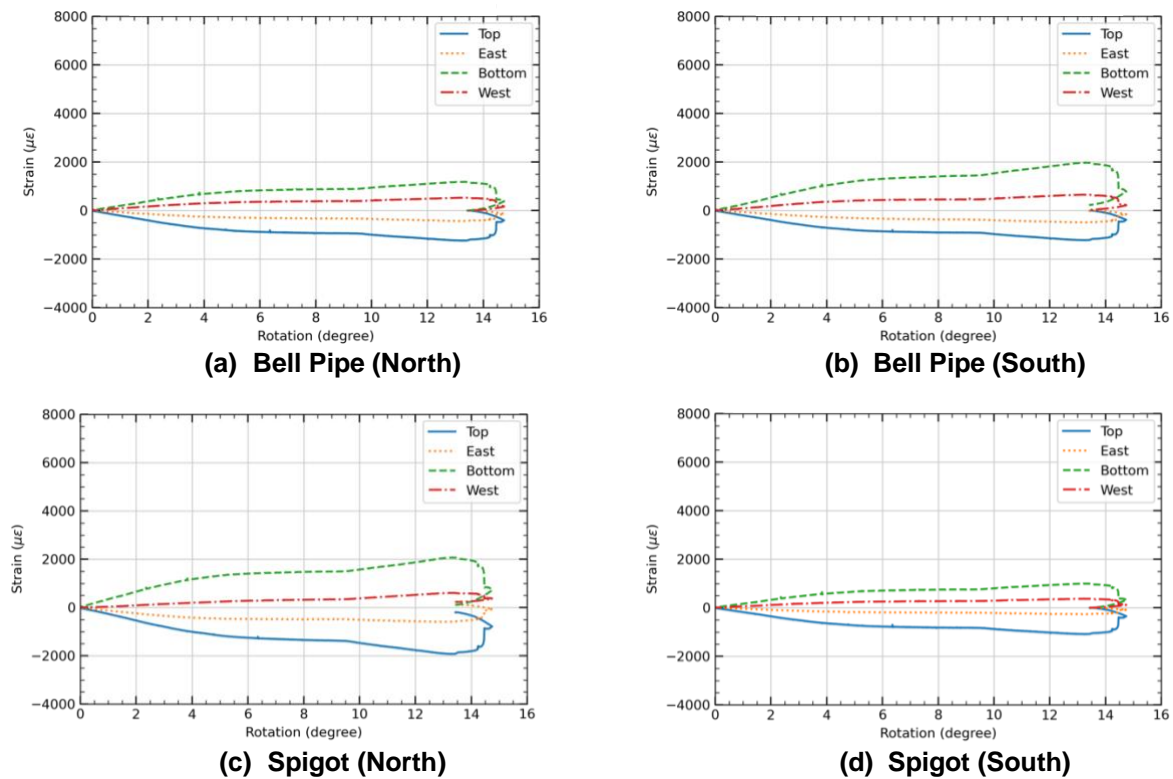
Figure 4-7 Axial strain vs. rotation of Specimen 1

The axial strain results measured by the strain gauges attached to Specimen 1 and 2 are shown in Figure 4-7 and Figure 4-8, respectively. For both specimens, a clear pattern can be observed; that is, the top side (12 o'clock) is generally under compression due to the bending, whereas the bottom side (6 o'clock) is mainly under tension. Theoretically, the axial strains at the east side (3 o'clock) and west side (9 o'clock) would be close to zero. However, the strain gauges were attached 20-degree offset from the quarter points due to the installation conflict. The strain gauges labeled "west" were placed 20 degrees toward the bottom side (6 o'clock), and

For Specimen 1, the strain distribution patterns on both sides of the pipe were similar. However, Specimen 2 showed different strain distributions at the locations closer to the bell (i.e., bell pipe-south, spigot-north). As discussed in the previous section, the spigot might not bear against the designed bedding inside the bell; instead, the spigot might fall into the groove. Figure 4-2 shows the ideal case of the bell under a bending force, meaning that the spigot is sitting on the bedding where the wall is thicker. However, during the test, since the bedding is short and the spigot is likely to fall into the groove, the spigot might be bearing against the groove where the wall is thinner, contributing to a more significant strain around the bell. As a result, the strain gauges located near the bell gave a larger magnitude of the strains than those placed further away. In addition, Specimen 2 has a non-symmetric configuration of the locking segments (i.e., locking segments were placed on the east side but not on the west side). Since the locking segment provides a better constraint than the rubber gasket, the pipe tends to move more on the rubber gasket side, resulting in an out-of-plane rotation. The continuous DFOS data can clearly observe the phenomenon, which is discussed in the following section.

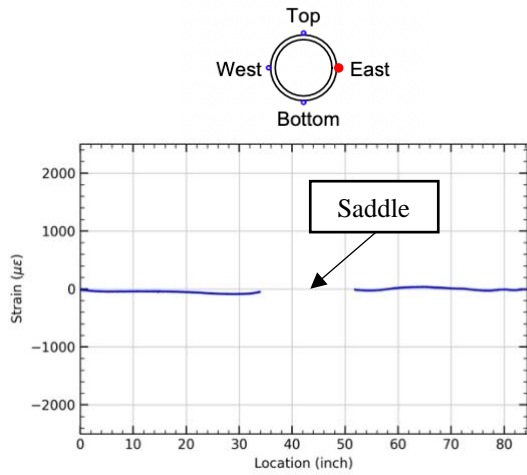
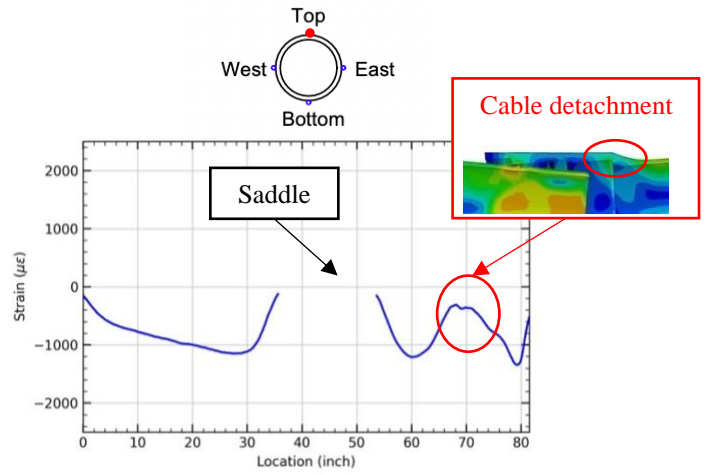
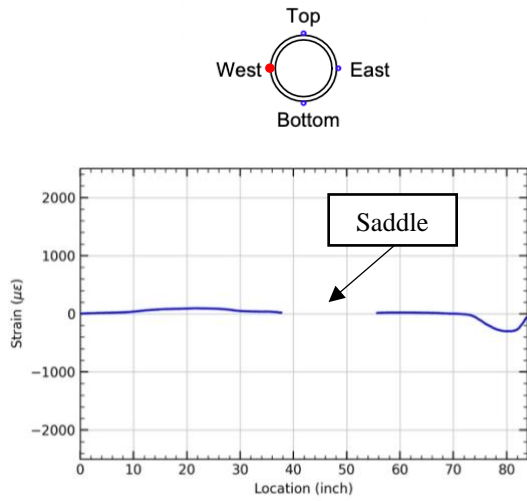
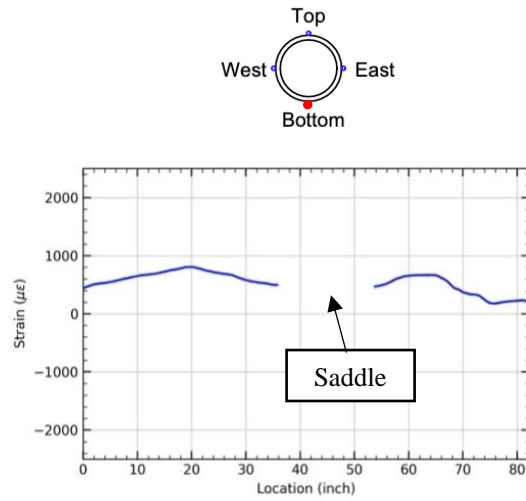
Figure 4-9 Axial strain development of bell pipe of Specimen 1 under 12.5-degree rotation condition. (a) East side, (b) Top side, (c) West side, (d) Bottom side

An anomalous strain distribution can be observed at the top side of the bell pipe close to the bell section, as shown in Figure 4-9(b). The reason for this is cable detachment. The detached location is close to the edge between the bell and the pipe where a slope exists. Because of the slope, the fiber optic cable was not fully attached to the pipe.

The strains at the sides of the pipe (i.e., 3 and 9 o'clock) were generally minimal. However, compressive strain can be found at the location on the west side (9 o'clock) of the bell pipe, as shown in Figure 4-9(c). For the spigot, compressive strains are recorded on the east side (3 o'clock) and tensile strains on the west side (9 o'clock), both at locations close to the bell. These results indicate an out-of-plane rotation happened inside the bell between the spigot and the bell pipe.

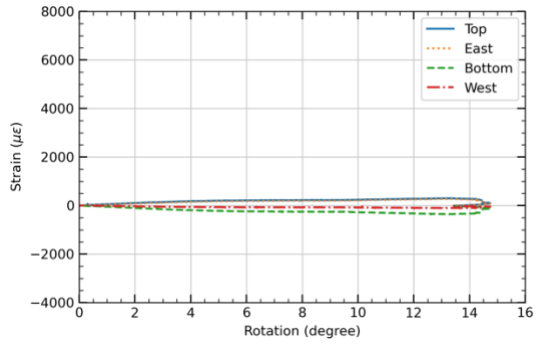
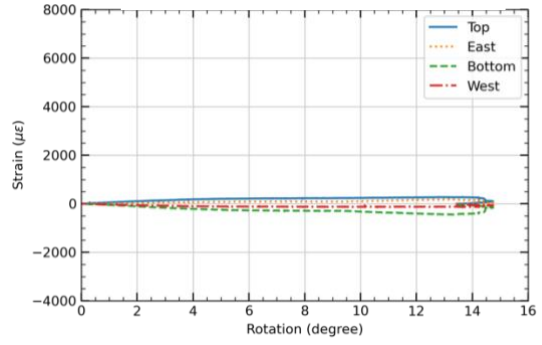
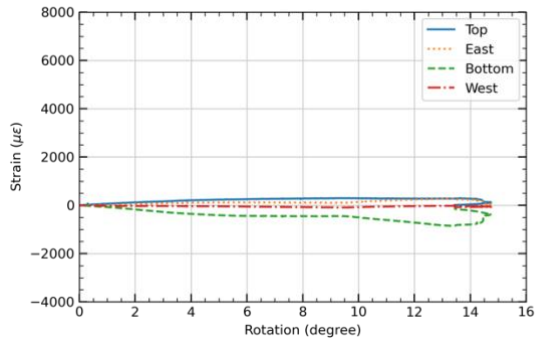
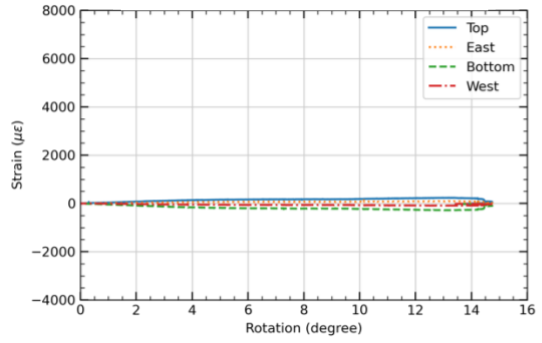
Figure 4-13 Hoop strain vs. rotation of Specimen 1

The relationships between the hoop strains, measured by strain gauges, and pipe rotation are plotted in Figure 4-13 and Figure 4-14 for Specimens 1 and 2, respectively. Due to Poisson's effect, the strains in the circumferential direction are mainly opposite to those in the longitudinal direction with a smaller magnitude. Again, the large strains in Specimen 2 were due to the out-of-plane rotation and potentially at the location where the spigot bore against the bell invert. Tensile hoop strains can be observed at the "top" and "east," whereas compressive hoop strains occur at the "bottom" and "west." This indicates that the pipes were squatting. A clear mechanism of the pipe deformation is provided in the following section using the DFOS data.

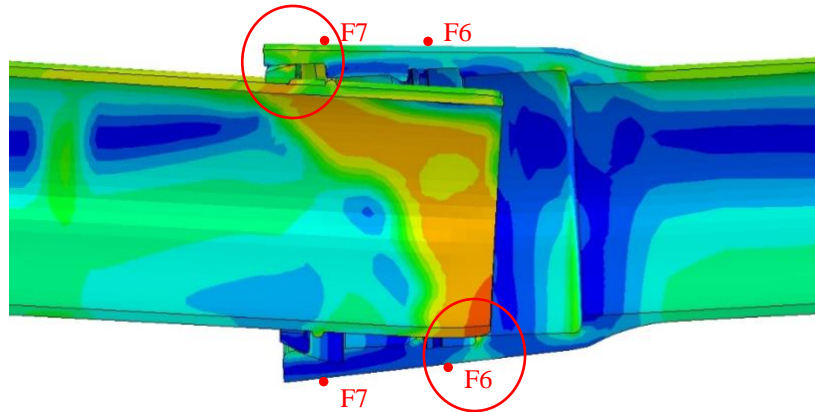
Figure 4-16 Sketch of the mechanism of the bell

The two sensors placed on the bell (F6 and F7) show different patterns. Sensor F6 showed that the bell was expanding on the bottom (12 o'clock). At the locations near the middle of the bell, the spigot was bearing against the bell invert while being pushed down, resulting in expansion on the bottom of the bell. On the other hand, sensor F7 indicated that the bell was squatting, expanding on the top and bottom (6 and 12 o'clock) and shrinking on the other sides (3 and 9 o'clock). The expansion on the bottom side was due to the spigot sitting on the bell invert. On the top side (12 o'clock), the spigot was contacting the bell crown, expanding the top side. The schematic of the mechanism is shown in Figure 4-16.

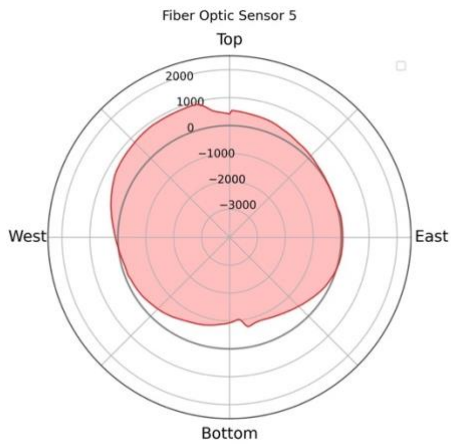
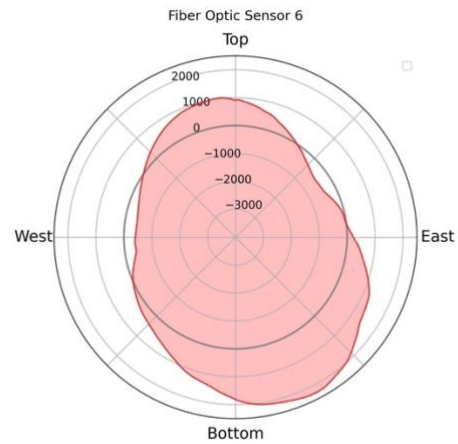
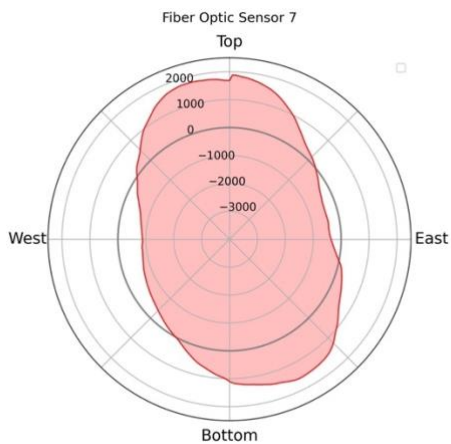
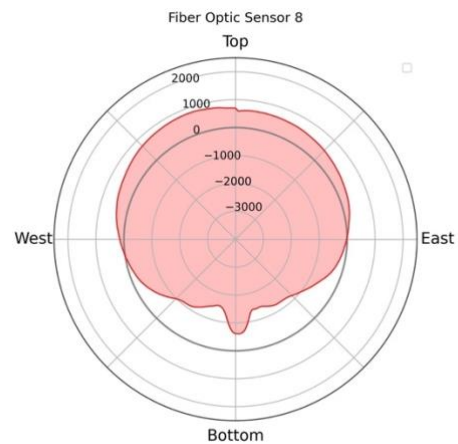
Figure 4-17 Strain distribution in the circumferential direction of Specimen 2 under 12.5-degree rotation condition. (a) sensor on the bell end (b) sensor on the middle of the bell (c) sensor on 3.5-inch away from the bell face (d) sensor on the spigot about 18-inch away from the bell face

Figure 4-17 shows the hoop strains measured in Specimen 2. A similar pattern of strains can be found on the pipes (i.e., F1-F4 and F8-F11) with larger strain values than Specimen 1. The top side (12 o'clock) was under compression, whereas the bottom side (6 o'clock) was under tension. Small strains were found on the other sides (3 and 9 o'clock). As mentioned in the previous sections, the difference in the location where the spigot inside the bell was sitting might be the reason for this strain magnitude difference.

On the bell, a rotation was observed, as shown in Figure 4-17 (a) – (c). The strain distribution in Specimen 1 was merely symmetric along the top-bottom axis. However, the symmetric center line of the strain distribution of Specimen 2 was about 20 degrees offset from the top-bottom axis toward the west side. The phenomenon is due to the non-symmetric locking segment orientation. On the west side (9 o'clock), a rubber gasket was placed instead of having a locking segment, providing less restraint. Therefore, an out-of-plane rotation occurred during the test. Expansion can be found on the top and bottom sides of the bell (F6 and F7) because the bottom of the spigot was bearing against the bell invert, and the crown of the bell face was contacted with the spigot. All the hoop strain results can be found in Appendix B.

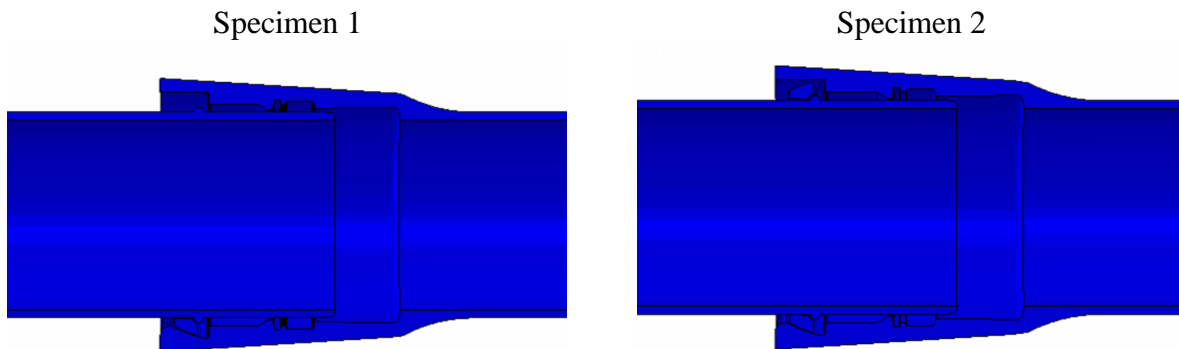
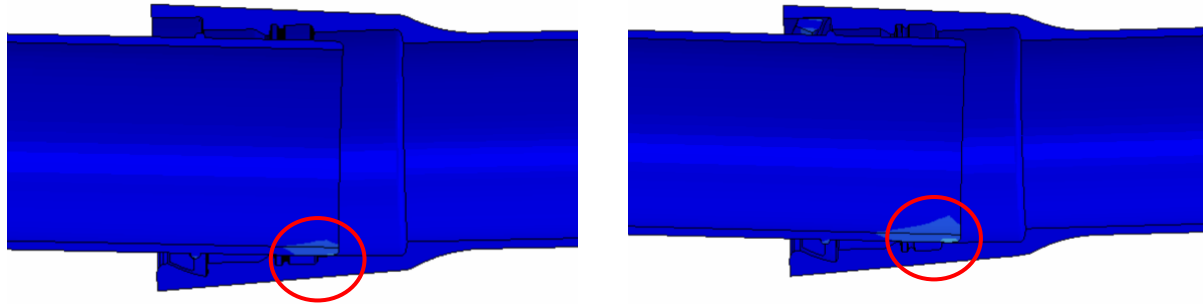
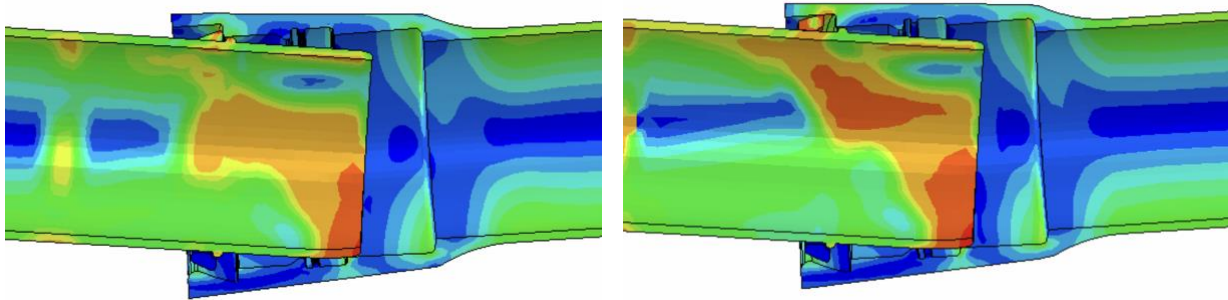
(a) Initial fully extended position

(b) Spigot rotated to contact the bell bedding

(c) Joint rotated at failure status

Figure 5-4 shows the Mises stress of the joint under different stages. The joint was initially installed at the fully extended position, meaning that the weld bead on the spigot contacted the locking segments. No significant stress was developed during this stage, as shown in Figure 5-4 (a). Figure 5-4 (b) shows the stage that the bottom of the spigot started to sit on the bedding in the bell. Stresses started to develop for both specimens at the bottom of the spigots. Figure 5-4 (c) depicts the stress distribution at the failure stage. The largest strains were developed at the bottom of the spigot for both specimens, meaning that the bottom of the spigot is the most vulnerable region. Moreover, for Specimen 2, a 45-degree crack started from the bottom of the spigot can be expected.

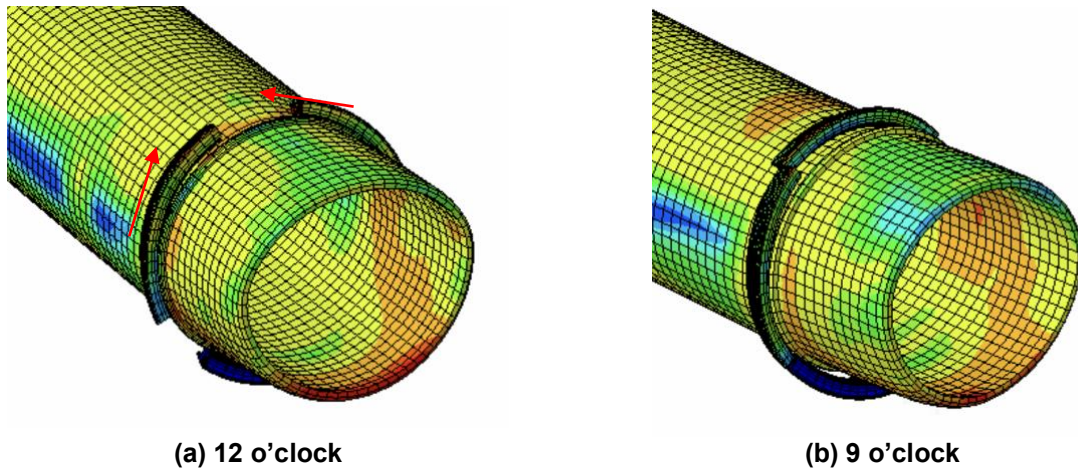
Figure 5-5 Position of locking segments

The moment for a given rotation varies between the experimental data and the FE analysis results, especially the magnitude of the moment in Specimen 1. The results from FEM are larger than that of the test results. This discrepancy could be attributed to the FE models not capturing the effect of the rubber gasket holding the locking segments in place. In the FE models, the rubber gasket is not modeled, meaning that the locking segments located at the sides are allowed to detach slightly and move upwards, as shown in Figure 5-5. Because the locking segments move upward, a certain portion of the spigot is bearing against the locking segment instead of a rubber gasket. This results in a larger moment being generated in comparison to the experimental scenarios where the spigot bears against the rubber gasket on the top. For Specimen 2, however, the locking segment at the top remains at its position. Hence, the phenomenon mentioned above is not observed. Consequently, the moment magnitude differed only slightly from the test results of Specimen 2.

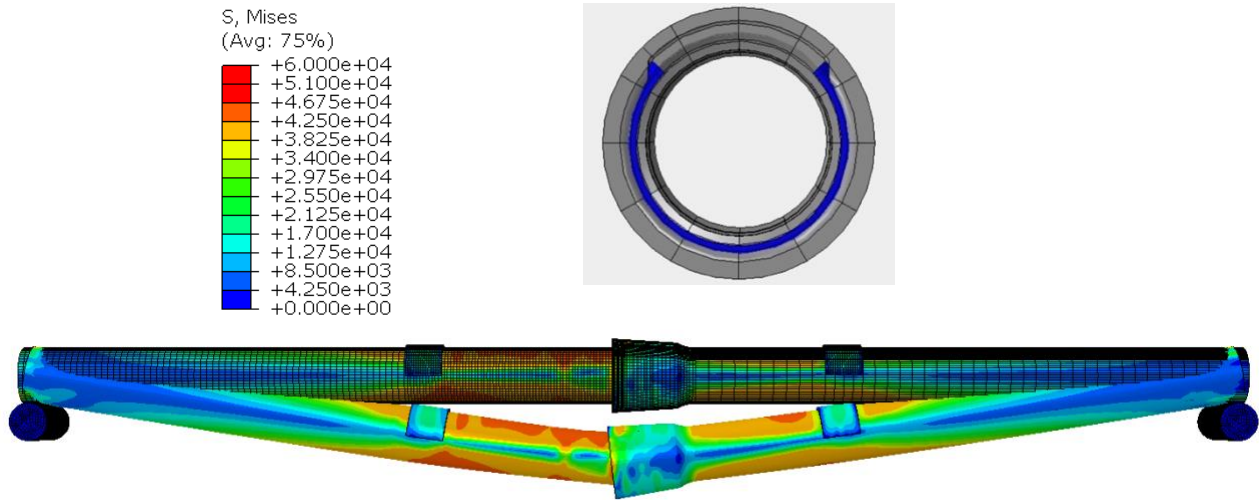
Figure 5-6 Overview of before and after pipeline deformation

For Specimen 1, the single slot is located on the top side (12 o'clock), as shown in Figure 5-6. The Mises stress contour and the deformation of the pipeline before-after test are presented.

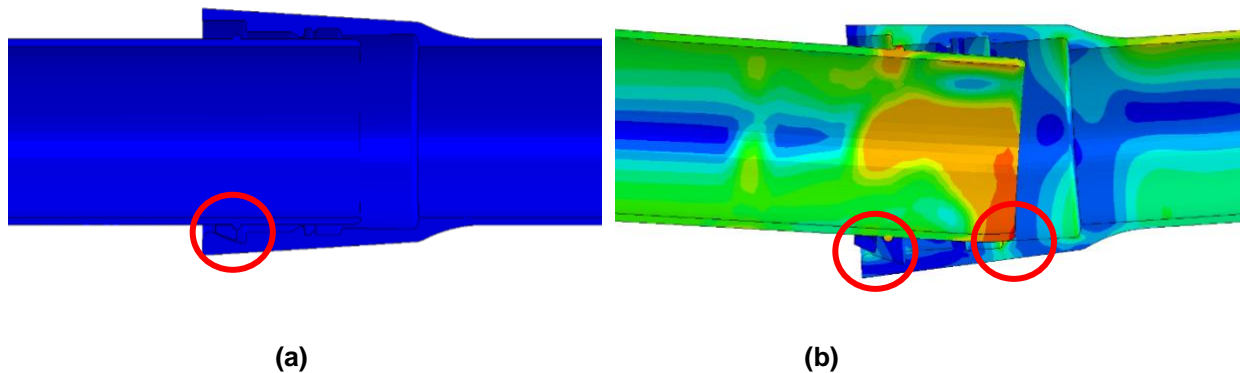
Figure 5-7 Cross-section of joint: (a) initial stage; (b) 10-degree rotation condition

The spigot and bell were set to begin with an extended location, as shown in Figure 5-7 (a), where the weld bead of the spigot started to contact the locking segments. Figure 5-7 (b) shows the Mises stress contour and deformation of the joint at the failure stage. Because of the rotation, a significant stress concentration can be found at the bottom of the spigot inside the bell, and the spigot bears against the bell invert. In addition, the locking segment at the bottom was detaching with the weld bead on the spigot and was trying to slip out of the bell.

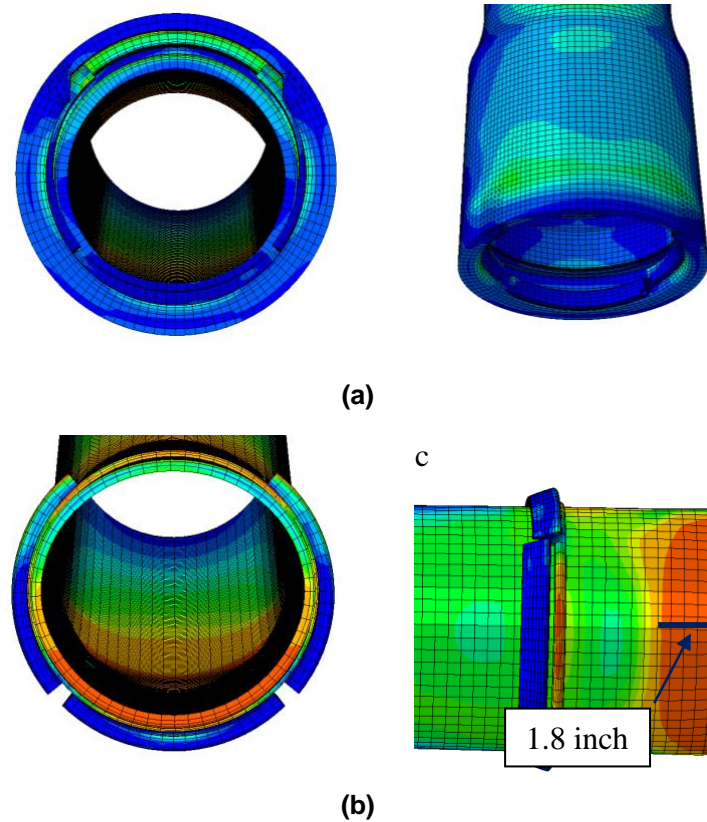
Figure 5-8 The stress contour and deformation of (a) bell (b) spigot

The Mises stress distribution of the joint at the 16-degree rotation condition is shown in Figure 5-8. The result indicates that the stresses distributed in the bell section are generally smaller than those in the spigot. A large stress concentration can be found at the bottom of the spigot. The locking segments were detaching from each other while the specimen was bent. In addition, the bottom locking segment was trying to slip out from the bell. The spigot cross section was squeezed into an ellipse with symmetrical deformation. On the contrary, the shape of the bell remained merely unchanged.

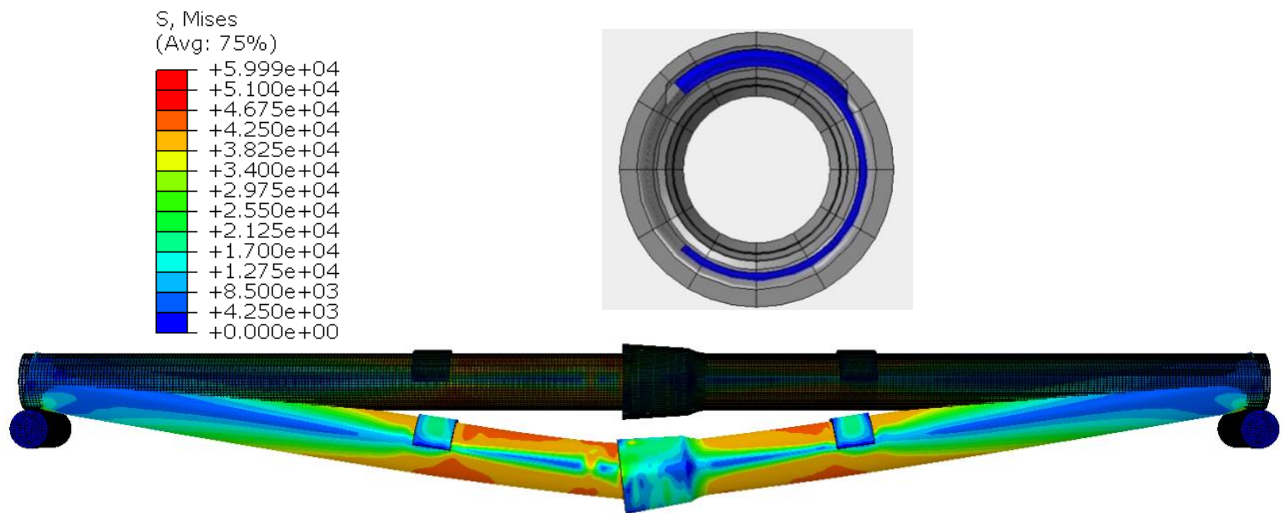
Figure 5-12 Overview of before and after pipeline deformation

The only difference between the modeling of Specimen 1 and Specimen 2 is the orientation of the three pieces of the locking segments. The single slot is located on the west side (9 o'clock), as shown in Figure 5-12. The Mises stress contour and deformation of the pipeline before-after test are also shown in the plot.

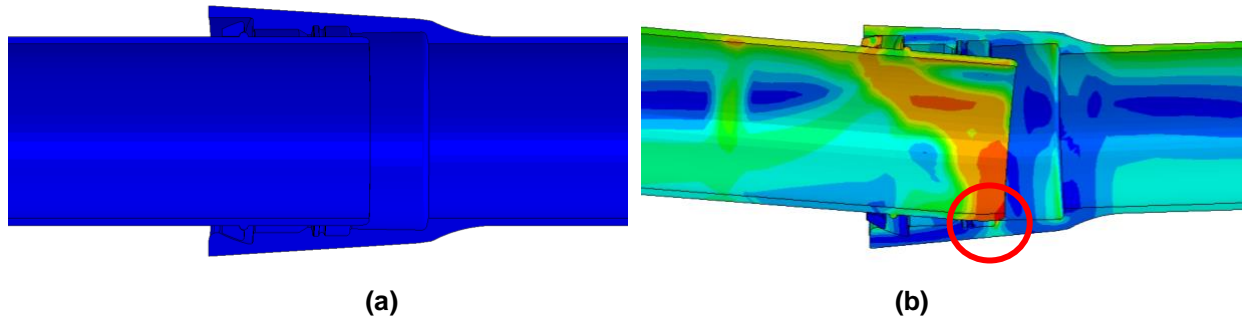
Figure 5-13 Cross-section of joint: (a) initial stage; (b) 10-degree rotation condition

The spigot and bell began at the extended position, where the weld bead of the spigot just contacted the locking segments. Figure 5-13 shows the Mises stress contour and deformation of the joint close to the failure stage (16-rotation condition). A significant stress concentration can be found at the bottom of the spigot inside the bell, similar to the observation made in Specimen 1. However, a different stress distribution is observed due to the different locking segment orientations. The locking segment at the bottom also detaches with a weld bead and tries to slip out from the bell, which was also observed in the FE model results of Specimen 1.

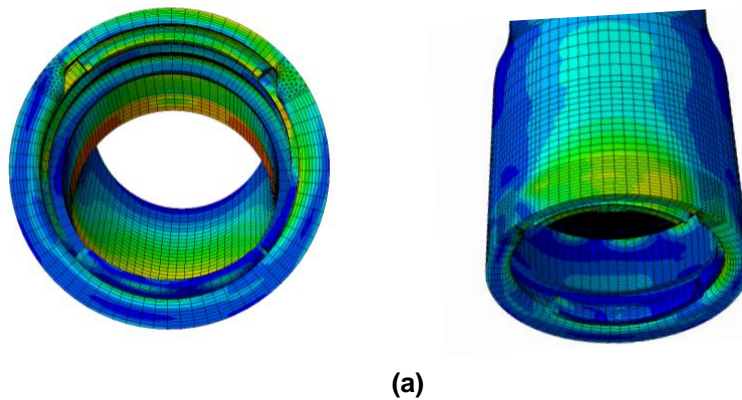
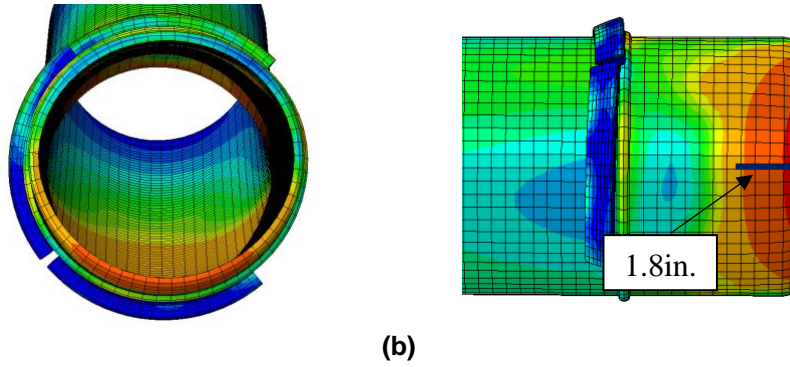
Figure 5-14 The stress contour and deformation of (a) bell (b) spigot

The Mises stress distribution of the joint at 16 degrees of rotation is shown in Figure 5-14. Similar to the observation made in Specimen 1, the stresses distributed at the bell section are generally small compared to those on the spigot. A large stress concentration can be found at the bottom of the spigot. Moreover, the locking segments detach from each other while the specimen is bent. The top and bottom locking segments are trying to slip out from the bell, which differs from what was observed in Specimen 1. The spigot cross-section deforms into an ellipse shape with symmetrical deformation.

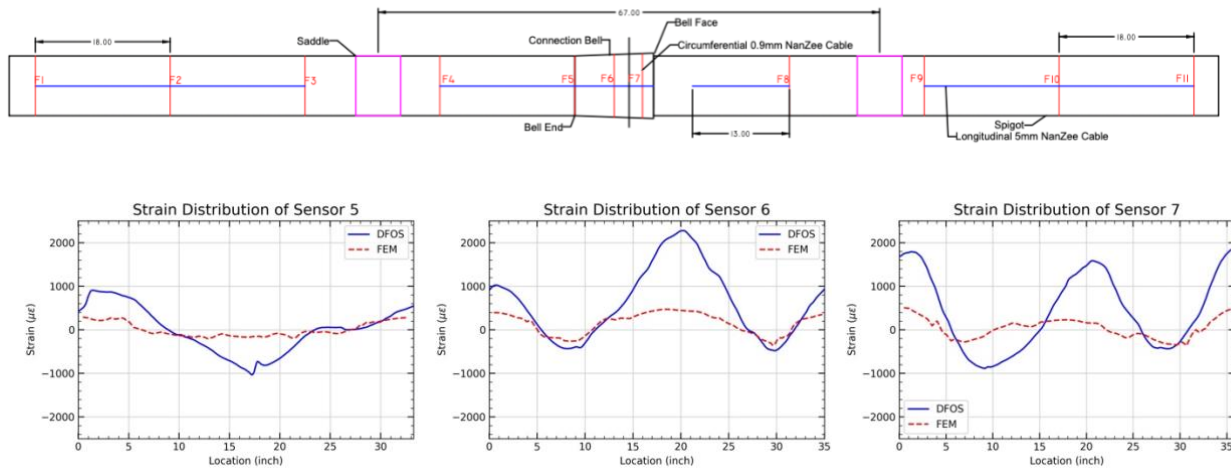
Figure 5-16 Comparison of circumferential strain

Figure 5-16 and Figure 5-17 show the comparison of the circumferential and longitudinal strain distribution on Specimen 2 between the FE analysis and the experimental data when the joint rotation reaches around 12 degrees of rotation in the FE model. This corresponds to 8 degrees of rotation in the experiment. Sensors F5, F6, and F7 measure the circumferential strains at the bell joint. The trends of the strain distribution measured by these sensors match well between the FE analysis results and DFOS data. However, the magnitudes are different. This may be because, during the lab test, the spigot edge displaced to the bell groove, as shown in Figure 5-18. Besides, the groove area is thinner than the other bell area, representing lower stiffness, which may cause more significant strain distribution and a large possibility of the bell joint failure.

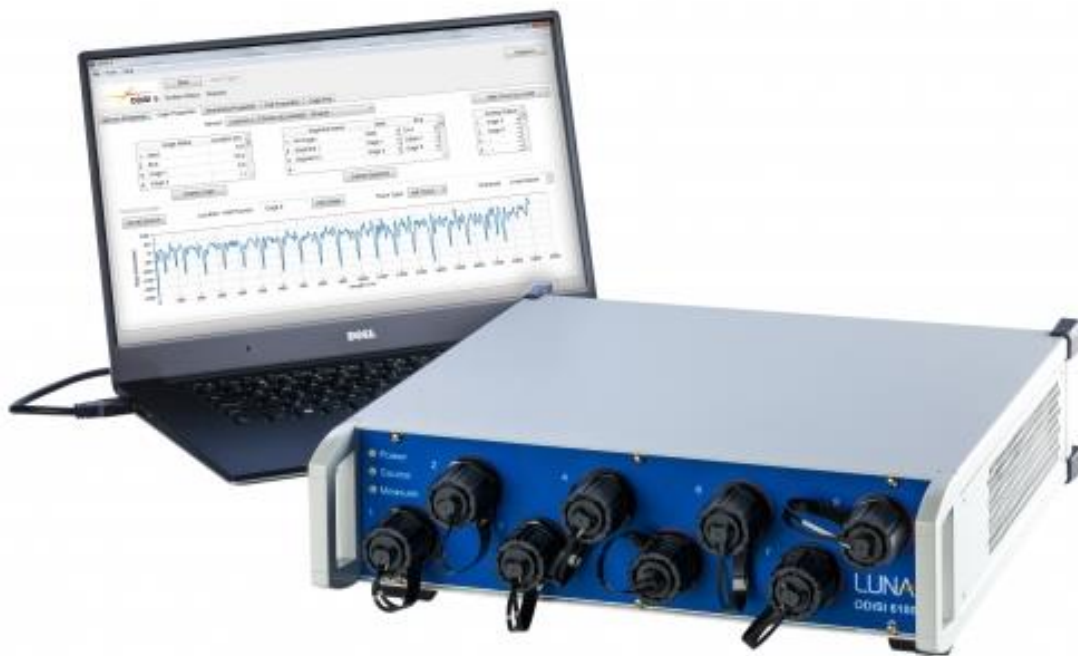
Figure A-1. LUNA ODiSI 6000 Series optical distributed sensor interrogator (LUNA, 2022)

Using the physical properties of light, fiber-optic sensing can detect changes in temperature, strain, and other parameters when light travels along a fiber, which uses fiber-optic cables as sensors and can measure over long distances at 100 to 1000s of points on a single cable or multiplexed cables depending on the analyzer used. Compared to the other sensing technologies, fiber-optic sensing has distinct advantages such as small size, light weight, and strong resistance to corrosion and water. Distributed fiber optic sensing consists of two main components, an analyzer, and fiber-optic cables. LUNA ODiSI 6000 series interrogator was used as the analyzer, and NanZee Sensing Technology Co manufactured the fiber-optic cables in the experiments.
