# **Four-Point Bending Testing of 8-in. (200-mm) Diameter AWWA C900 DR14 iPVC Pipe**

CSI Report 2023/03  
Center for Smart Infrastructure (CSI)  
Department of Civil and Environmental Engineering  
University of California, Berkeley May 2023

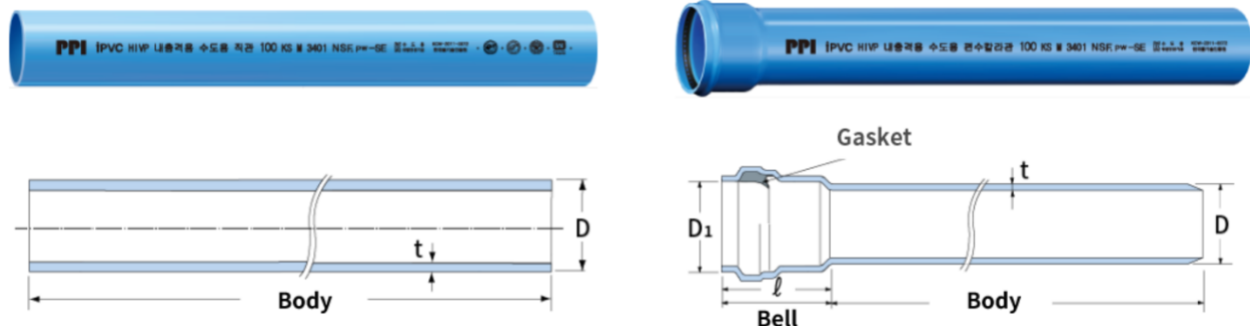
Figure 1-1 Schematic of the bell of AWWA C900 DR14 iPVC pipe (PPI, n.d.)

The pipe is equipped with a bell used for connecting the pipes. The pipe is designed to be inserted into the bell pass through a rubber gasket, which is deployed for water leaking prevention purposes, as shown in Figure 1-1. Two types of restraints were used for the experiments, EBAA 1900 restraint and RCT restraint, as shown in Figure 1-2. The restraints are used to restrict the relative movement between the pipes. Both the EBAA 1900 and RCT restraints are made of ductile iron. However, their locking mechanism is different. For EBAA 1900, four rods are used to prevent the pipes from moving apart. Two bolts are deployed to the serrated rings to provide nominal forces for the friction between the pipe and the rings. Instead of having an external locking mechanism, the RCT restraint provides specially designed teeth inside the restraint, which allows only one direction movement (i.e., the direction point into the restraint). In this study, the pipe's bell section was cut to implement the RCT restraint. That is, two identical pipes were connected using the RCT restraint. In addition, rubber gaskets were placed inside the restraint to prevent the water from leaking. This study aims to understand the deflection contraction capacity and failure mechanism of the pipes equipped with the two different restraints under bending force.

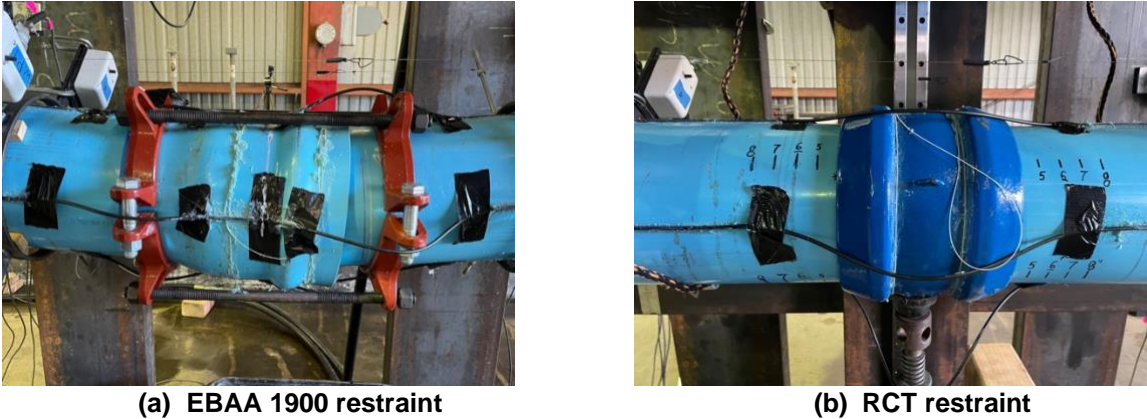
(a) EBAA 1900 restraint

(b) RCT restraint

Figure 1-2 Restraints for the specimens

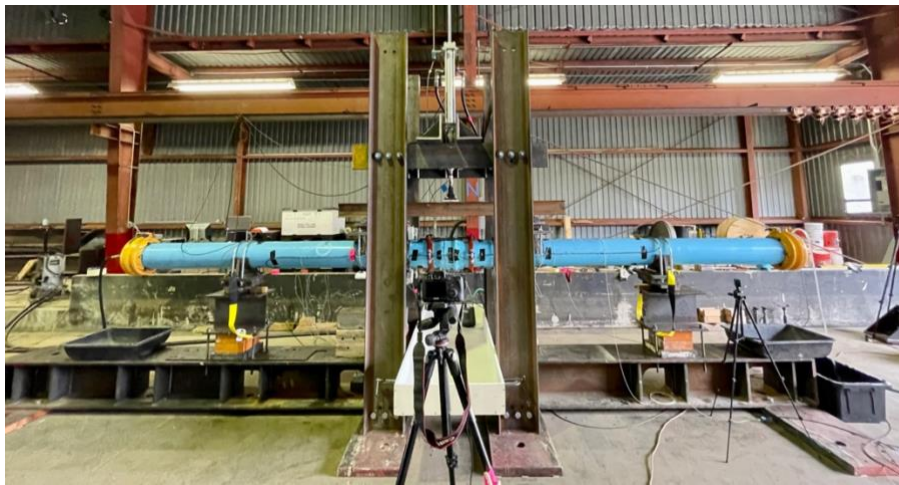
Figure 2-1 Specimen 1 (EBAA 1900 restraint) experimental setup

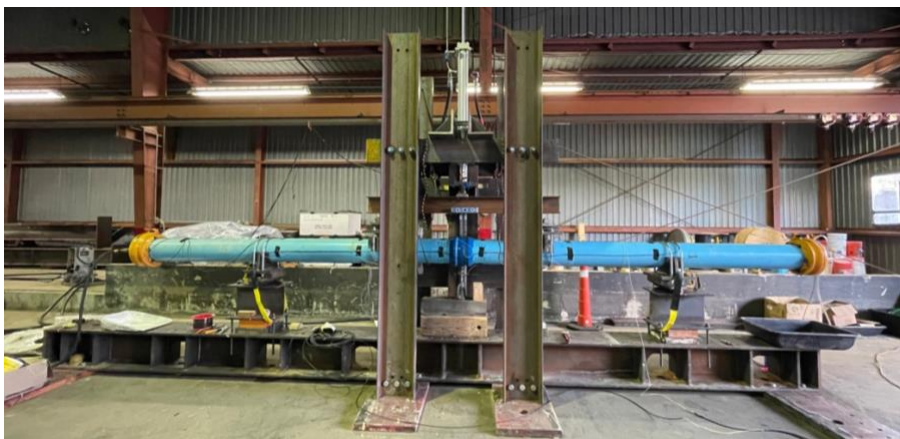
Figure 2-2 Specimen 2 (RCT restraint) experimental setup

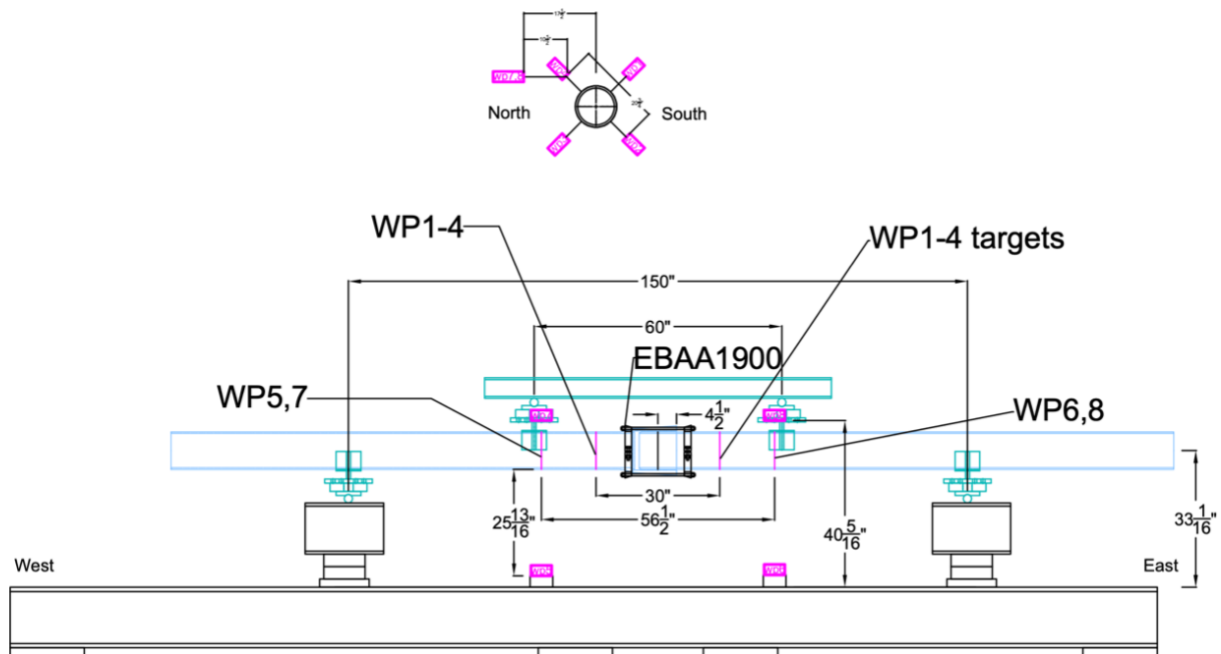
**Figure 3-1 Instrumentation plan of Specimen 1 (EBAA 1900 restraint)**

Eight string pots were installed on the specimens to measure the displacements. Four wire pots were used to measure the joint opening, located 45 degrees apart from the quarter points. Another four wire pots were used for monitoring displacements of the pipes during the experiment. The exact locations of the instruments for the three specimens are shown in Figure 3-1 and Figure 3-2. They were mounted on both ends of the pipes, on the north and bottom sides. The two wire pots mounted on the north side aimed to measure the horizontal displacement, and the ones on the bottom side were attached to monitor the vertical displacements. The local instrument names are shown in Table 3-1.

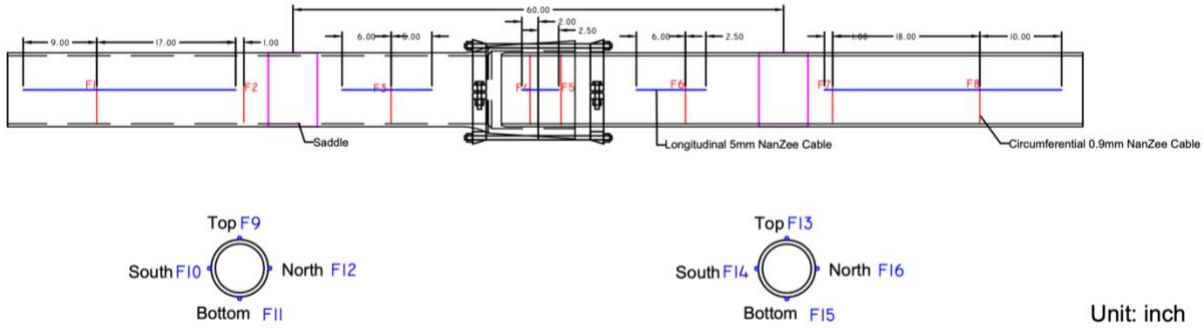
**Figure 3-3 Instrumentation plan of fiber optic sensors of Specimen 1 (EBAA 1900 restraint)**

Two types of fiber optic cables manufactured by NanZee Sensing Technology Co. were used; (a) 5 mm diameter armored cable (NanZee 5mm) and (b) 0.9 mm diameter cable (NanZee 0.9mm). 3M SCOTCH-WELD DP8010 epoxy was used to attach the cables to the pipes. Figure 3-3 and Figure 3-4 show the layout and locations of the sensors. NanZee 5mm cables (blue lines) were used in the longitudinal direction to mimic the use on construction sites. They were attached on both pipes, 90 degrees apart, numbered F9-F16. On the other hand, to better understand the deformation mechanism of the pipes, NanZee 0.9mm (red lines) was used for measuring circumferential strains, numbered F1-F9. Three circumferential sensors with about 18-inch spacing were installed on both pipes. In addition, two sensors measured hoop strains were attached at the bell section on Specimen 1, and two circumferential sensors were attached to the RCT restraint for Specimen 2. The local names of DFOS are listed in Table 3-2.

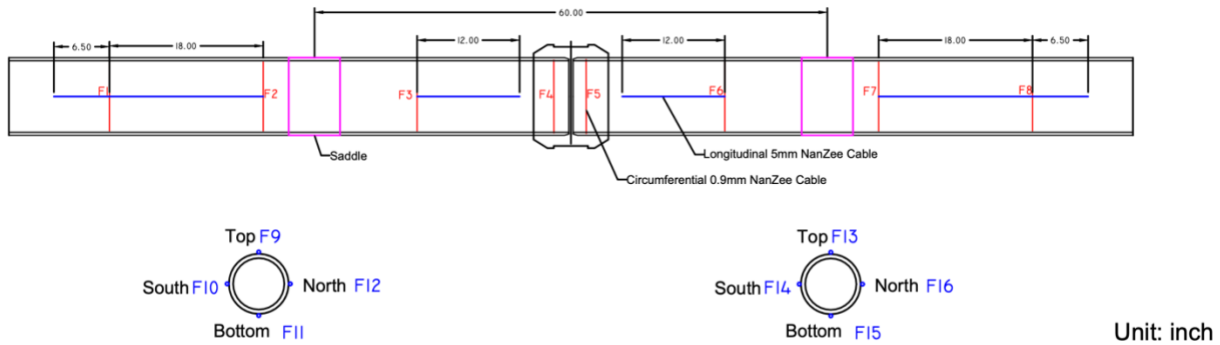
**Figure 3-4 Instrumentation plan of fiber optic sensors of Specimen 2 (RCT restraint)**

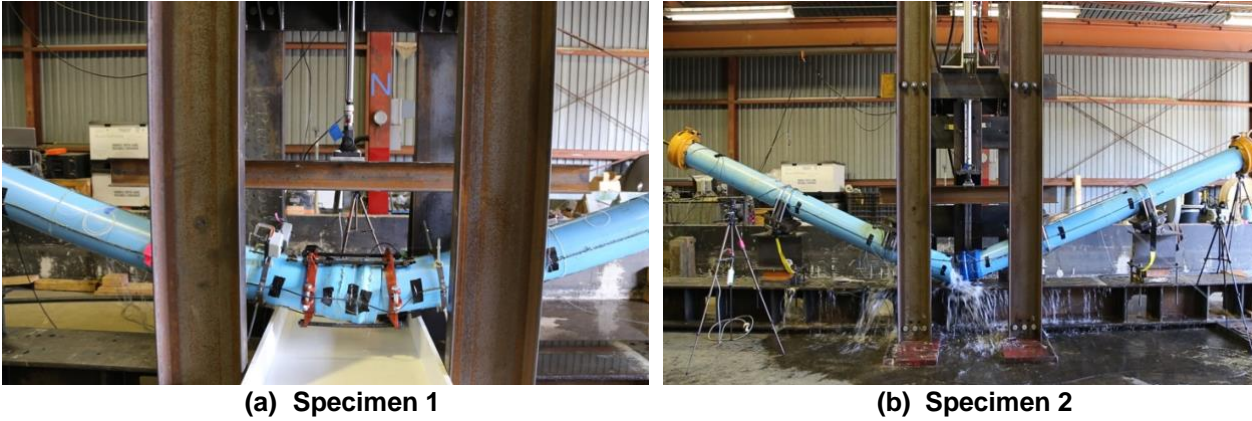
**Figure 4-2 Large deformation of Specimen 1 and 2**

No significant failures were found in Specimens 1. Figure 4-2 shows the figures of the two specimens with large deformation. The main difference between these two specimens is the restraints. For Specimen 1, EBAA 1900 restraint, which prevents the pipes from moving apart by the external locking ring, was used. This locking mechanism allowed the pipes to have relative movement within the bell section. While being bent, the top side of the spigot tended to move inward to the bell; on the contrary, the bottom side of the spigot tended to move out from the bell. Because the bottom side of the spigot was moving out, a continuous small leakage can be observed after the specimen reached about 28-degree rotation.

For Specimen 2, RCT restraint, which provides an internal locking mechanism to prevent the pipes from moving apart, was adopted. In this case, pipes were not allowed to move out from the connection section. Hence, no water leakage was found throughout the test before a significant pipe failure. In addition, since the length of the RCT restraint was shorter than the EBAA 1900 restraint, a larger concentrated compressive stress was expected at the boundary of the RCT restraint and the pipes.

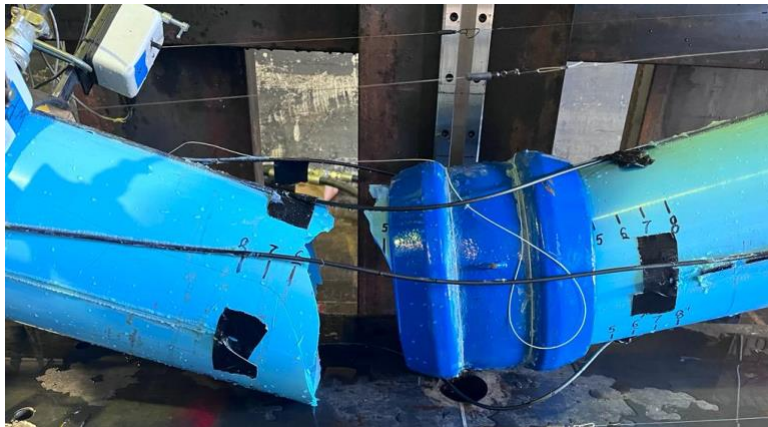
**Figure 4-3 Failure of Specimen 2**

A significant pipe failure occurred at the boundary of the RCT restraint and the west-side pipe when the rotation reached about 34.45 degrees, as shown in Figure 4-3. This indicates that the weak point is the edge of the two components. While the pipe was being pushed down, the pipes were squashing, but the restraint was not. This is because the RCT restraint was made of ductile iron which is much stiffer. In addition, because of the stiffness difference at the boundary of the restraint and the pipe, a shear force was developed at the edge resulting in a larger compression force on the top side (12 o'clock), where the pipe first broke.

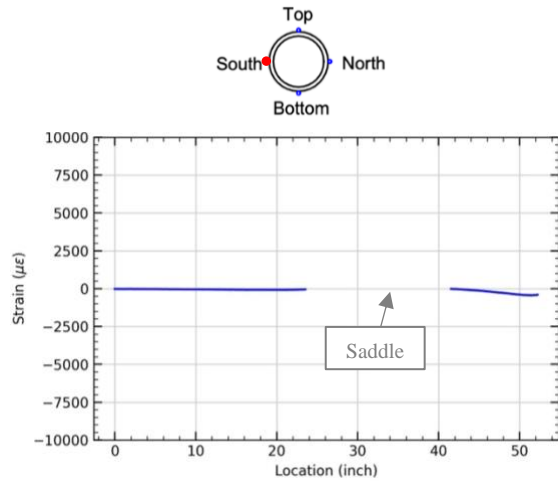
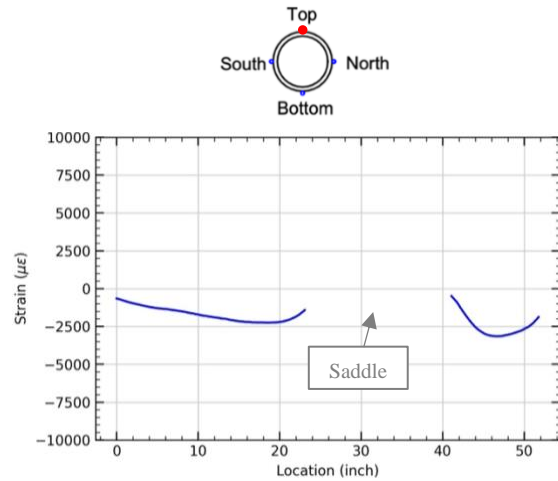
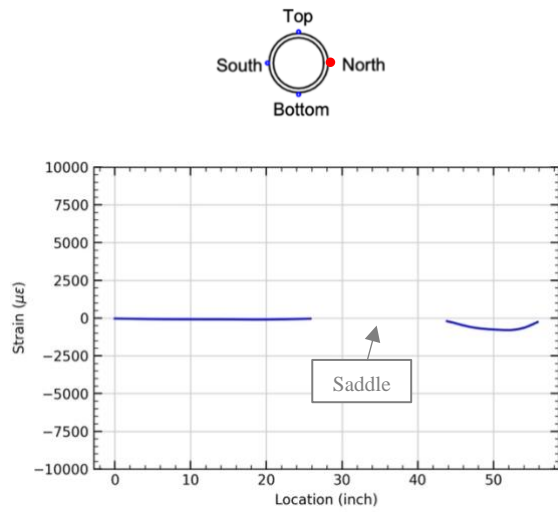
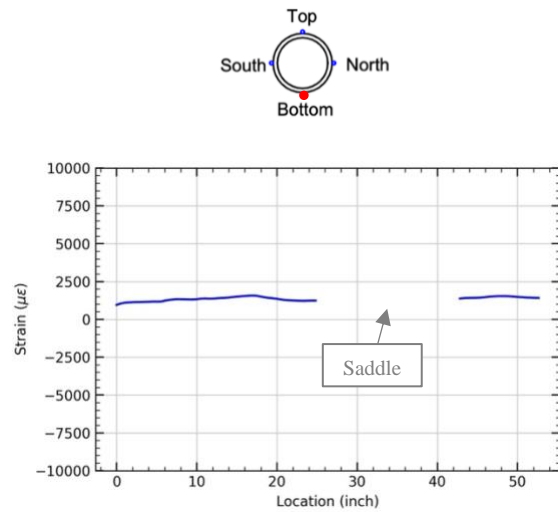
**Figure 4-7 Axial strain development of west pipe of Specimen 2 under 18-degree rotation condition. (a) South side, (b) Top side, (c) North side, (d) Bottom side**

The axial strain results of the west-side of Specimen 2 are shown in Figure 4-7. The results are similar to that of Specimen 1. Tensile strains were observed on the bottom side (6 o'clock), compressive strain on the top side (12 o'clock), and a small strain on the sides (3 and 9 o'clock). Larger compressive strains can be found on the north, south, and top sides (3, 9, and 12 o'clock) close to the restraint. Since the RCT restraint is made of ductile iron, which is much stiffer than the pipe, the restraint did not deform but introduced a shear force close to the boundary of the pipe and the restraint, especially on the top side. Due to Poisson's effect, larger compressive strains were observed on the sides (3 and 9 o'clock) and top side (12 o'clock). A similar phenomenon can be found on the east-side pipe, as shown in Figure 4-8.

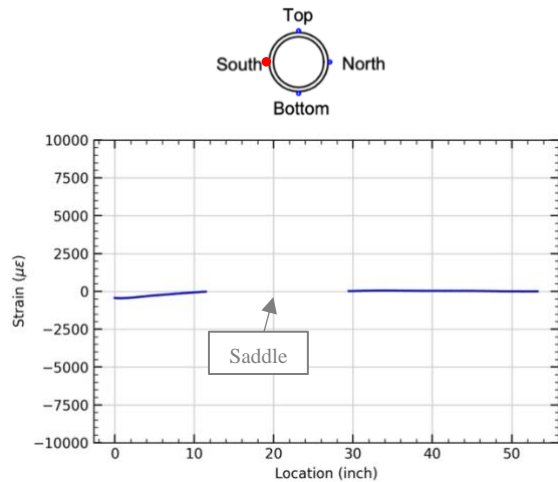
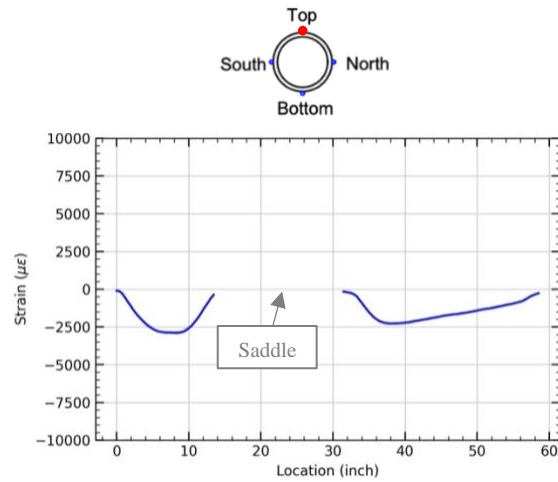
**Figure 4-8 Axial strain development of east pipe of Specimen 2 under 18-degree rotation condition. (a) South side, (b) Top side, (c) North side, (d) Bottom side**

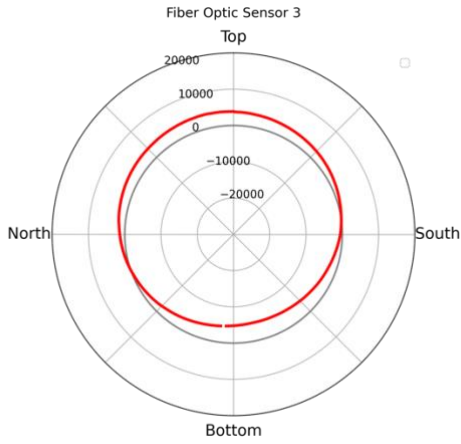
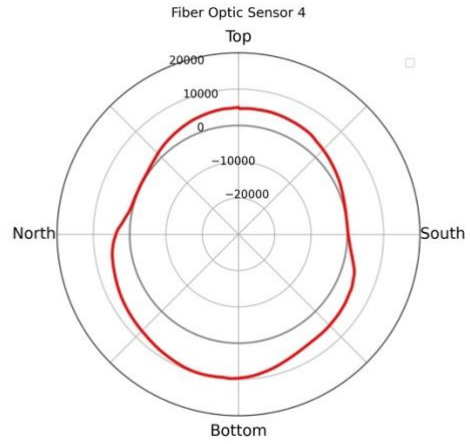
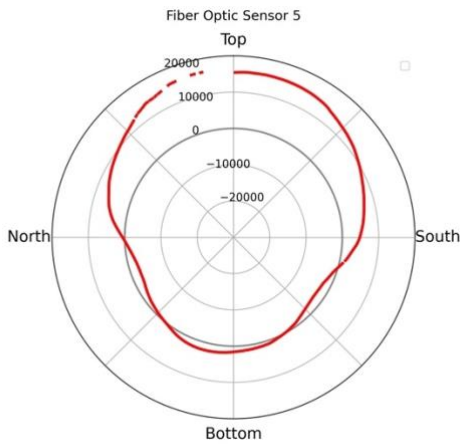
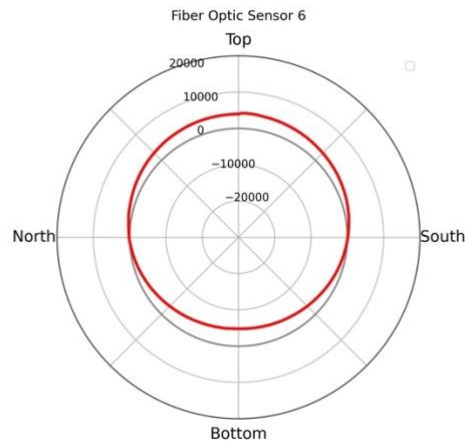
**Figure 4-9 Strain distribution in the circumferential direction of Specimen 1 under 18-degree rotation condition. (a) sensor on the west pipe (b) sensor on the bell to the west of the center (c) sensor on the bell to the east of the center (d) sensor on the east pipe**

The hoop strain results measured from Specimen 1 are plotted in Figure 4-9. The figure shows the results measured by the sensors placed on the bell (F4 and F5) and the sensors that are the closest to the bell on both of the pipes (F3 and F6).

Results of F3 and F6 on the pipes show that the top side (12 o'clock) was expanding, and the bottom side (6 o'clock) was compressing. This is due to Poisson's effect that the strains in the circumferential direction were mainly opposite to those in the longitudinal direction with a smaller magnitude. Tensile hoop strains can be observed at the top side and compressive hoop strains showed at the bottom side with small strains on the other two sides, indicating the pipes were squashing eccentrically during bending. The deformation mechanism of the pipe cross-section is shown in Figure 4-10. The rest of the circumferential sensors placed on the pipes (i.e., F1, F2, F7, and F8) showed similar patterns, as shown in Appendix C. However, the magnitude of the strain decreased as the distance from the sensor to the bell increased.

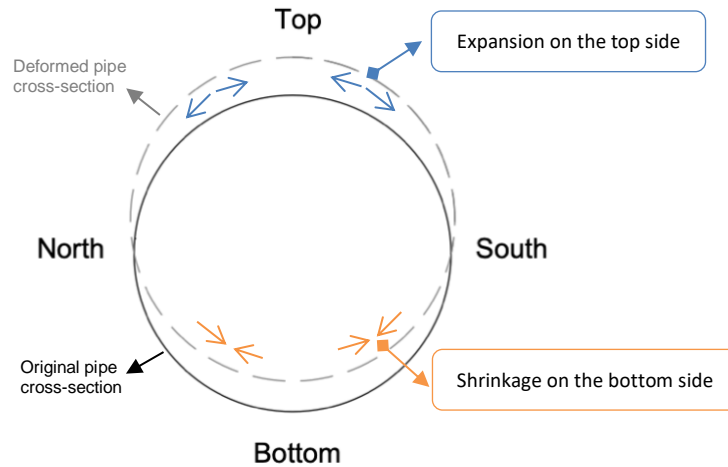
**Figure 4-10 Sketch of pipe cross-section deformation mechanism under bending condition**

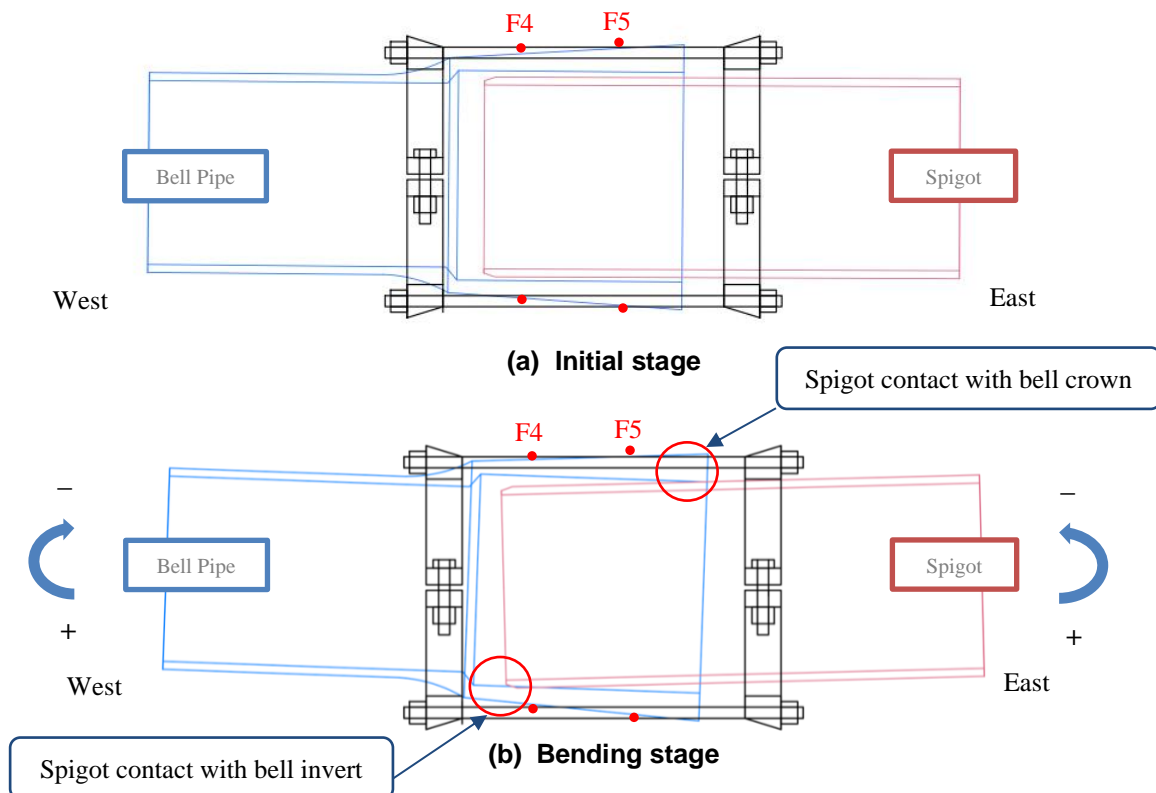
**Figure 4-11 Sketch of EBAA 1900 restraint deformation mechanism**

Figure 4-11 shows the bell deformation mechanism at the initial stage and under bending conditions. As shown in Figure 4-11(a), the spigot and the bell pipe were not contacted at the initial stage. As the pipe being pushed down, the spigot started to bear against the bell. The two sensors placed on the bell (F4 and F5) showed different patterns. The one to the west side of the center point (F4) showed that the bell was expanding more on the bottom than on the top (see Figure 4-9). This is because the spigot was bearing against the invert of the west side of the bell while being pushed down. On the contrary, for F5, the spigot contacted the crown of the bell face and hence expands the bell on the top resulting in smaller strains at the bottom (see Figure 4-9). The sketch of the mechanism is shown in Figure 4-11(b). The test stopped due to reaching the testing capacity. No severe water leakage or pipe failure was found.

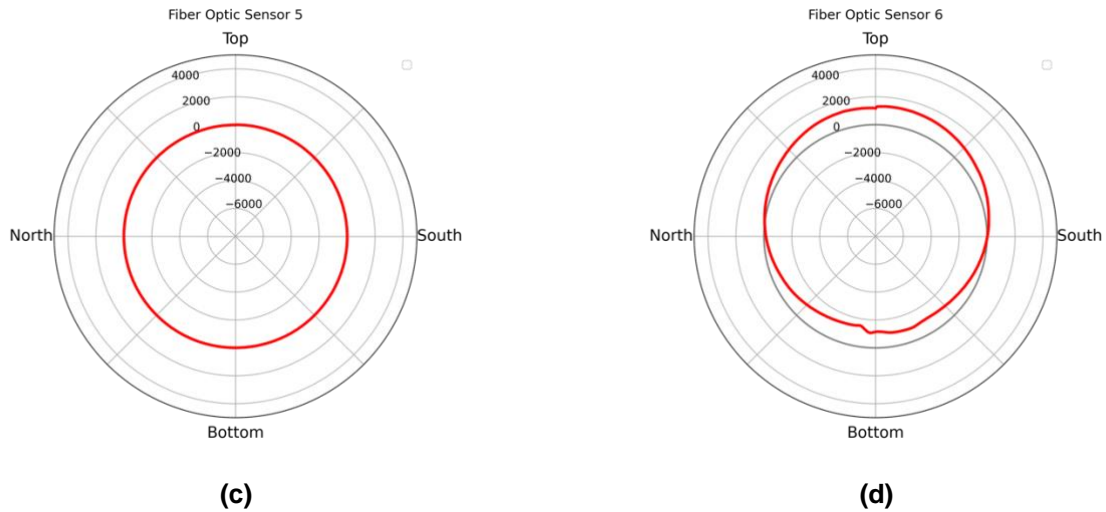
**Figure 4-12 Strain distribution in the circumferential direction of Specimen 2 under 18-degree rotation condition. (a) sensor on the west pipe (b) sensor on the bell to the west of the center (c) sensor on the bell to the east of the center (d) sensor on the east pipe**

Figure 4-12 shows the hoop strain results in Specimen 2 from Test 2. Two sensors (F3 and F6) were on the pipes closest to the center point, and two were attached to the RCT restraint. Similar to the observations of the pipes in Specimen 1, the pipes were eccentrically squashing, with expansion on the top side (12 o'clock) and compression on the bottom side (6 o'clock). The zero values close to the bottom of F3 are due to cable detachment, shown in Figure 4-12(a). The rest of the sensor results are listed in Appendix C. The results indicated that the pattern on the pipes is similar, but the magnitude varies due to the distance between the sensor and the restraint. The magnitude of the strains is larger when the sensor is closer to the restraint.

In addition, comparing the magnitude of the strain developed on the pipes at a given rotation, the strains are generally smaller in Specimen 2. This is again due to the locking mechanism difference. The EBAA 1900 restraint utilized in Specimen 1 permitted the bell pipe and spigot to make direct contact with each other, leading to greater deformation of the pipes. Conversely, due to the material's stiffness difference, the RCT restraints used for Specimens 2 resulted in significant strain concentration at the top of the pipes near the restraint boundary, while producing smaller deformations elsewhere along the pipes.

The behavior of the restraint is different from the previous one. Since the stiffness of the RCT restraint is much larger, the deformation on the RCT restraint was much smaller than that of the pipes, resulting in smaller strains developed on the restraint. The strains developed on the RCT restraint are close to zero. All the hoop strain results are given in Appendix C.

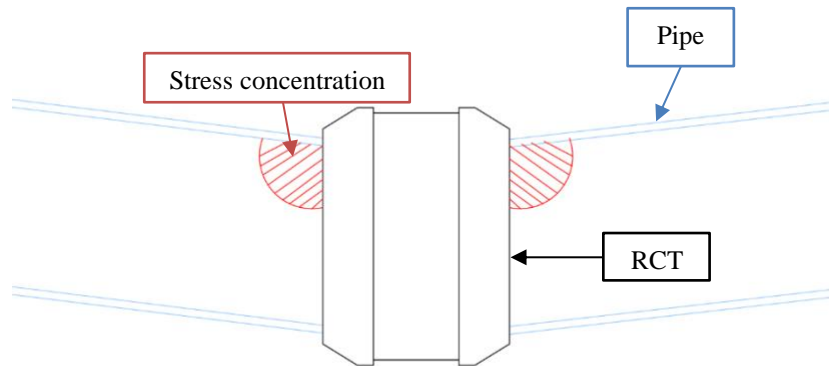
**Figure 4-13 Sketch of strain concentration on pipes of Specimen 2**

The RCT restraint was crafted from ductile iron, which offered superior stiffness. Consequently, while the pipe was being pushed down, it was squashed, but the restraint remained intact. Additionally, due to the large stiffness difference between the restraint and the pipe, a shear force was generated at the boundary, resulting in a large stress concentration at the top of the pipes close to the restraint, where the pipe initially failed. Figure 4-13 illustrates the stress concentration areas. The stress concentrated at those particular locations contributed to a large localized strain, which led to a sudden failure.

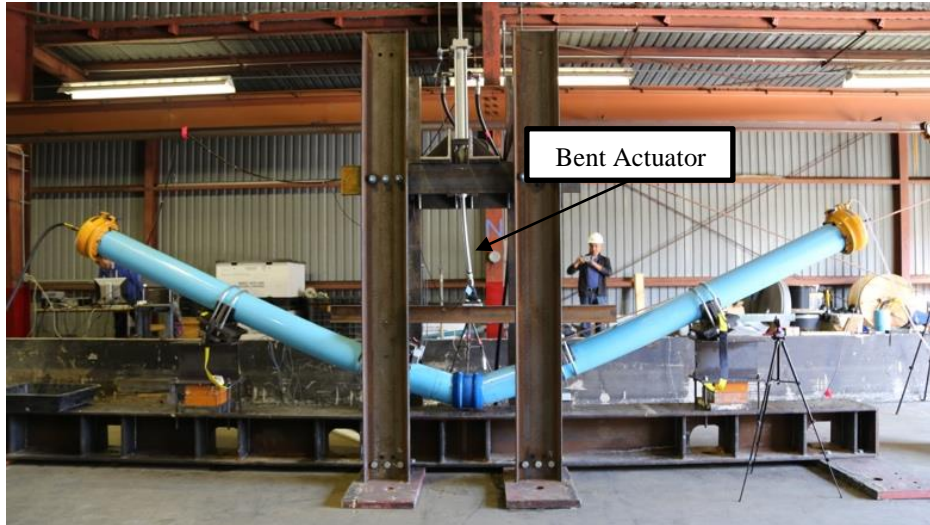
**Figure A-1 Experimental setup and large deformation of the additional trial specimen**

An additional trial test was conducted using specimen with the RCT restraint. The experimental setup is similar to the one used for Specimen 2. However, FO sensors were not installed on this specimen. The results and experimental findings are reported in this section. Figure A-1 shows the experimental setup of the additional trial test while the specimen was bent to a large deformation.

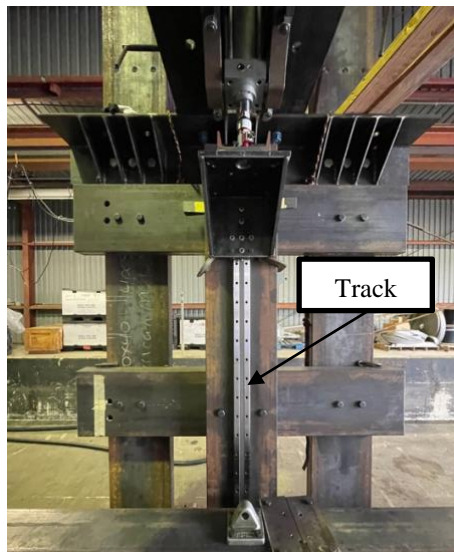
**Figure A-2 Specially designed track for actuator**

During this trial test, the actuator was found not moving exactly toward the desired direction (i.e., point down to the perpendicular axis of the longitudinal direction), but bending was found on the actuator, shown in Figure A-1, which influenced the pushing direction and required larger forces. To ease the situation, a specially designed track was installed to ensure the pushing direction of the actuator for Specimen 2 in Test 2. The specially designed track is shown in Figure A-2.

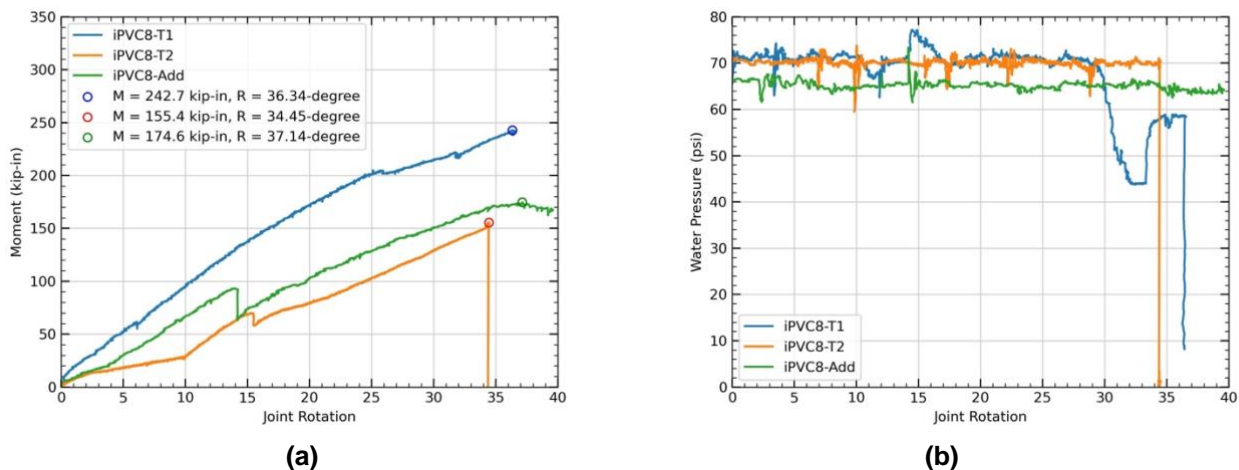
Figure A-3 Moment, rotation, and water pressure of the tests. (a) Joint rotation versus moment (b) Joint rotation versus water pressure

The result of the additional trial test is reported herein. The maximum rotations with corresponding moments of the specimen is 37.14 degrees rotation with 174.6 kip-in moments. As mentioned before, due to the bent actuator, the acquired moment to reach a certain rotation is greater than that of the result from Specimen 2 in Test 2, shown in Figure A-3 (a). Figure A-3 (b) shows the relation between water pressure and the joint rotation of each test. For the additional trial specimen, no obvious pipe failure was found throughout the test until the test reach the limitation of the experiment (about 37-degree rotation). The result of the three tests are reported in Table A-1.

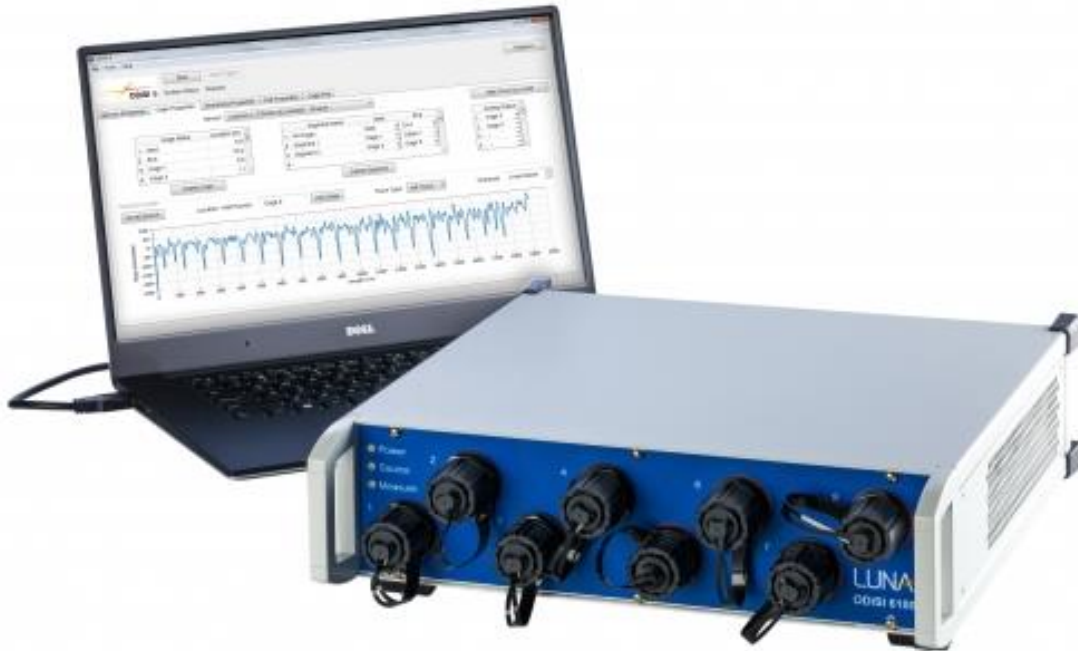
**Figure B-1. LUNA ODiSI 6000 Series optical distributed sensor interrogator (LUNA, 2022)**

LUNA ODiSI 6104 is an optical distributed sensor interrogator that can provide thousands of strain or temperature measurements per meter of a single high-definition fiber sensor. High-Definition H.D.D) Sensors - Strain & Temperature (HD-SC) temperature sensors utilize an advanced interrogation mode of the ODiSI to increase the accuracy of measurements when the sensors are subjected to strain, such as in embedded and surface-mount installations. It can achieve a sensor gauge pitch (the distance between two measurement points) as small as 0.65 mm, a sensor length of up to 50 m, and a measurement rate of up to 250 Hz with an accuracy of less than  $\pm 1$  microstrain.

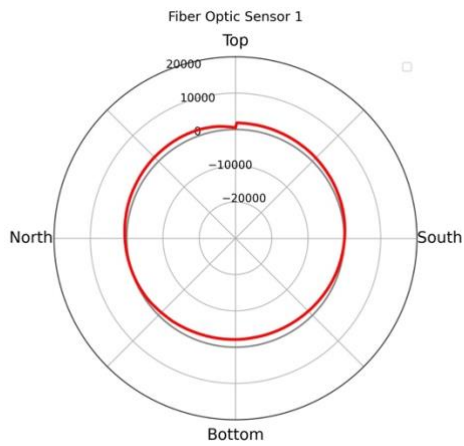
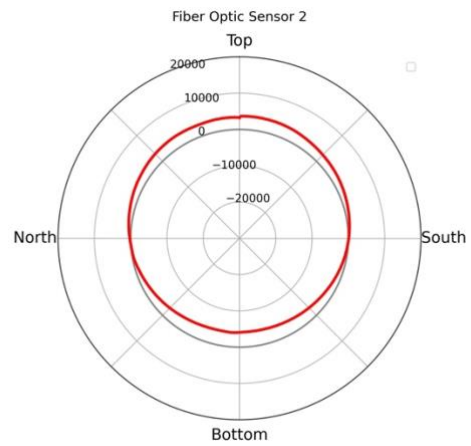
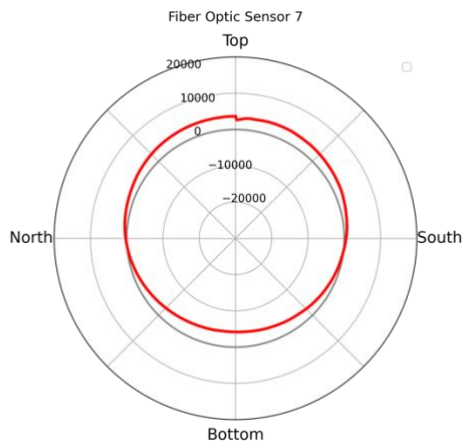
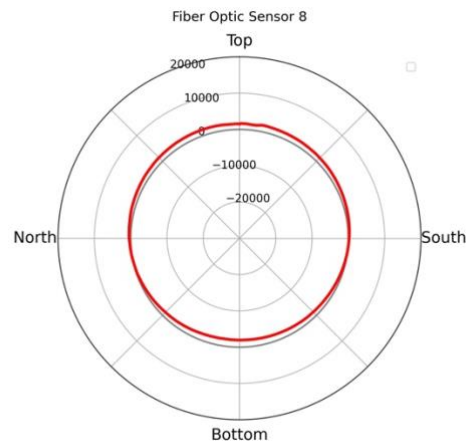
Figure C-1 Strain distribution in the circumferential direction of Specimen 1 under 18-degree rotation condition. (a)(b) sensors on the west pipe (c)(d) sensors on the east pipe

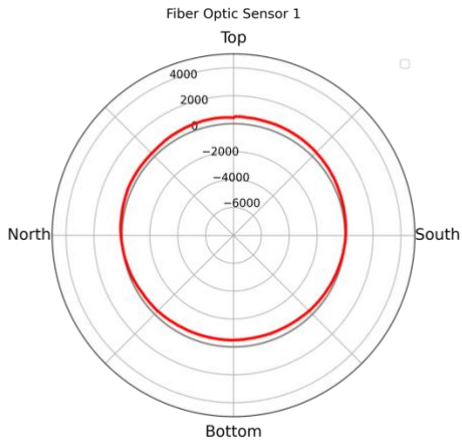
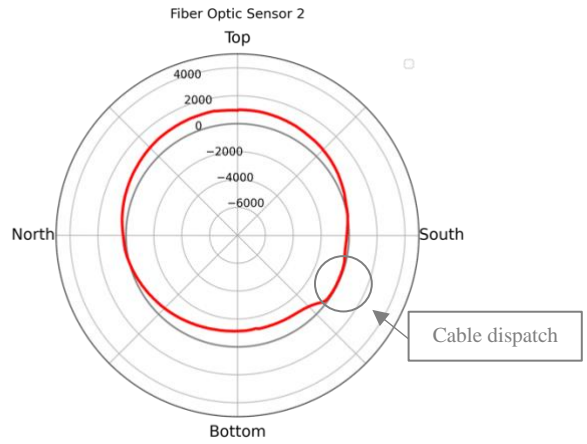
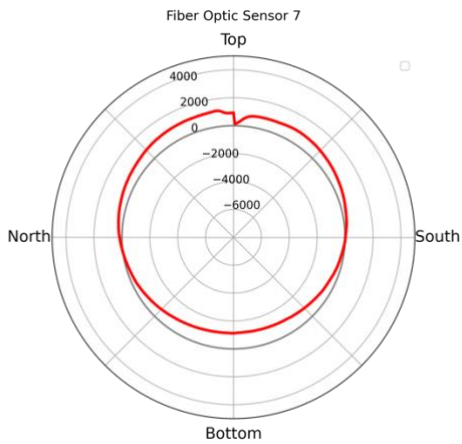
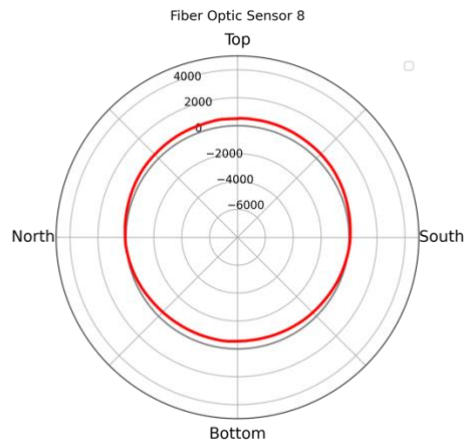
**Figure C-2 Strain distribution in the circumferential direction of Specimen 2 under 18-degree rotation condition. (a)(b) sensors on the west pipe (c)(d) sensors on the east pipe**
