# **Tension Testing of 8-in. (200-mm) Diameter TR-XTREME™ Ductile Iron pipe with HDSS Quiklok**

CSI Report 2024/04  
Center for Smart Infrastructure (CSI)  
Department of Civil and Environmental Engineering  
University of California, Berkeley September 2024

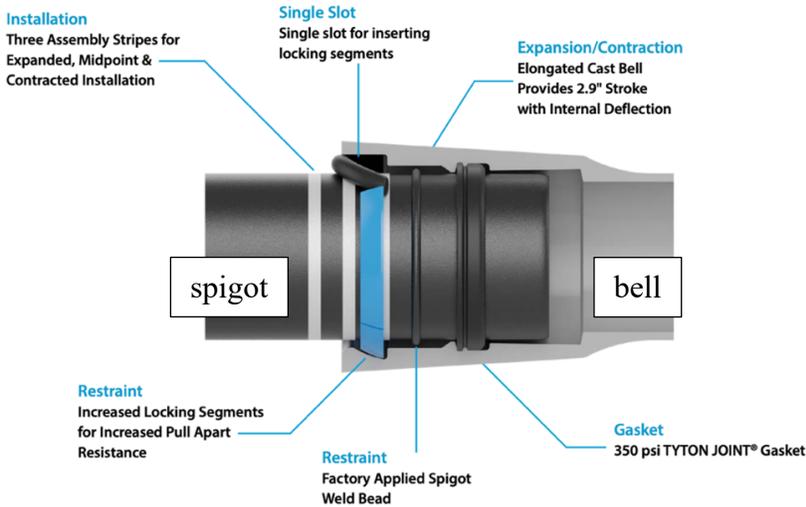
Figure 1-1 Mechanism of TR-XTREME™ joint (U.S. Pipe, 2024)

This report presents the experimental results of a tension test conducted on an 8-inch TR-XTREME™ earthquake-resistant ductile iron pipe specimen, manufactured by U.S. Pipe. The pipe is designed to maintain full water service during seismic events to enhance the seismic resiliency of pipeline systems. It features a single-restrained bell joint, allowing 2.9 inches of horizontal movement and a 5-degree allowable deflection capacity, with a schematic of the bell joint shown in Figure 1-1.

In standard installations, the spigot is inserted into the bell through a water-prevent rubber gasket, typically equipped with a weld bead to bear against the locking segments as a locking mechanism during axial pulling. The bell joint features a single slot for inserting the locking segments that are contained within a cavity in the bell, and three white stripes on the spigot guide the correct installation position, as shown in Figure 1-2. The manufacturer recommends three positions: collapsed, midpoint, and extended. In this test, the spigot started in the fully extended position (Option C), with the snap ring already in contact with the locking segments.

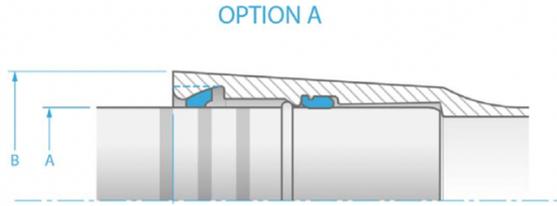
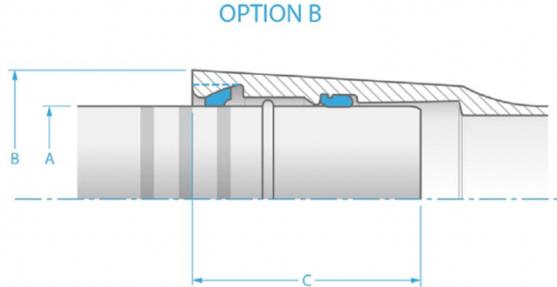
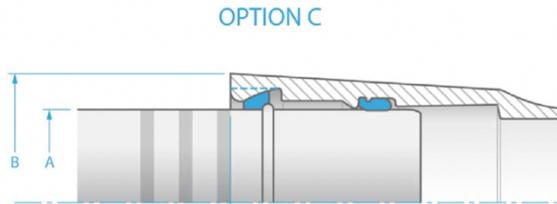
**Figure 1-2 Recommended installation positions (U.S. Pipe, 2024)**

**Option A-Collapsed** – Correct assembly is determined when the front edge of the assembly stripe furthest from the spigot tip lines up with the face of the pipe bell as viewed from above, leaving only one assembly stripe shown.

**Option B-Midpoint** – Correct assembly is determined when the front edge of the middle assembly stripe lines up with the face of the pipe bell as viewed from above, leaving two assembly stripes shown.

**Option C-Extended (Restrained)** - Correct assembly is determined when the front edge of the assembly stripe closest to the spigot tip lines up with the face of the pipe bell as viewed from above, leaving three assembly stripes shown. This is the proper assembly when immediate joint restraint is required.

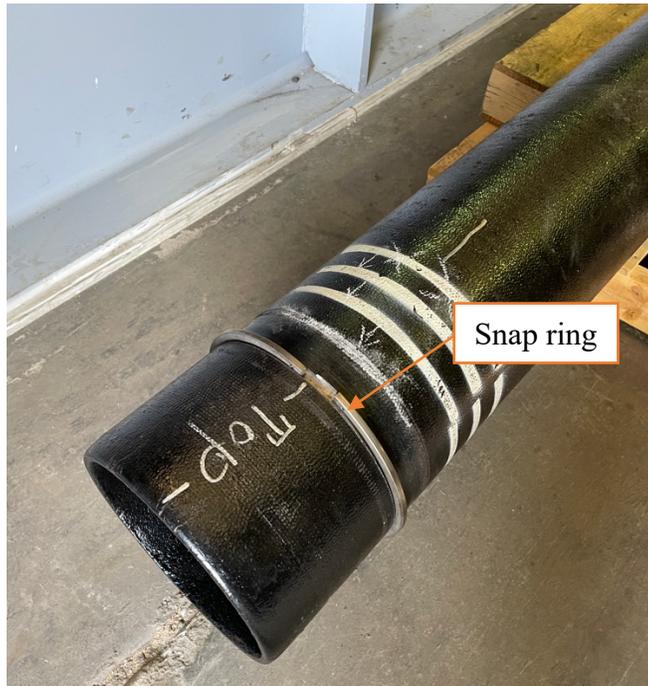
**Figure 1-3 HDSS QuikLok**

However, on-site pipe cutting can remove the factory-installed weld bead. To address this, U.S. Pipe offers the HDSS QuikLok system, which allows installers to cut, groove, and install a snap ring onto the spigot, preserving the strength and deflection capacity of the original joint while providing field flexibility. For this experiment, the HDSS QuikLok was installed in place of the weld bead, as illustrated in Figure 1-3.

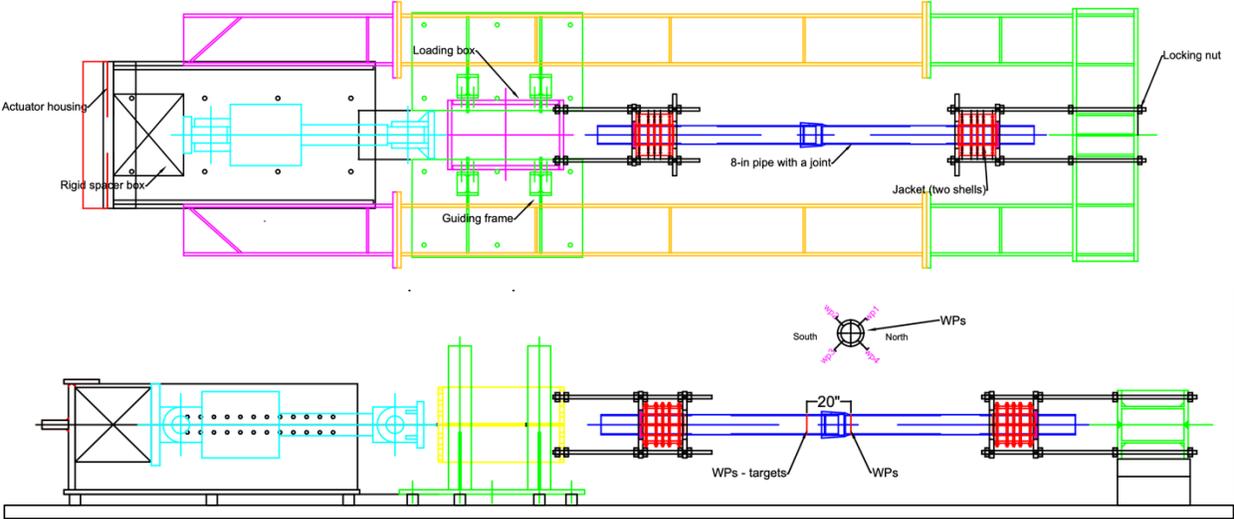
Figure 2-1 Experimental setup design

The experimental setup for this study was developed at the Center for Smart Infrastructure (CSI) at UC Berkeley. The design of the experimental setup is shown in Figure 2-1. A self-reacting frame was designed to accommodate both the loading and reaction sections. The system employed a hydraulic actuator with a compression capacity of 314 kips and a total stroke of 12 inches. To restrain the pipeline, two specially designed jackets were utilized. The hydraulic actuator applied force to the spigot through a loading fixture, which bore against the weld bead at the pipe's end. A similar mechanism was used to secure the bell pipe to the reaction beam. An overview of the experimental setup is shown in Figure 2-2.

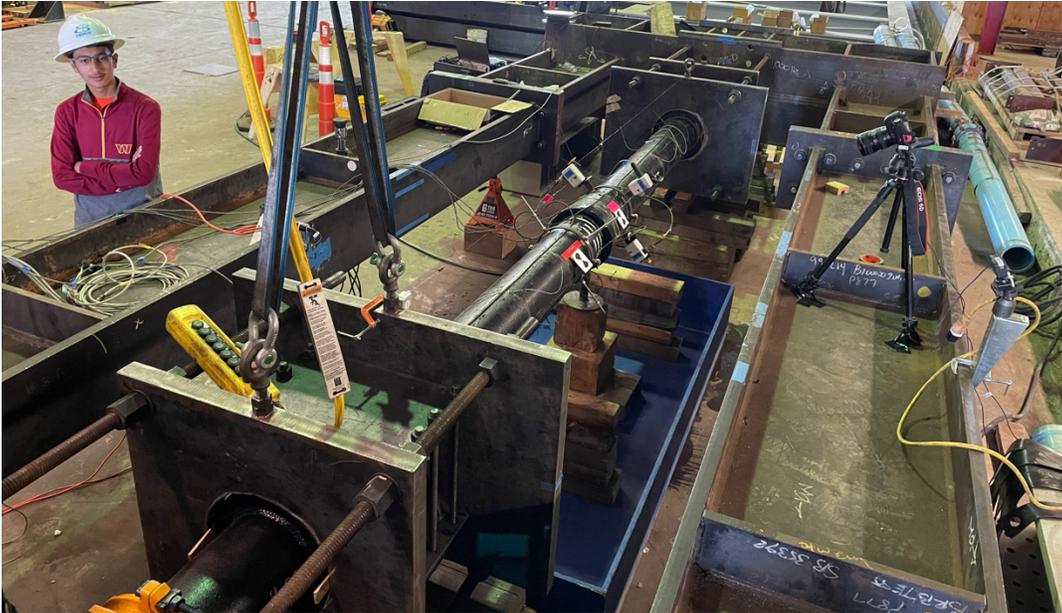
Figure 2-2 Overview of the experimental setup

The 8-inch diameter TR-XTREME™ pipes, made of ductile iron and manufactured by U.S. Pipe, were tested in their extended position, where the locking segments were in contact with the snap ring on the spigot at the initial stage. During the experiment, the pipes were pressurized to approximately 70 psi. The hydraulic actuator then applied axial force to pull the spigot until significant failure occurred, followed by severe water leakage.

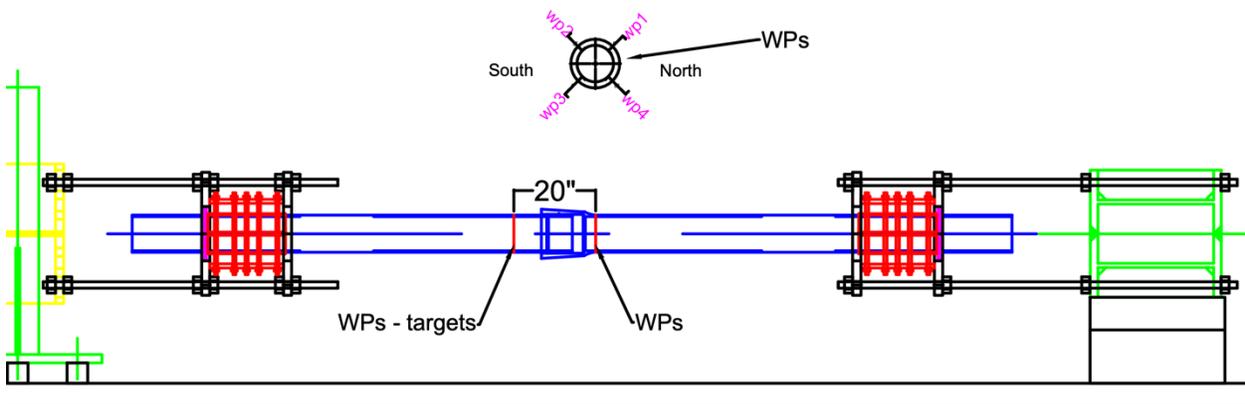
Figure 3-1 Instrumentation plan of position transducers

The locations of the instruments are shown in Figure 3-1, and the local instrumentation names are shown in Table 3-1. Four position transducers (or wired pots herein) were placed on the bell pipe at 45 degrees apart from the quarter points around the circumference and were fixed to the spigot to measure the joint opening. The installation of the wired pots is shown in Figure 3-2.

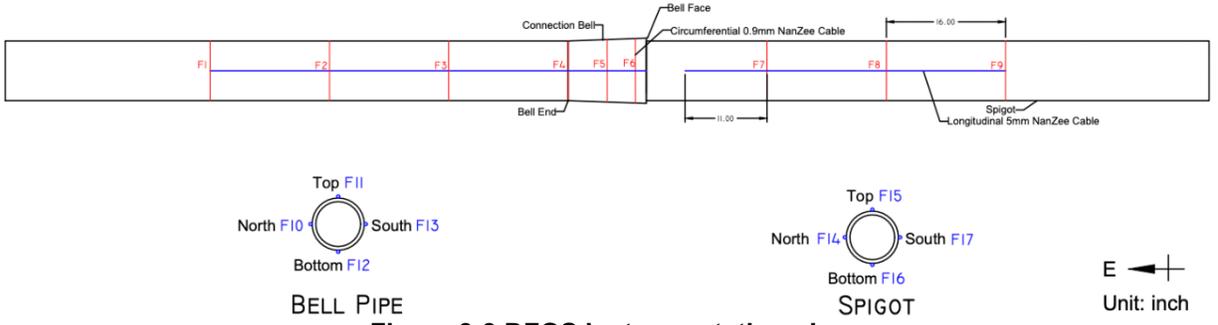
**Figure 3-3 DFOS instrumentation plan**

Two types of fiber optic cables manufactured by NanZee Sensing Technology Co. were used as shown in Table 3-2; (a) 5 mm diameter armored cable (NanZee 5mm) and (b) 0.9 mm diameter cable (NanZee 0.9mm). The local instrument names are listed in Table 3-3, and the layouts of the cables are shown in Figure 3-3. Huntsman Araldite 2021-1 epoxy was used to attach the cables to the pipes.

NanZee 5mm cables (blue lines), which are commonly used in the field due to their robustness, were used in the longitudinal direction to check their performance for actual field application. They were attached on both pipes, 90 degrees apart, numbered F10-F17. To better understand the deformation mechanism of the pipes and bell section, NanZee 0.9mm cables (red lines), which are fragile but cost-effective in laboratory conditions, were used for measuring circumferential strains, numbered F1-F9. Four circumferential sensors with about 16-inch spacing were installed on both pipes. In addition, another three circumferential sensors were

attached to the bell end, the middle of the section, and the location on top of the locking segments (i.e., about 3.5 inches from the bell face).

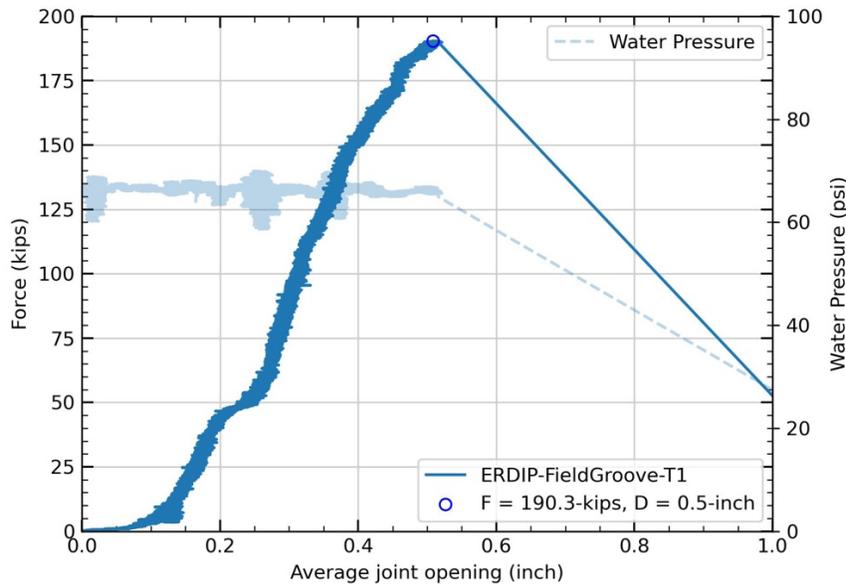
Figure 4-1 Axial force, average joint opening, and water pressure results

In this experiment, the pipes were filled with water and pressurized to 70 psi. A monotonic force was applied along the spigot's longitudinal axis, and four wire pots, positioned 90 degrees apart around the circumference of the bell pipe, were used to measure joint opening. The average joint opening, calculated from the wire pot readings, and the axial force results are shown in Figure 4-1. The maximum axial force reached 190.3 kips, with an average joint opening of 0.5 inches. Water pressure drops were observed at the point of maximum axial force.

The ultimate axial force performance of the present test was similar to those of the specimens with factory-manufactured weld bead that were previously tested at the Center for Smart Infrastructure (Chiu et al., 2023). However, the failure location and water leakage time varied.

Table 4-1 summarizes the performance of the three tension tests conducted. Specimen-WB1 and Specimen-WB2 refer to the previous tests that the specimens were equipped with factory-manufactured weld bead on the spigot. The difference between these two specimens are the end weld bead which are used for transfer the force from the actuator to the specimen. In Specimen-WB1, the end weld bead failed before a significant pipe failure. Therefore, Specimen-WB2 was equipped with double-sided weld (trust collar), which provided a much stronger end weld bead. As a consequence, the bell failed when the applied force reached 174-kips. No water leakage was found at this stage. The pipe was still capable of maintaing water service not until an additional 2.9 inches of axial movement.

In contrast, Specimen-HDSS (tested with HDSS QuikLok) exhibited slightly higher ultimate axial resistance, but water leakage occurred immediately after the peak load failure. This variation in performance is attributed to different failure mechanisms, which will be discussed in the next section.

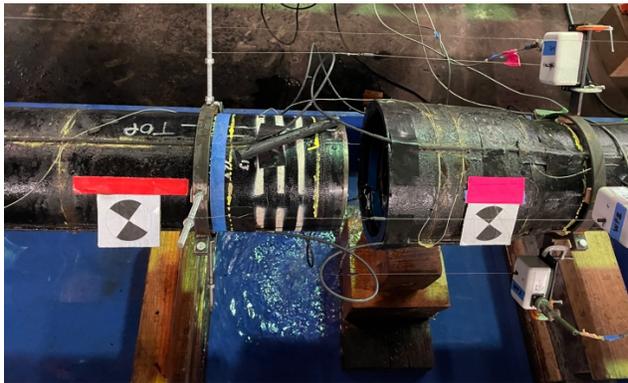
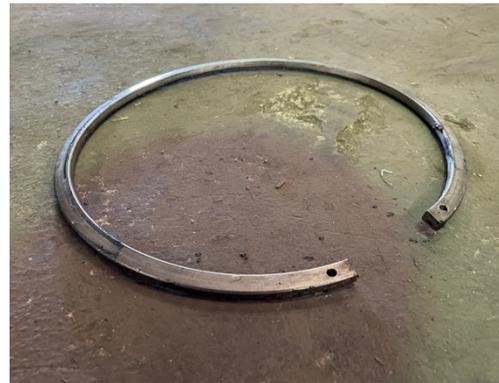
**Figure 4-2 Failure of the Specimen. (a) tensile failure at the circumference of the groove, (b) failed off snap ring**

The test concluded at a force of 190.3 kips when the spigot failed and the pipe experienced severe water leakage at the same time. As shown in Figure 4-2 (a), the spigot experienced a tensile failure at its groove. The thinner wall and the snap ring's pressure against the locking segment likely caused high stress concentration. This resulted in a full circumferential tensile failure around the groove, leaving a portion of the pipe trapped in the bell. The snap ring fell off as the groove failed, as shown in Figure 4-2 (b). Water leaked immediately when the spigot failed. The spigot was pulled out, as shown in Figure 4-3, rendering it incapable of holding water.

are attributed to the distinct failure patterns, particularly the sudden groove failure in the HDSS QuikLok specimen.

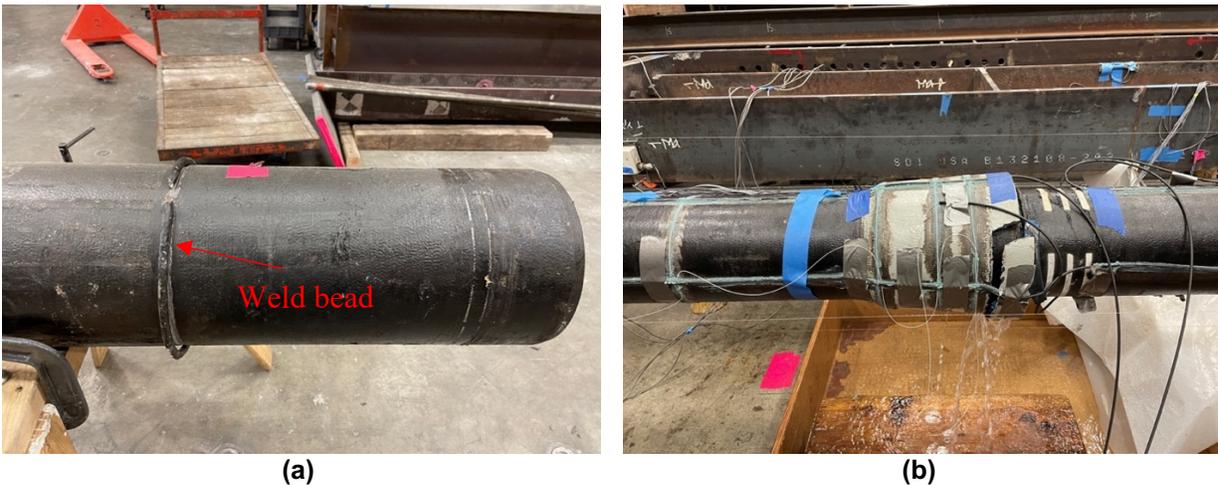
**Figure 4-4 Failure of previous tests that the specimens were equipped with factory-manufactured weld bead on the spigot (Chiu et al., 2023) (a) Weld bead failure on spigot of Specimen-WB1 (b) Bell failure of Specimen-WB2**

In the previous tension tests ([Chiu et al., 2023](#)), water remained contained despite a crack in the bell (see Figure 4-4(b)). Even with a crack on the bell, the rubber gasket inside the bell sealed the water until further axial movement caused leakage. In summary, while the ultimate axial force capacity between the specimen with a weld bead and the one with HDSS QuikLok were similar, the failure mechanisms differed, resulting in different timing for water leakage.

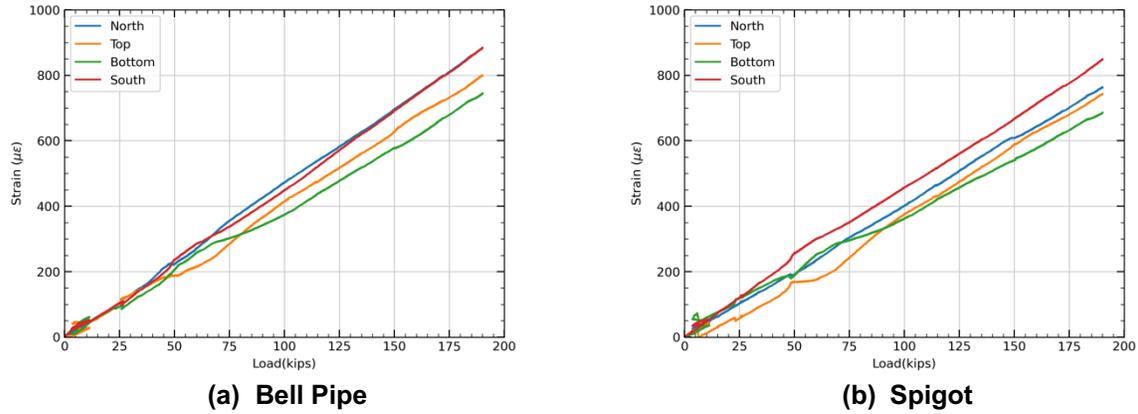
Figure 4-5 Axial strain vs. load

The axial strain data collected from the DFOS sensors are presented in Figure 4-5, illustrating the relationship between axial strain and axial load. Measurements were taken at the midpoints of F2 and F3 (bell pipe) and F7 and F8 (spigot) using longitudinal sensors. As the monotonic force was applied along the longitudinal axis of the pipe, the resulting axial strains were all tensile. The strain magnitudes for both the bell pipe and the spigot are comparable,

suggesting an effective transfer of force through the locking mechanism (i.e., snap ring and locking segments).

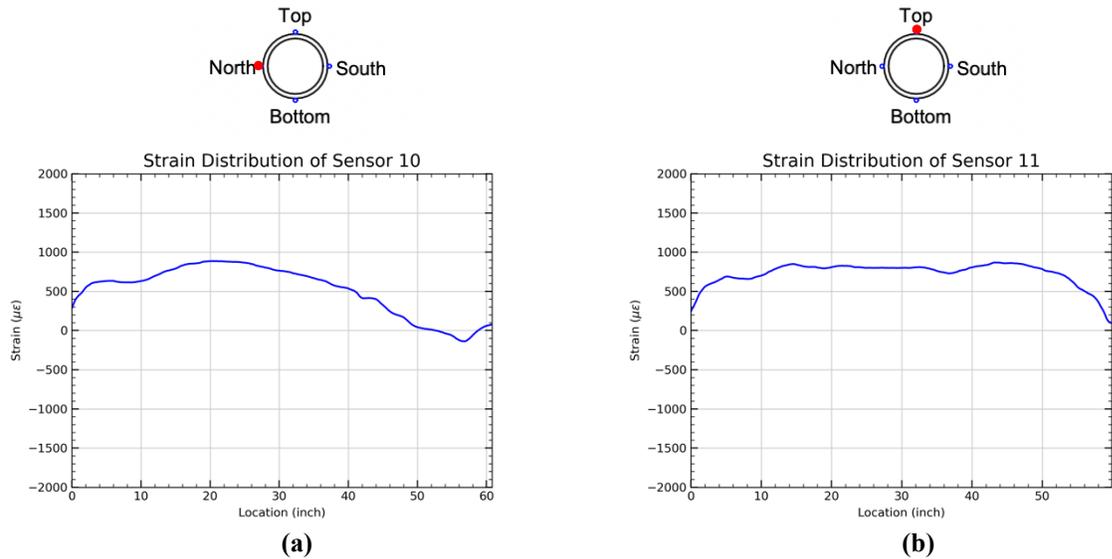
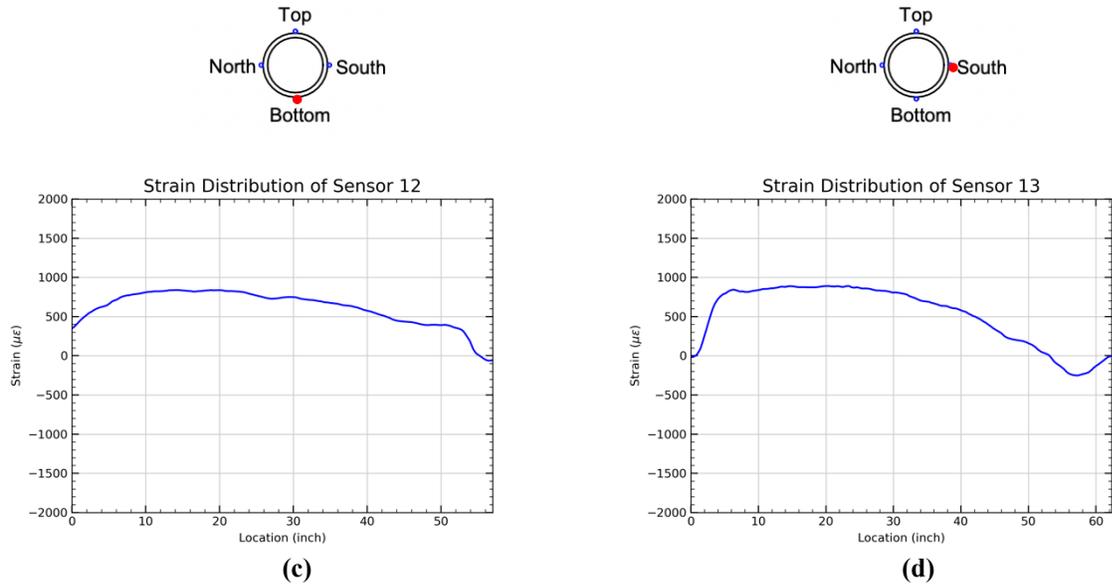
**Figure 4-6 Axial strain development of bell pipe under 180-kips loading condition. (a) North side, (b) Top side, (c) Bottom side, (d) South side**

Figure 4-6 illustrates the axial strain distribution under a 180-kip force as measured on the bell pipe. While the majority of the pipe experienced tensile strains due to the applied tensile force, compressive strains were observed on the north, south, and bottom sides of the bell (around the 50-60 inch mark). This phenomenon likely occurred as the spigot was being pulled out, causing the snap ring to bear against the locking segments. As the locking segments pushed outward, the bell bent locally at the locking segment location. This resulted in compressive stress developing on its outer surface, as depicted in Figure 4-7.

This localized bending behavior was less pronounced on the top side of the bell for two reasons. First, no locking segments were placed on the top side; instead, a rubber retainer was used to position the other locking segments. Since the rubber gasket has lower stiffness and is compressible, it did not cause the bell to bend much at this location. Second, there is a gap on the top side of the snap ring for installation purposes, preventing direct force transfer at that specific location.

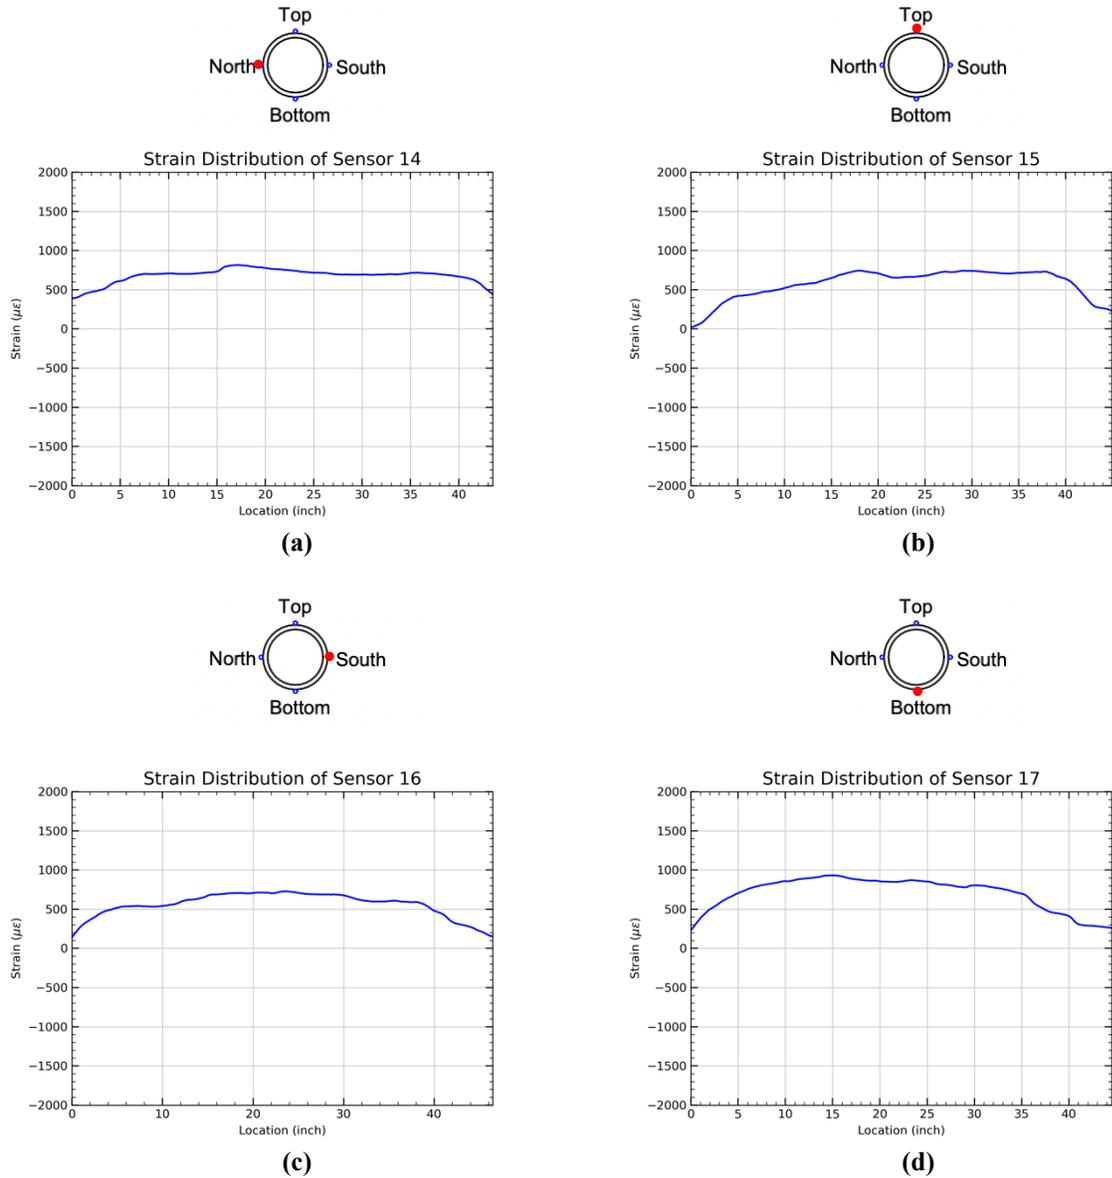
**Figure 4-8 Axial strain development of spigot under 180-kips loading condition. (a) North side, (b) Top side, (c) Bottom side, (d) South side**

Figure 4-8 presents the axial strain results measured on the spigot. As a unidirectional axial force was applied to the pipe, tensile strains were recorded throughout the spigot sections. The strain magnitudes were similar across all four measured locations (i.e., top, bottom, south, and north), which indicates a uniform distribution of strain and confirms effective force transfer through the locking mechanism.

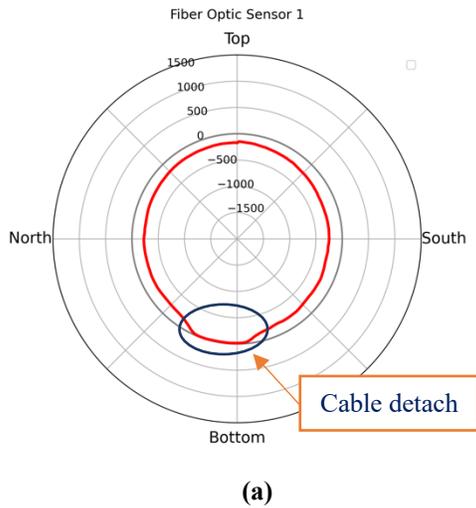
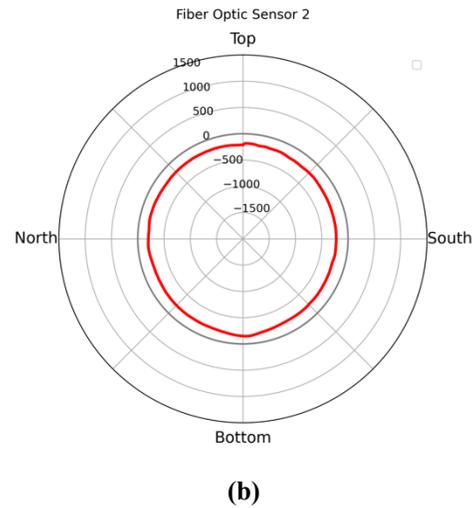
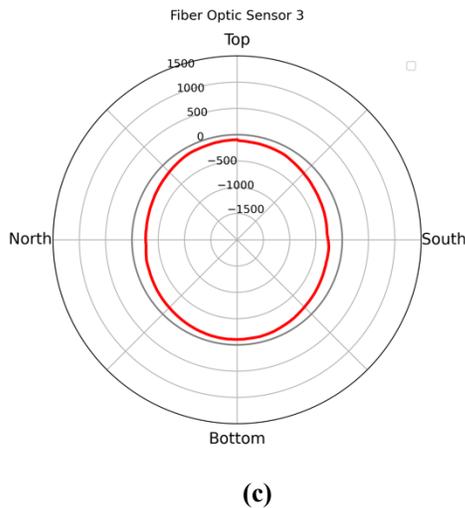
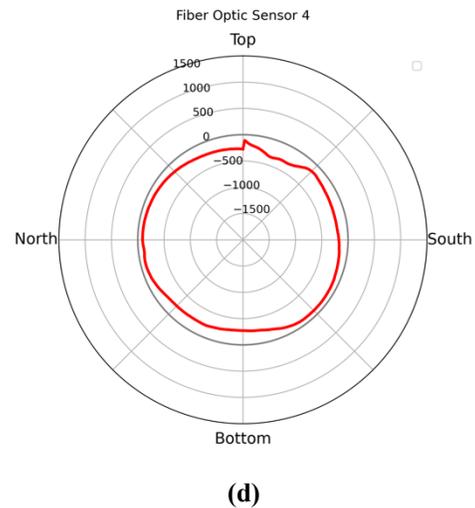
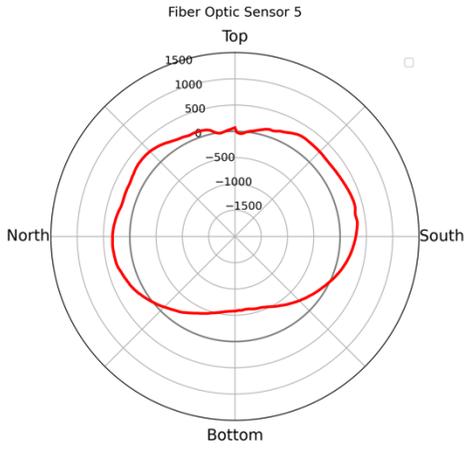
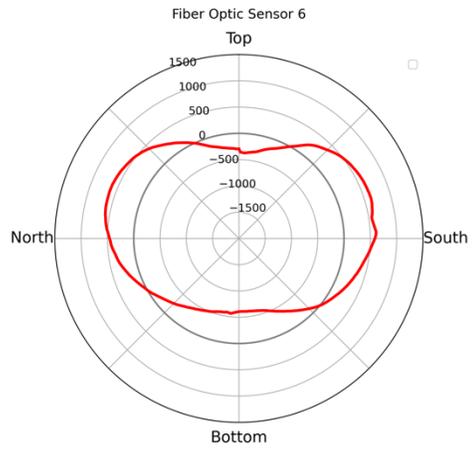
Figure 4-9 Strain distribution in the circumferential direction under 180-kips loading condition.

The hoop strain measurements under the 180-kip axial loading condition are plotted in Figure 4-9. Due to Poisson's effect, the circumferential (hoop) strains generally exhibit an opposite trend to the longitudinal strains, but with a smaller magnitude. Since the pipes were primarily under tensile forces in the longitudinal direction, compressive strains were recorded in the hoop direction by the sensors located along the pipe (i.e., F1-F4, F7-F9).

The hoop strain behavior in the bell section (F5 and F6) is more complex. As the spigot was pulled, the locking segments inside the bell came into contact with the snap ring on the spigot. The top side of the bell was sealed with a softer rubber retainer instead of stiffer locking

segments, causing compressive strains on the top and bottom sides and tensile strains on the north and south springline sides. The bell squatted in the vertical direction as the locking segments pulled out. Sensor F6, which is closest to the locking segments, clearly reflects this behavior, showing distinct patterns of strain. A similar, yet smaller, pattern is visible on Sensor F5, which is located farther from the locking segments in the middle of the bell section. Similar phenomnom was observed in the previous two tests.

Comparing the strain magnitudes on Sensors F5 and F6 between the top and bottom sides, the compressive strain is noticeably larger on the bottom side than the top. This difference is likely due to the gap on the snap ring on the top side and the presence of the rubber gasket, which replaced the locking segment on the top. Consequently, less force was transferred on the top side, leading to reduced strain in that area.

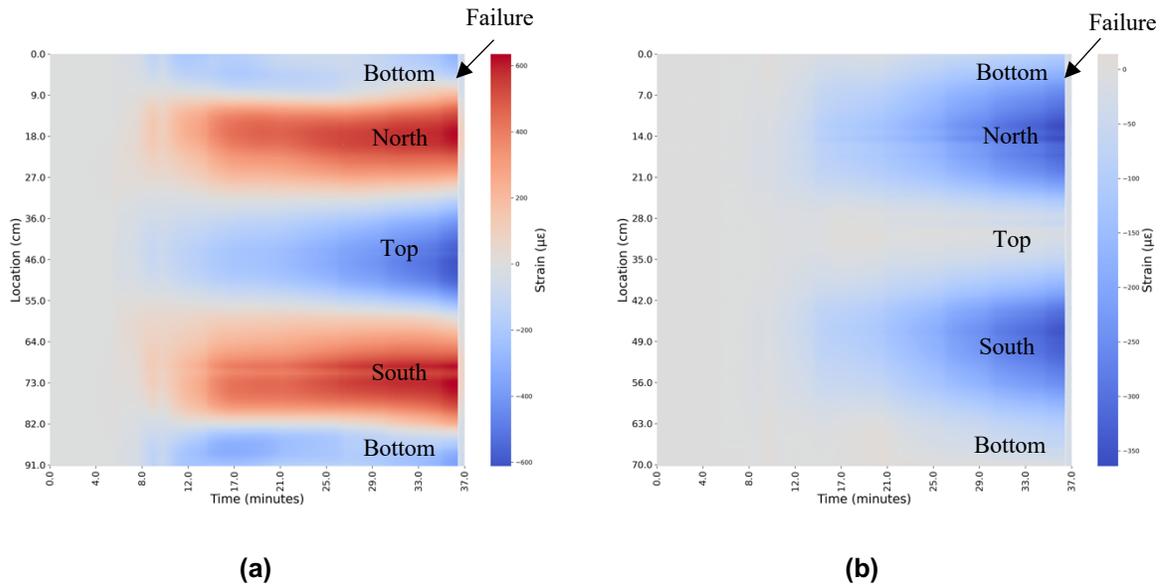
**Figure 4-10 Waterfall plot of sensors on the bell and spigot (a) Sensor 6 (b) Sensor 7**

Figure 4-10 presents a waterfall plot depicting the strain versus time and location for Sensor F6 (positioned on the bell near the locking segments) and Sensor F7 (located on the spigot closest to the bell face). The plots illustrate the strain evolution over time up to the point of failure. F6 shows squatting behavior of the bell section, whereas F7 shows more compressive force transferred at the springline locations rather than the top and bottom sections.

The better force transfer at the spring line may be attributed to the gap at the top of the snap ring and the rubber positioned within the top of the single slot. Since the snap ring is not fully attached to the spigot, relative movement between the two components might occur. Consequently, as the bell contracts at the top and bottom sides and expands at the spring lines, the spigot could shift upward, potentially widening the gap at the top of the snap ring to accommodate this movement. This upward motion might enhance contact between the spigot and the snap ring along the sides, while reducing contact at the bottom. This mechanism likely results in better force transfer at the spring line and reduced transfer along the vertical axis, as illustrated in Figure 4-11(a). Numerical simulation to investigate this issue will be done as future study.

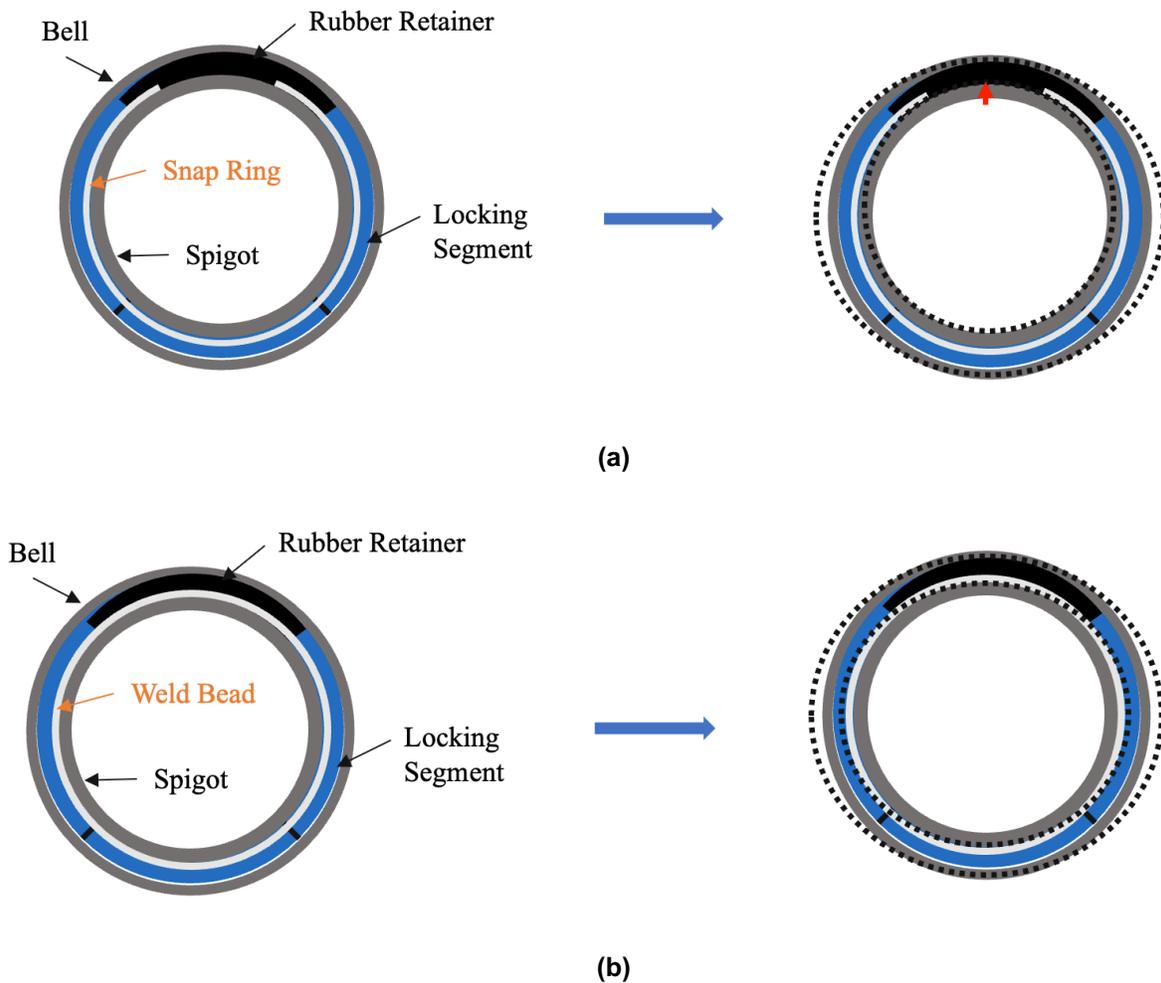
Figure 4-11 Sketch of squatting mechanism (a) Specimen-HDSS (b) Specimen-WB1 & Specimen-WB2

This phenomenon differs from observations in the previous two tests, where the weld beads were firmly attached to the spigots, preventing relative movement. Additionally, no gap was present at the top of the weld bead. These factors ensured more uniform force transfer, causing the spigot's squatting mechanism to be similar to the bell's squatting behavior, as depicted in Figure 4-11(b).

The distributed fiber optic sensing (DFOS) data further clarified the strain development in both the longitudinal and circumferential directions, confirming efficient force transfer through the locking mechanism. The strain patterns also revealed the squatting mechanism especially at the bell location to accommodate the locking segments being pulled out. A distinct force transfer mechanism near the bell was observed compared to previous tests. When a weld bead was used, the force transfer was more uniform. However, with a HDSS QuikLok, the force transfer was more concentrated and effective along the spring line.

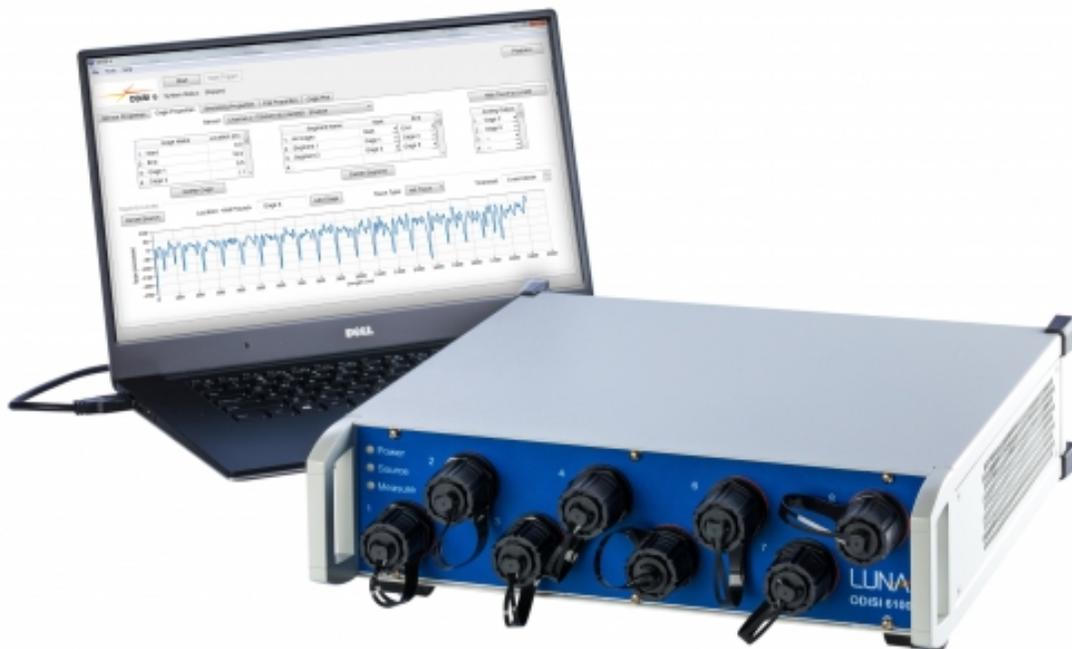
**Figure A-1. LUNA ODiSI 6000 Series optical distributed sensor interrogator (LUNA, 2022)**

LUNA ODiSI 6104 is an optical distributed sensor interrogator that can provide thousands of strain or temperature measurements per meter of a single high-definition fiber sensor. High-Definition H.D.D) Sensors - Strain & Temperature (HD-SC) temperature sensors utilize an advanced interrogation mode of the ODiSI to increase the accuracy of measurements when the sensors are subjected to strain, such as in embedded and surface-mount installations. It can achieve a sensor gauge pitch (the distance between two measurement points) as small as 0.65 mm, a sensor length of up to 50 m, and a measurement rate of up to 250 Hz with an accuracy of less than  $\pm 1$  microstrain.

A Rayleigh-based optical frequency domain reflectometry (OFDR), Luna ODiSI 6100 series (LUNA, 2022), was used in this experiment for data acquisition. The analyzer is capable of measuring up to 100 meters long fiber optic cable with an accuracy of less than  $\pm 1$  micro strain when taking a measurement every 0.65mm. Further details about the cables and analyzer can be found in Appendix A.
