# **Compression Testing and FEA of 8-in. (200-mm) Diameter AWWA C900 DR14 iPVC Pipe**

CSI Report 2026/03  
Center for Smart Infrastructure (CSI)  
Department of Civil and Environmental Engineering  
University of California, Berkeley August 2026

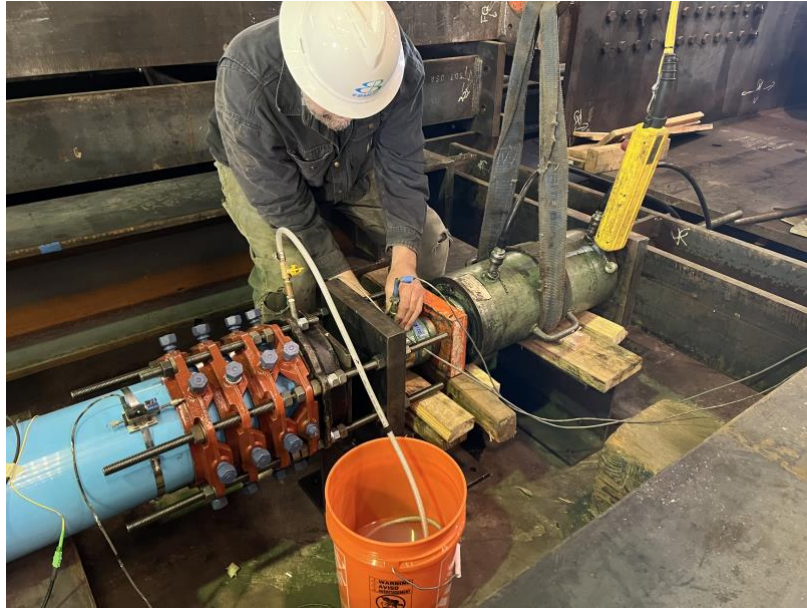
**Figure 2-2 Hydraulic cylinder and load cell on the loading side**

To minimize the global buckling of the test specimen, two restrainer frames were introduced as shown in Figure 2-1. The load was applied by a hydraulic cylinder with an ultimate load capacity of 132-kips. The stroke capacity of the cylinder was greater than 6-in. A hollow hydraulic cylinder was selected for this setup to ensure that the loading rod could be fed through the hole in the W10x112 beam and locked with a nut and a washer plate. The latter locking nut was placed far enough from the W10x112 beam to accommodate displacement toward the joint. As shown in Figure 2-2, a load cell was installed between the hydraulic cylinder and the short beam.

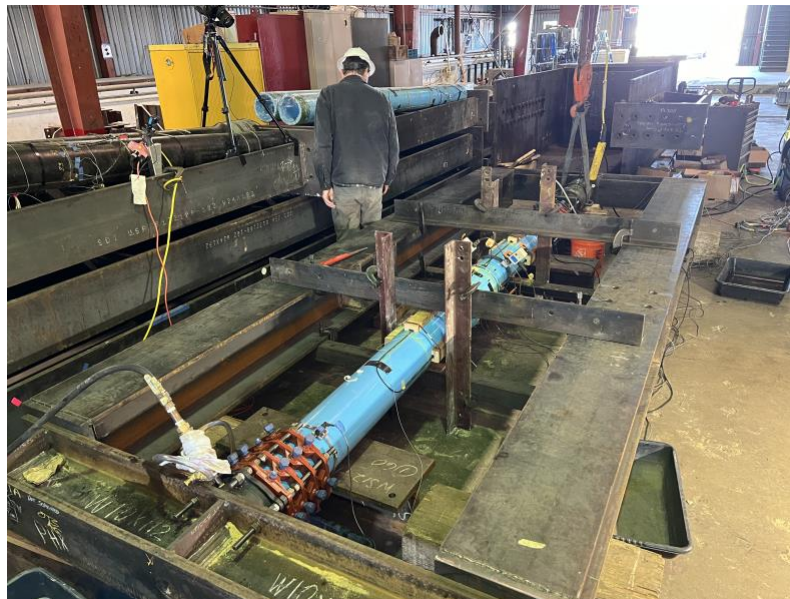
**Figure 2-5 Photo of the completely assembled test setup: view from the reaction side**

Figure 2-5 is a photo of the final setup, showing a view from the loading side. Figure 2-6 is a photo of the experimental setup with the specimen during a test, showing a side view.

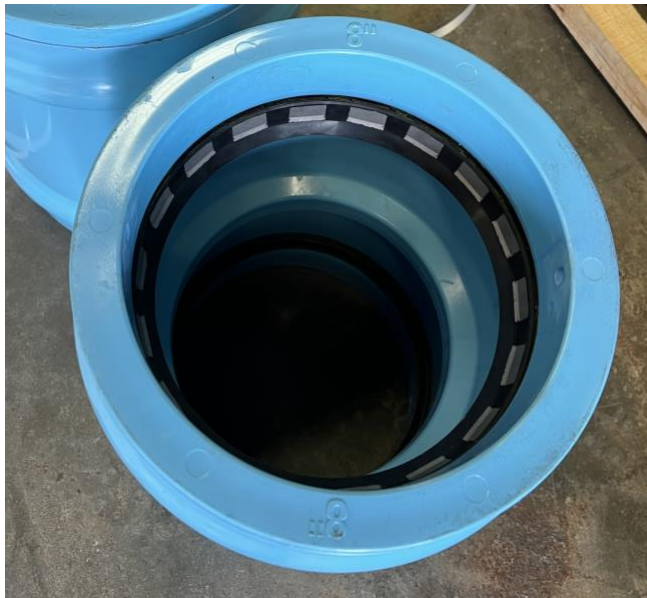
**Figure 2-7 Reiberlok gaskets were installed into the sleeve joint**

**Test specimen.** One test specimen was tested in compression. The test was conducted on 03/18/2024, and both iPVC pipes were fully inserted into the sleeve joint. Reiberlok gaskets (PN 012-MWG-1023) was installed in the sleeve joint prior to the insertion of the iPVC pipes, as shown in Figure 2-7.

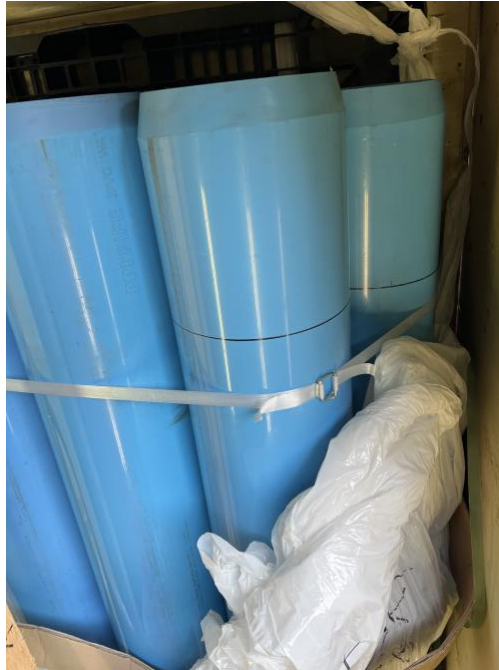
**Figure 2-8 The beveled sides of the supplied iPVC pipes were inserted into the sleeve joint**

As instructed by PPI, only the beveled sides of the iPVC pipe, shown in Figure 2-8, were driven into the sleeve joint.

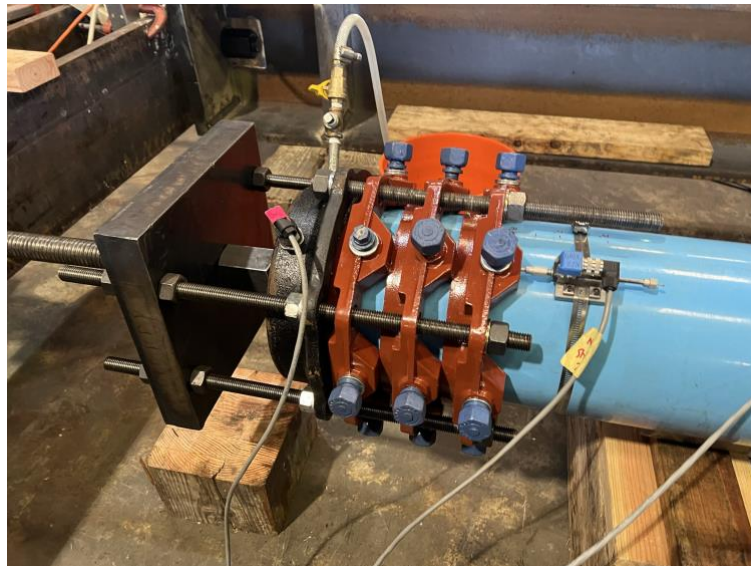
**Figure 3-3 Transducer for monitoring the displacement of MegaLug**

A typical installation of the position transducer monitoring MegaLug's displacement (the pipe on the loading side is shown) is shown in Figure 3-3.

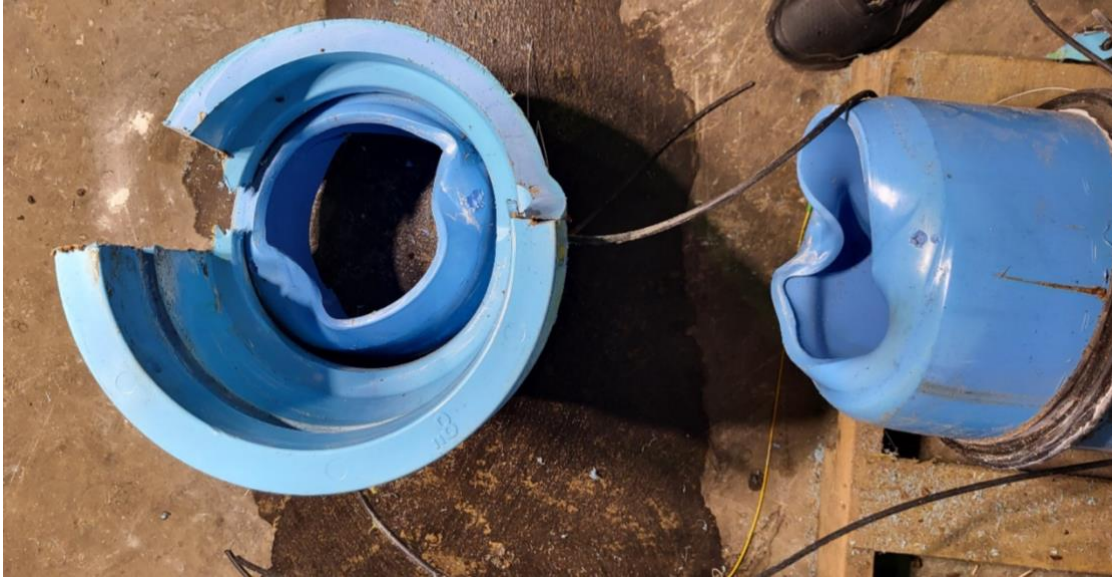
**Figure 5-7 Severe material damage and local buckling at the beveled sides of both iPVC pipeline segments telescoping inside the coupling, following the compression test.**

The numerical results show the telescoping failure mechanism associated with severe damage and local buckling of the beveled sections of the pipe segments inside the coupling, which is consistent with the experimental observations, as shown in Figure 5-7.

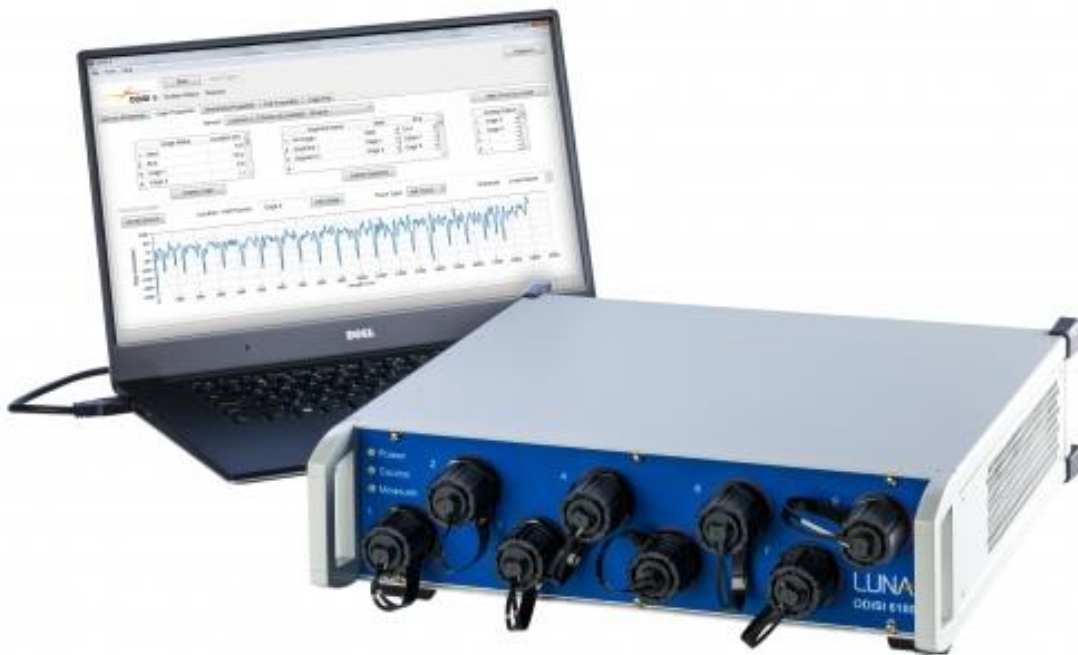
**Figure A-1. LUNA ODiSI 6000 Series optical distributed sensor interrogator (LUNA, 2022)**

LUNA ODiSI 6104 is an optical distributed sensor interrogator that can provide thousands of strain or temperature measurements per meter of a single high-definition fiber sensor. High-Definition H.D.D) Sensors - Strain & Temperature (HD-SC) temperature sensors utilize an advanced interrogation mode of the ODiSI to increase the accuracy of measurements when the sensors are subjected to strain, such as in embedded and surface-mount installations. It can achieve a sensor gauge pitch (the distance between two measurement points) as small as 0.65 mm, a sensor length of up to 100 m, and a measurement rate of up to 250 Hz with an accuracy of less than  $\pm 1$  microstrain.
