Four-Point Bending Testing of 24-in. (600-mm) Diameter NS-type Ductile Iron Pipe

CSI Report 2023/05
Center for Smart Infrastructure (CSI)
Department of Civil and Environmental Engineering
University of California, Berkeley July 2023

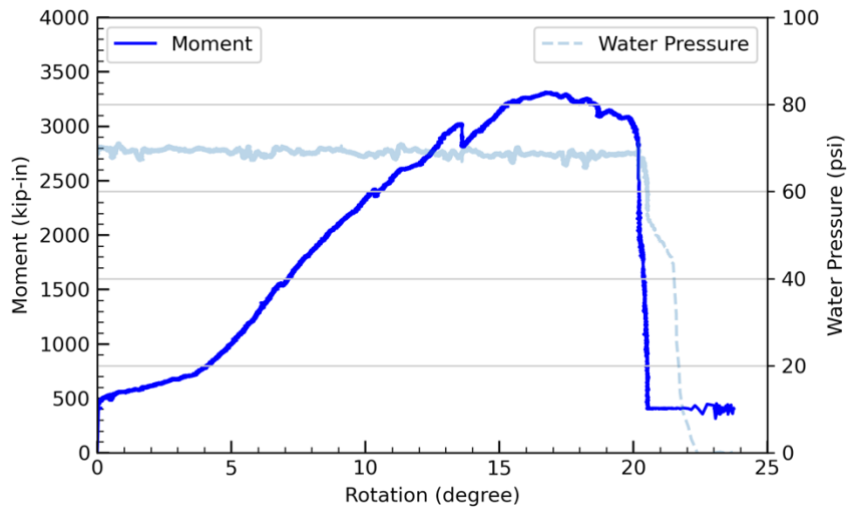
Figure 4-1 Moment, rotation, and water pressure

the center point of the load transfer beam. This force was then transferred to the pipes through the two loading saddles. Using the formulas specified in the previous section, the moments and rotations of the specimen were calculated. The results are visualized in Figure 4-1. The maximum rotation is about 20 degrees. This rotation is approximately three times larger than the manufacturer's specified deflection capacity, which is mentioned to be 7 degrees. The maximum moment is about 3,313 kip-in. In addition, no water leakage was detected in the specimens until the pipe joint reached a rotation of approximately 20 degrees.

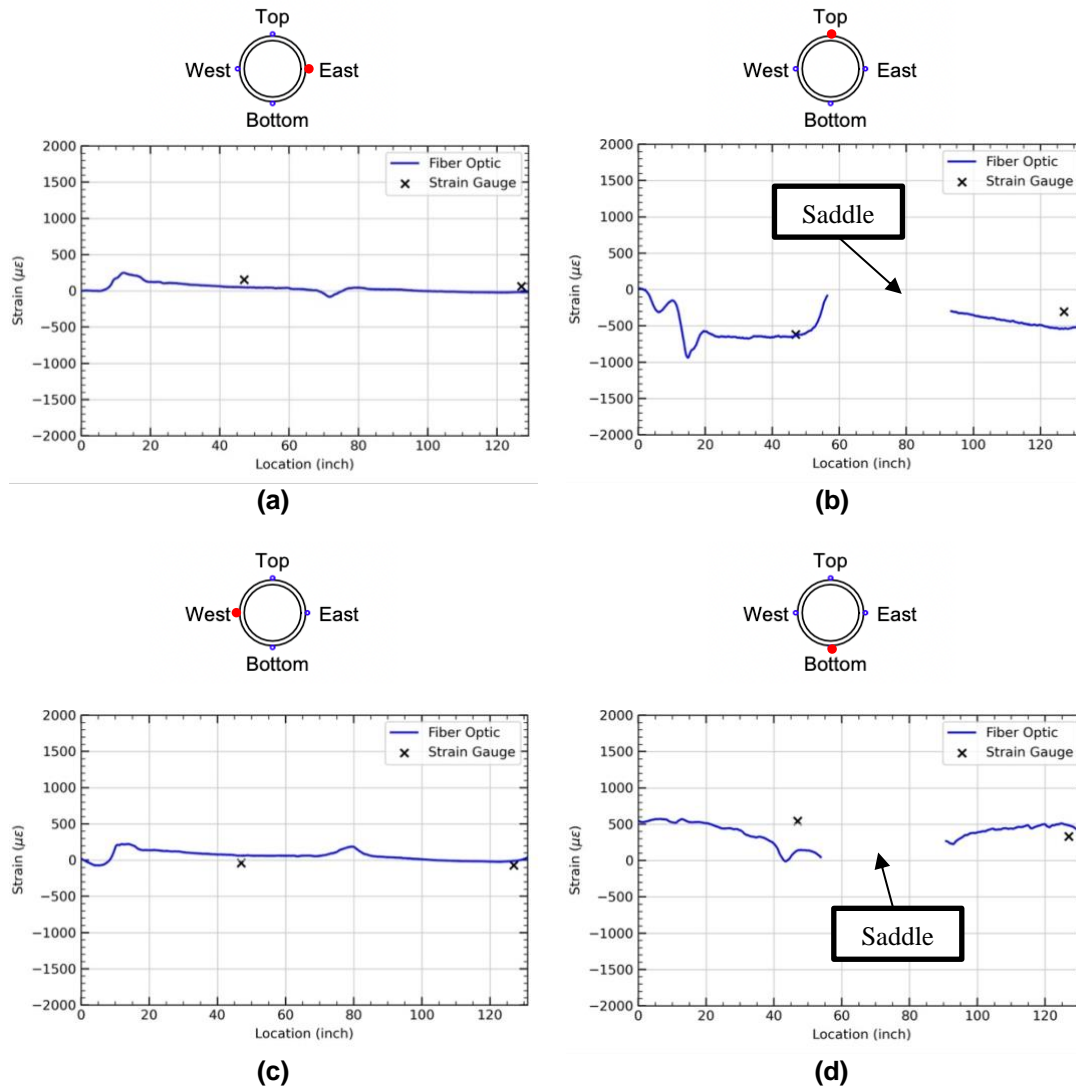
Figure 4-7 Axial strain development of bell pipe under 19-degree rotation condition. (a) East side, (b) Top side, (c) West side, (d) Bottom side

Figure 4-7 shows the axial strain results of the bell pipe. Compressive strains were observed on both the west and east sides (3 o'clock and 9 o'clock positions) of the bell section (i.e., about 0 to 10 inches location), as depicted in Figure 4-7 (a) and (c). This compressive strain pattern can be attributed to the expansion of the bell caused by the locking ring. As the bell expands, a moment is introduced on its surface, leading to compressive strains on the bell's outer surface. On the top side, as shown in Figure 4-7 (b), relatively small compressive strains were observed on the bell section. This might be because the split of the locking ring was located on the top side. While the pipe is being pushed downward, the locking ring might deformed or moved upward in order to tolerate the movement, which might result in tensile stress at the bell section.

Following the bell section (i.e, about 10 to 20 inches location), large tensile strains can be observed on the west and east side of the bell pipe, as shown in Figure 4-7 (a) and (c), and large compressive strains on the top side of the bell pipe, as shown in Figure 4-7 (b). These locations correspond to the transition location from the bell to the pipeline. This phenomenon can be attributed to the geometry and wall thickness changes at this transition region. The altered geometry and wall thickness can lead to localized stress concentrations, resulting in the observed

Examining Figure 4-7 (a) and (c) in the axial strain results, noticeable strain fluctuations were observed at the loading saddle locations, which are situated at approximately 70-80 inches locations. These fluctuations were raised due to the concentrated forces acting within these regions during the bending tests. As a result, the pipe experiences larger deformation in these specific areas, leading to larger strains.

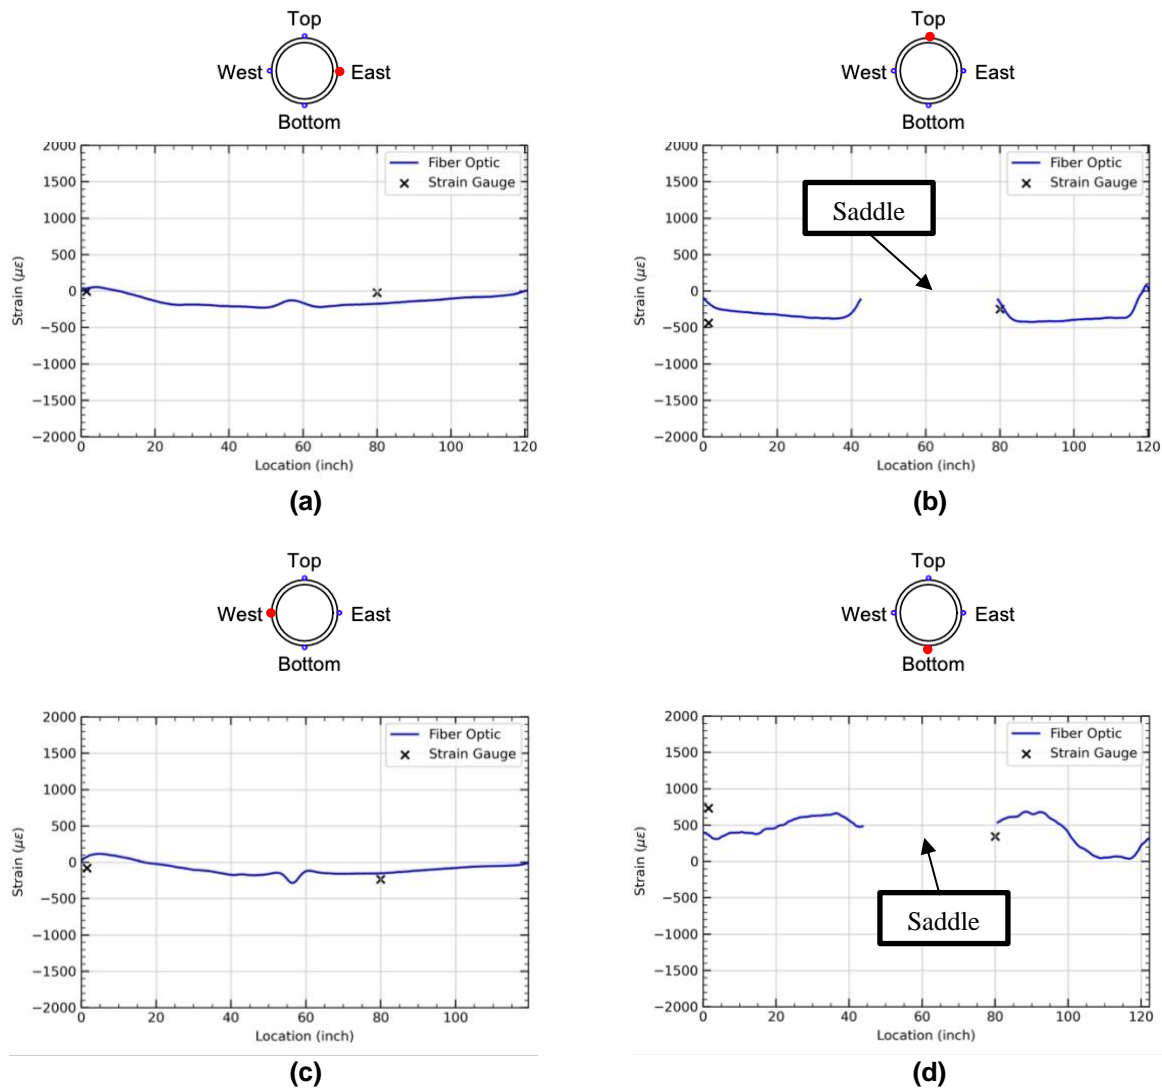
Figure 4-8 Axial strain development of spigot under 19-degree rotation condition. (a) East side, (b) Top side, (c) West side, (d) Bottom side

Figure 4-8 presents the axial strain results of the spigot under conditions where the rotation reaches approximately 19 degrees, which is close to the failure stage. The observed strain patterns align with the bending theorem, with compressive strains on the top side (12 o'clock) and tensile strains on the bottom side (6 o'clock) of the spigot. Additionally, minimal strains are recorded on the west and east sides (3 o'clock and 9 o'clock), as expected.

However, it is noteworthy that relatively smaller tensile strains were observed at the bottom side of the spigot near the bell, specifically in the 100-120 inches location shown in Figure 4-8 (d). This phenomenon might be attributed to the yielding or cracking at the bottom side of the spigot prior to failure (when the specimen reached approximately 20 degrees of rotation). The existence of these potential yielding/ cracking areas affected the proper transfer of stress at these particular locations, resulting in smaller tensile strains being measured.

Furthermore, a significant deformation was observed on the spigot near the bell. This deformation and the Poisson's ratio effect may contribute to the small tensile strains measured in this region. The axial deformation and associated stress concentration near the bell might lead to a reduction in tensile strains. The presence of yielding/ cracking areas and the Poisson's effect are potential factors influencing the observed strain behavior in the spigot near the bell. These issue will be carefully discussed in the finite element analysis planned in the future.

Lastly, a fluctuation of the strains near the loading saddle, approximately 50-60 inches locations, was observed on the west and east sides of the spigot, as shown in Figure 4-8 (a) and (c). These strain fluctuations can be attributed to the concentrated forces applied at these locations. The concentrated force application created a localized stress concentration, resulting in large deformation of the pipe in that region. As a consequence, larger strain values were recorded.

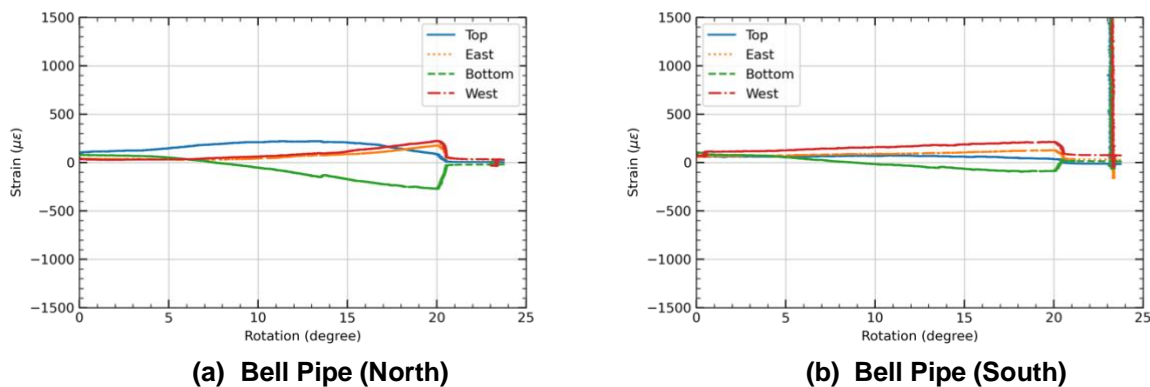
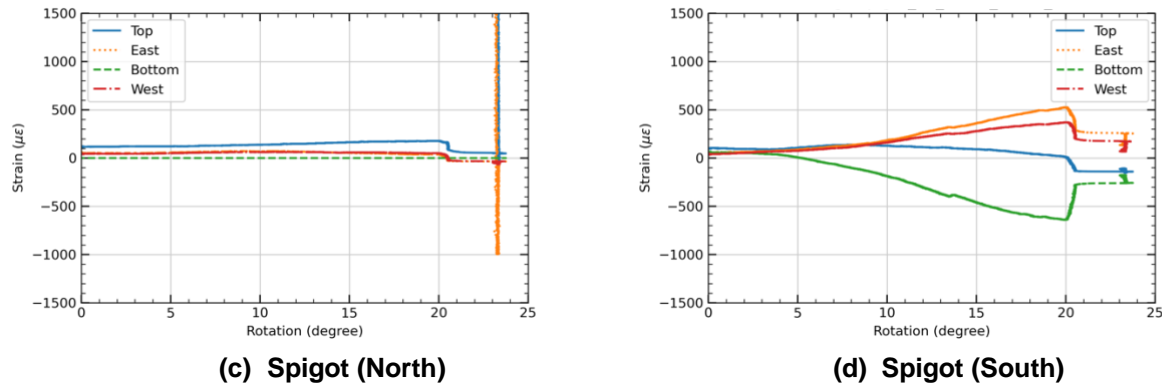
Figure 4-9 Hoop strain vs joint rotation

Figure 4-9 displays the relationships between the hoop strains, measured by strain gauges, and the rotation of the pipe specimen. Initially, when the specimen rotation is small (less than 3 degrees), the strains in the circumferential direction are primarily opposite in direction to those in the longitudinal direction, but with a smaller magnitude. This behavior can be attributed to the Poisson's effect, which refers to the lateral expansion or contraction of a material due to axial deformation.

However, as the rotation increases beyond this small range, the strain results exhibit a different pattern. The bell pipe and the spigot demonstrate expansion at the east and west sides, while experiencing shrinkage at the top and bottom sides. This distinctive strain pattern indicates that the pipe undergoes a squatting deformation. A clear mechanism of the pipe deformation is provided in the following section using the DFOS data.

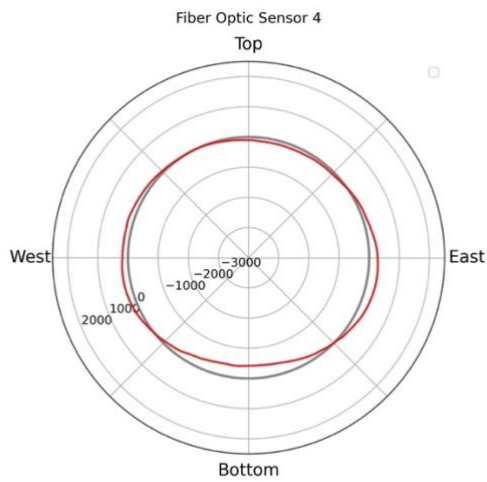
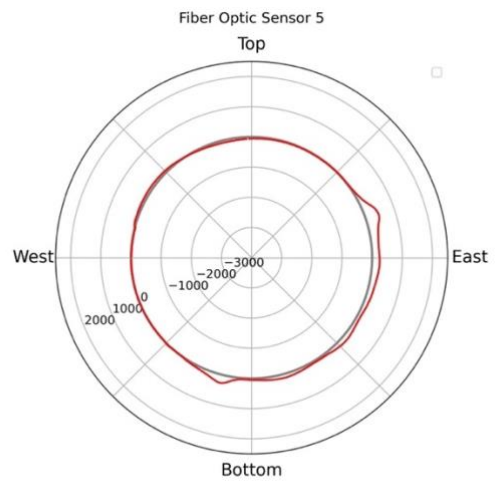
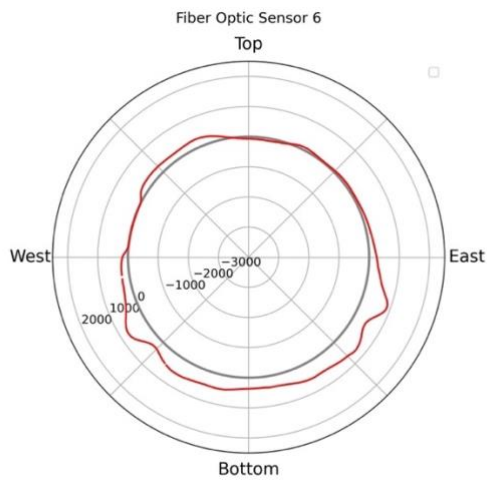
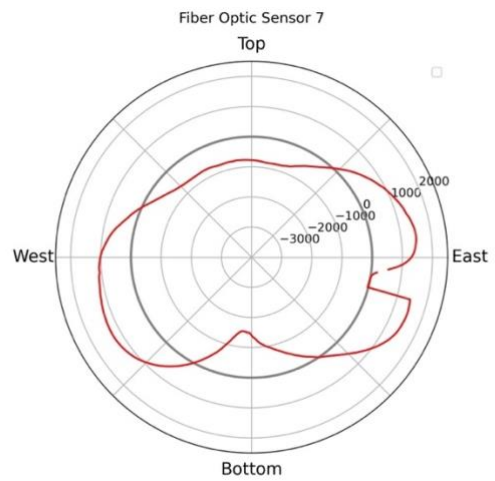
Figure 4-10 Strain distribution in the circumferential direction under 19-degree rotation condition. (a) sensor on the bell end (b) sensor on the center of the bell (c) sensor on the centerline of the specimen (d) sensor on the spigot

The results from sensor F4 indicate that the top and bottom sides (12 o'clock and 6 o'clock) of the bell were experiencing compression, while the west and east sides (3 o'clock and 9 o'clock) were expanding. These strain distributions suggest that the bell pipes undergo eccentric squatting during bending. Similar strain patterns can be observed on the other circumferential sensors located on the bell pipes (i.e., F1-F3).

For sensors F5 and F6, the results indicate that the bottom side of the bell was expanding. This expansion is attributed to the contact between the bottom of the spigot and the invert of the bell during bending. This contact causes the bottom side of the bell to expand.

Sensor F7, placed on the spigot, exhibits a strain distribution where the top and bottom sides (12 o'clock and 6 o'clock) are shrinking, while the east and west sides (3 o'clock and 9 o'clock) are expanding. This behavior is attributed to the bottom side of the spigot bearing against the invert of the bell, leading to compression on the bottom side. Furthermore, as the spigot is bent, the top side contacts the crown of the bell, resulting in a concentrated compressive strain on the top of the spigot. Similar strain patterns can be observed from other sensors placed on the spigot (i.e., F8-F10), with the magnitude of the strain decreasing as the distance from the sensor to the bell increases.
