# **Tension Testing of 8-in. (200-mm) Diameter AWWA C900 DR14 iPVC Pipe**

CSI Report 2026/02  
Center for Smart Infrastructure (CSI)  
Department of Civil and Environmental Engineering  
University of California, Berkeley August 2026

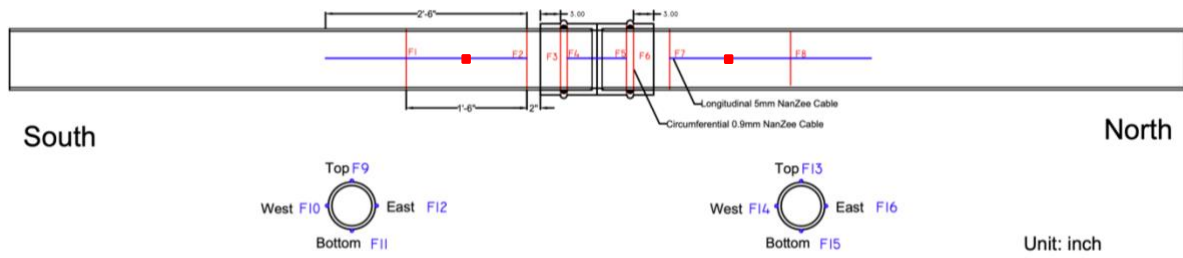
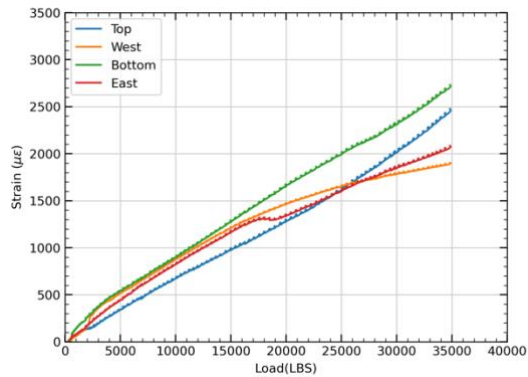
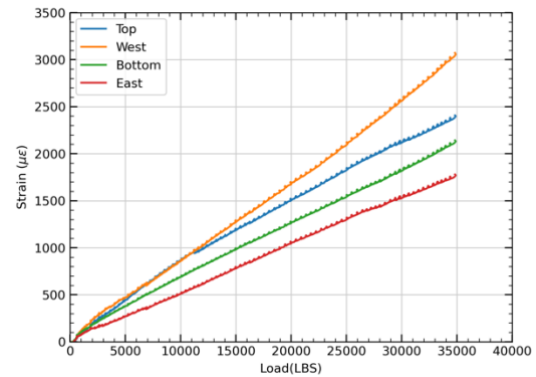
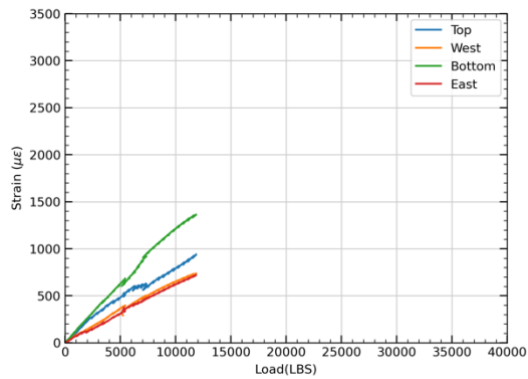
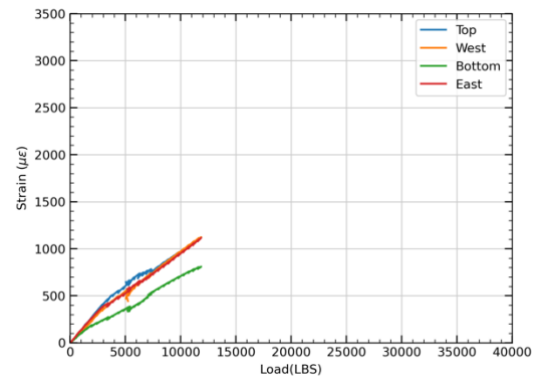
Figure 4-3 Axial strain vs load. (Left) South pipe. (Right) North Pipe.

The axial strain results of Specimens 1 and 2 from the distributed fiber optic strain (DFOS) sensors are shown in Figure 4-3 to Figure 4-6. Figure 4-3 shows the relationship between the axial strain and axial loads at the midpoints of F1 and F2 (south pipe), and the midpoints of F7 and F8 (north pipe), measured by the longitudinal sensors. The results from both specimens show that all the pipes were experiencing tensile stresses. However, difference on magnitude of the strains at different locations are observed on both specimens.

The strain data on the north pipe of Specimen 1 show that there are significant differences in strain development compared to the south pipe. When comparing the strains on the top and bottom, it is observed that the pipe was slightly bent towards the downside. Similarly, when comparing the strains on the west and east sides, it is noticed that the pipe was bending towards the east side. One possible explanation for this phenomenon could be attributed to the initial relative movement between the locking gaskets and the pipes. Due to this initial adjustment, there is a possibility that the locking gasket was not engaged with the pipe on a perfect vertical plane, causing some bending force when axial force was applied.

The fitting broke at the north pipe connection, potentially because of the larger spatial variation in strains on the north side connection compared to the south side connection.

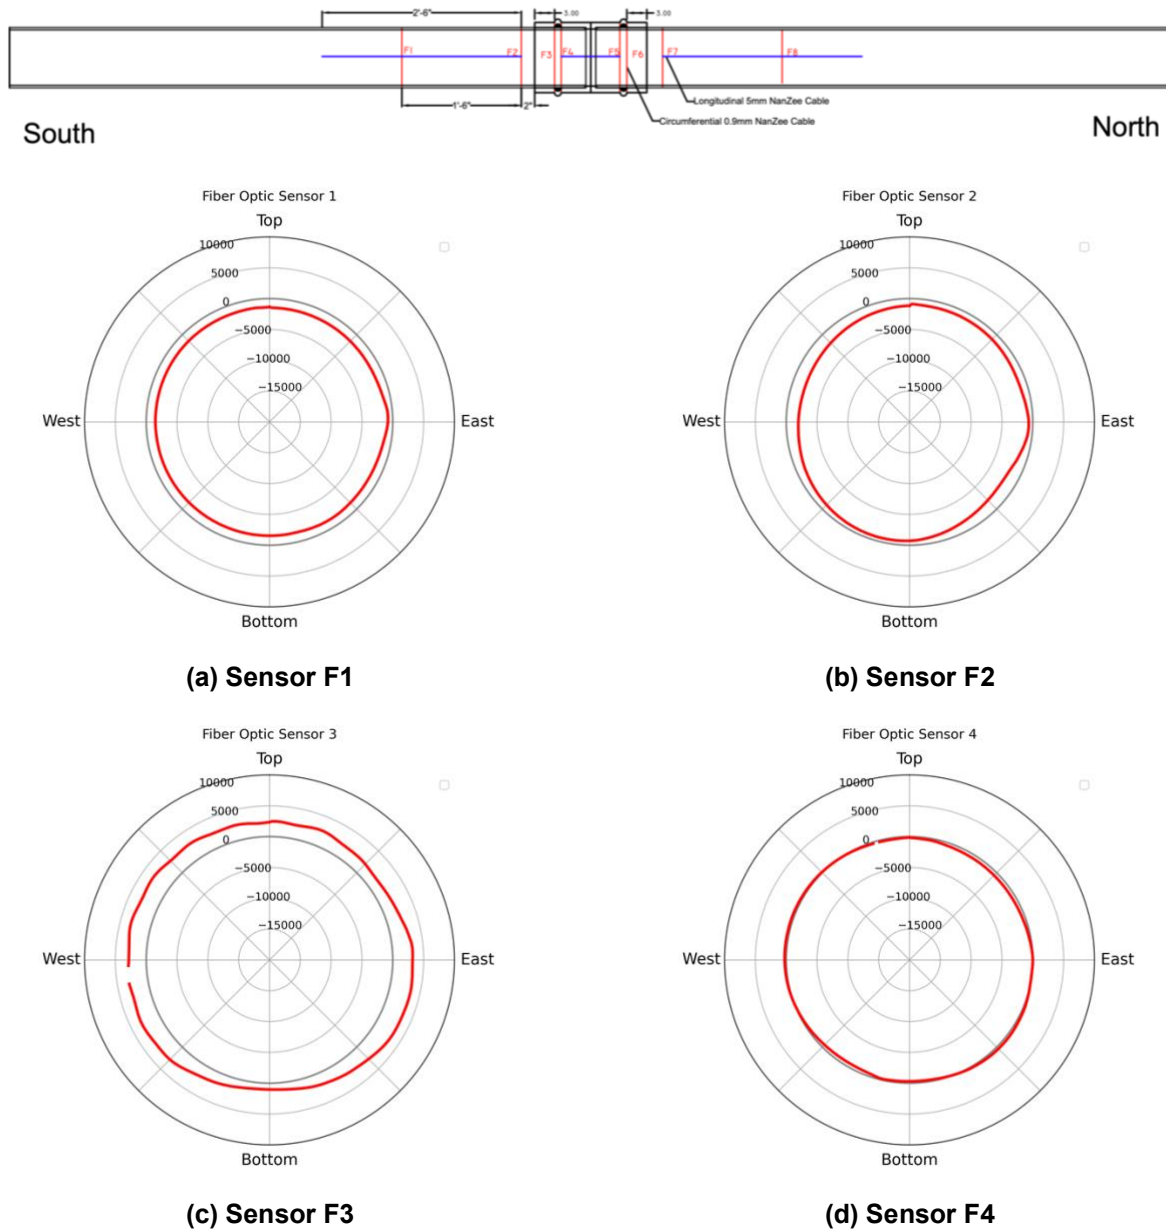
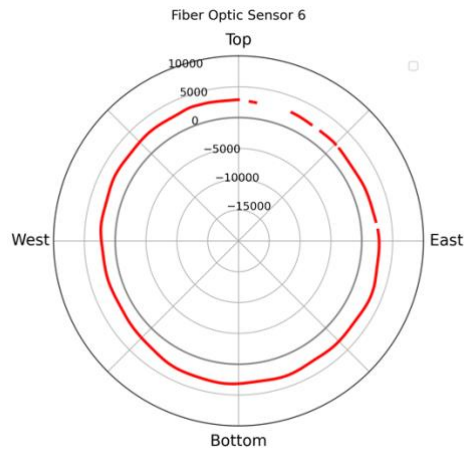
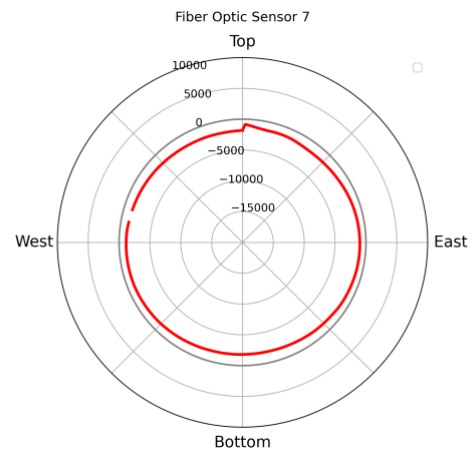
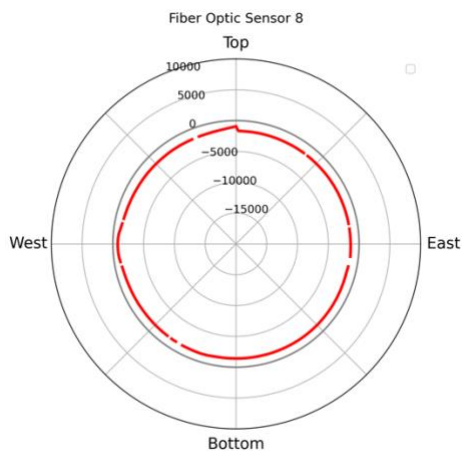
**Figure 4-7 Strain distribution in the circumferential direction of Specimen 1 under 32,000-LBS loading condition.**

The hoop strain results measured from Specimen 1 are plotted in Figure 4-7. The figure illustrates the results obtained by the sensors positioned on the fitting (F3 and F4) and the sensors nearest to the fitting on both pipes (F2 and F7).

interaction, as shown in Figure 4-8. This phenomenon is clearly observable in the results measured by Sensor F3, where the fitting exhibited tension all around its circumference. A similar pattern is evident in the results from Sensor F6.

Compressive strains are observed on the inner side of the fitting from the gasket location, as indicated by Sensor F4 measurements. As demonstrated in earlier sections, the longitudinal strains in this section are smaller, leading to reduced hoop strains due to Poisson's effect. Although similar behavior would be expected at the location of Sensor F5, its results are not reported in this study due to sensor damage during testing. The fitting degormation mechanism is visualized in Figure 4-8.

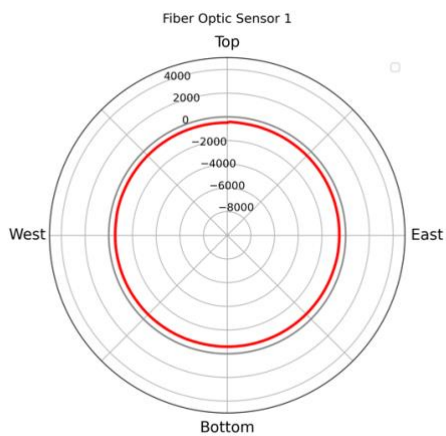
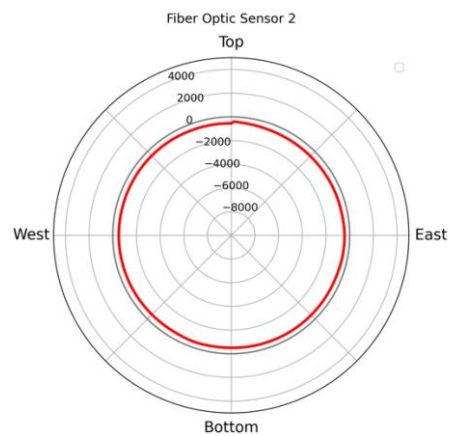
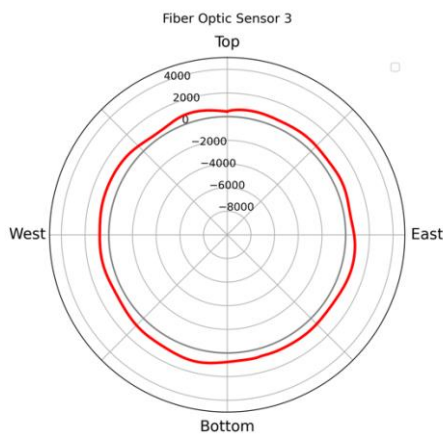
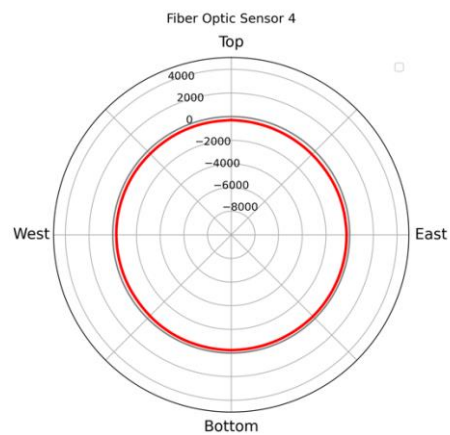
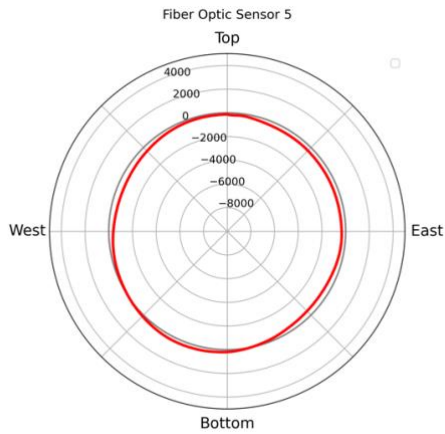
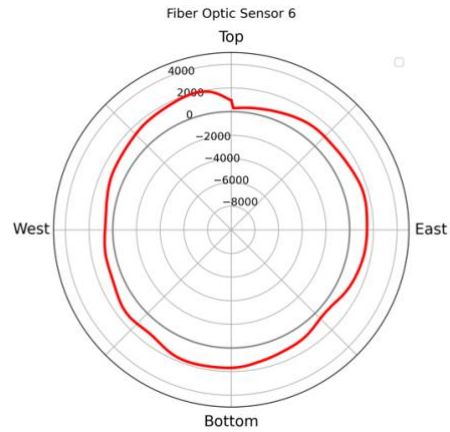
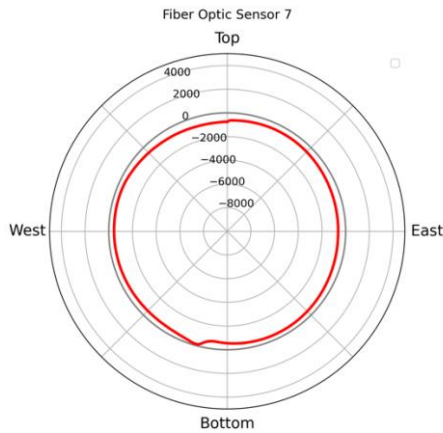
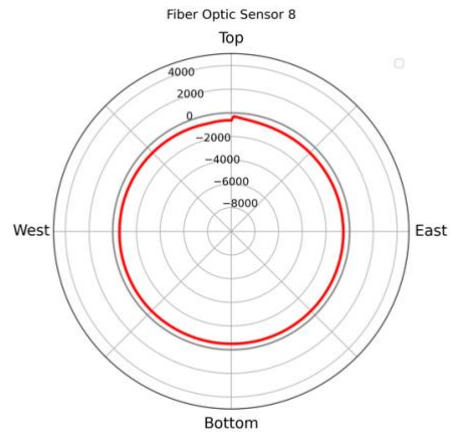
**Figure 4-9 Strain distribution in the circumferential direction of Specimen 2 under 11,500-LBS loading condition.**

Figure 4-9 shows the hoop strain results in Specimen 2. The sensor's locations are the same as that of Specimen 1. Similar to the observations in Specimen 1, both north and south pipes exhibited circumferential compression due to Poisson's effect. Circumferential tension was observed on the outer parts of the fitting (i.e., F3 and F6), while compressive strains were detected at the middle section of the fitting (F4 and F5). The observed mechanism in Specimen 2 is the same as that in Specimen 1.
